**MERRIGUM FLOOD STUDY
GREATER SHEPPARTON**

FINAL REPORT

September 2005

| Synopsis: | This report documents hydrologic and hydraulic modelling, results of a community flood questionnaire, damage assessment and inundation mapping for the township of Merrigum, located adjacent to the Mosquito Depression, 24 km west of Shepparton. The report focuses on the determination of flood levels and flood extents within the township and associated floodplain areas for a range of flood events. | |

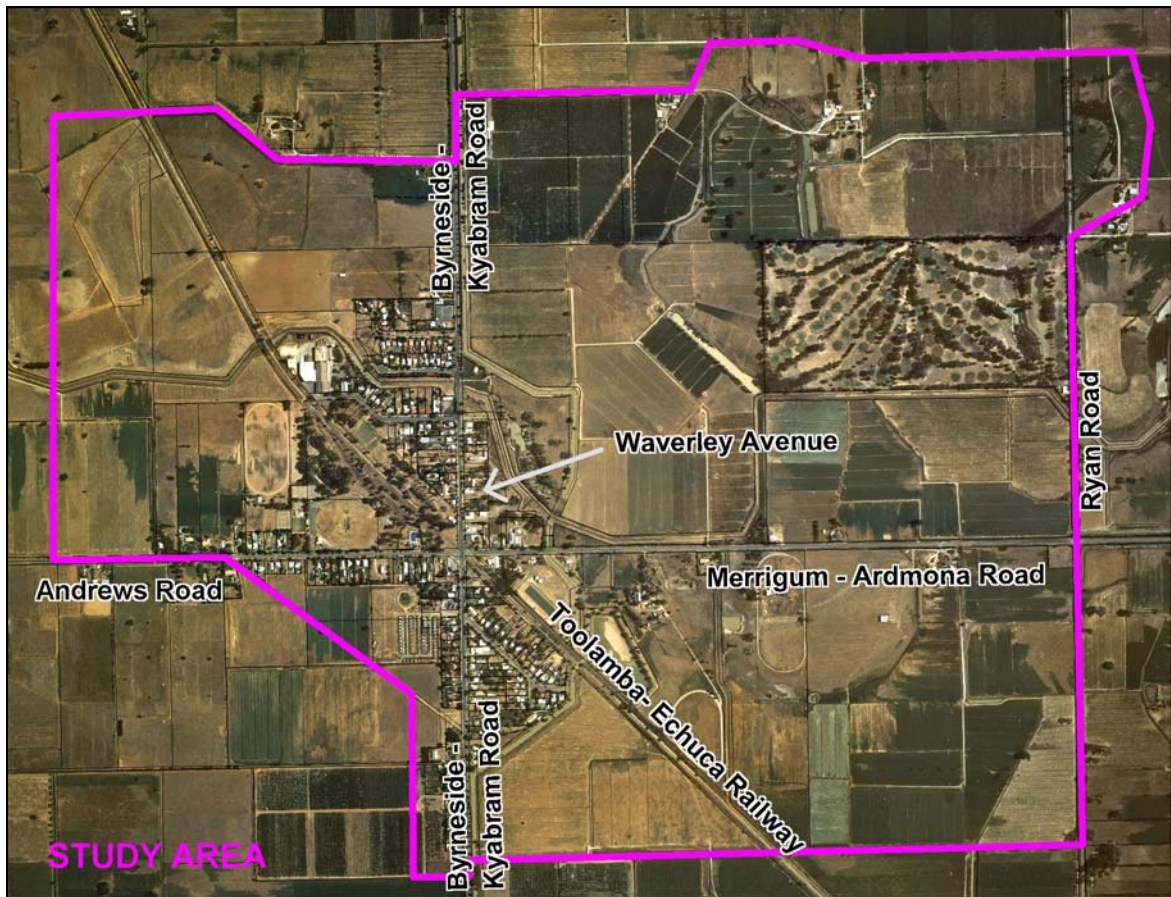
The Study Area is shown in Figure 1-1. The study area is the area to be hydraulically modelled and mapped using a two-dimensional flood model.

Figure 1-1 Study Area

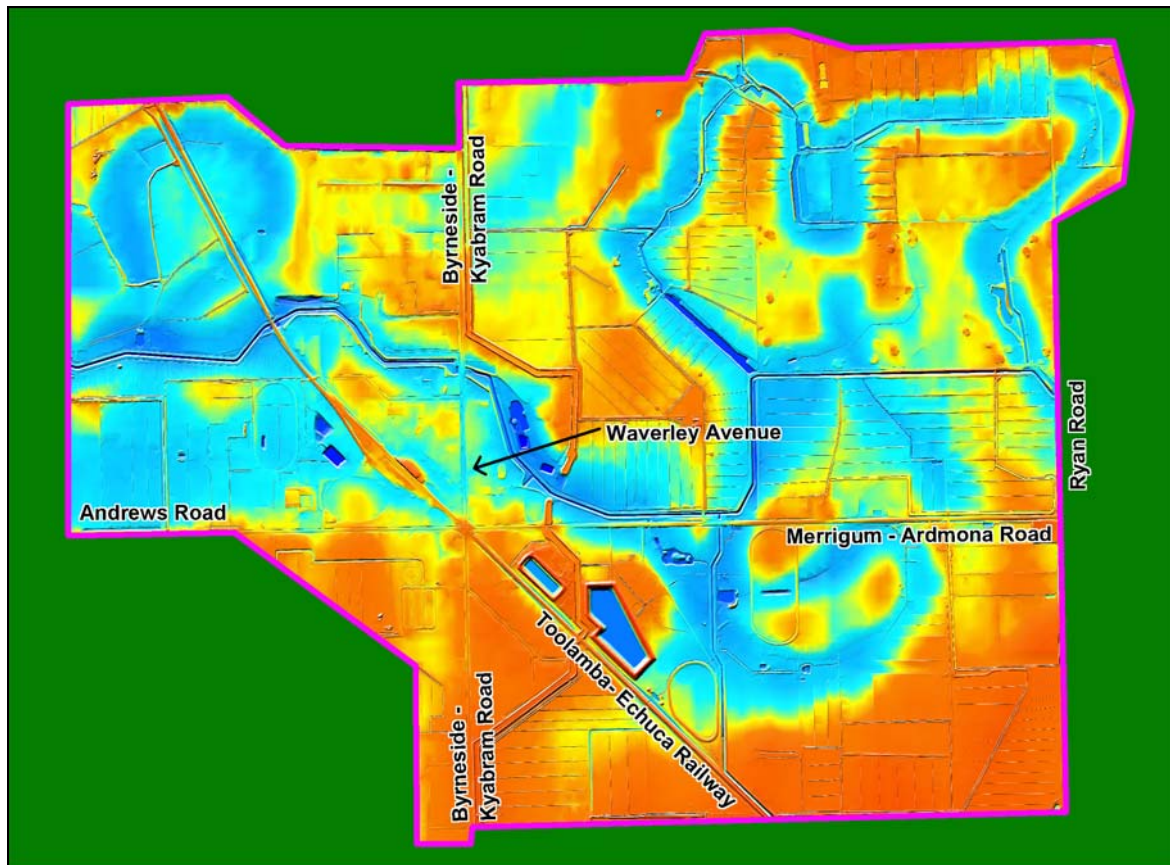
Aerial photography of the study area was flown on 17 November 2000 by QASCO, with photo control survey and data capture completed shortly thereafter. Data capture involved the derivation of spot heights and break lines over the entire Study Area. This data was later processed to develop a DEM of the study area, (Refer to Figure 2-1).

Figure 2-1 Merrigum Study Area DEM

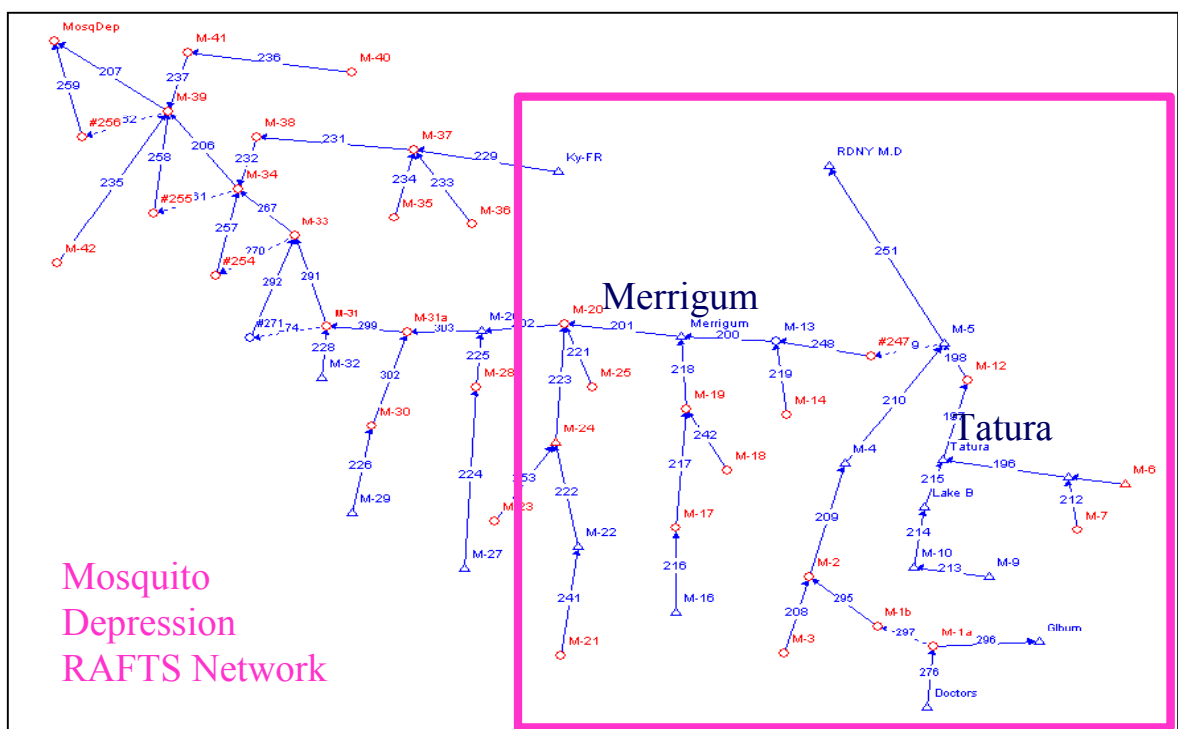
The RAFTS model at Merrigum is an overall model for the depression. It consists of the Mosquito Depression upstream of Tongala including East and West Branches. The total catchment area at Merrigum is 228 km² and is modelled in RAFTS by 19 sub-catchments.

Upstream of Merrigum, there is significant floodplain storage in the Depression. The model has major storages referred to as Doctors, Goulburn, Lake Boga and Lake Bartlett, and wetlands upstream of Tatura and in the catchment to the south of Merrigum or upper Byrneside-Merrigum catchment. A schematic of the model is presented in Figure 3-1. Note that low flows of up to 240 ML/d or 2.8 m³/s are diverted out of the depression 5 km downstream of Tatura to the Rodney Main Drain labelled in the schematic as RDNY MD node.

Figure 3-1 Mosquito Depression RAFTS Model Network

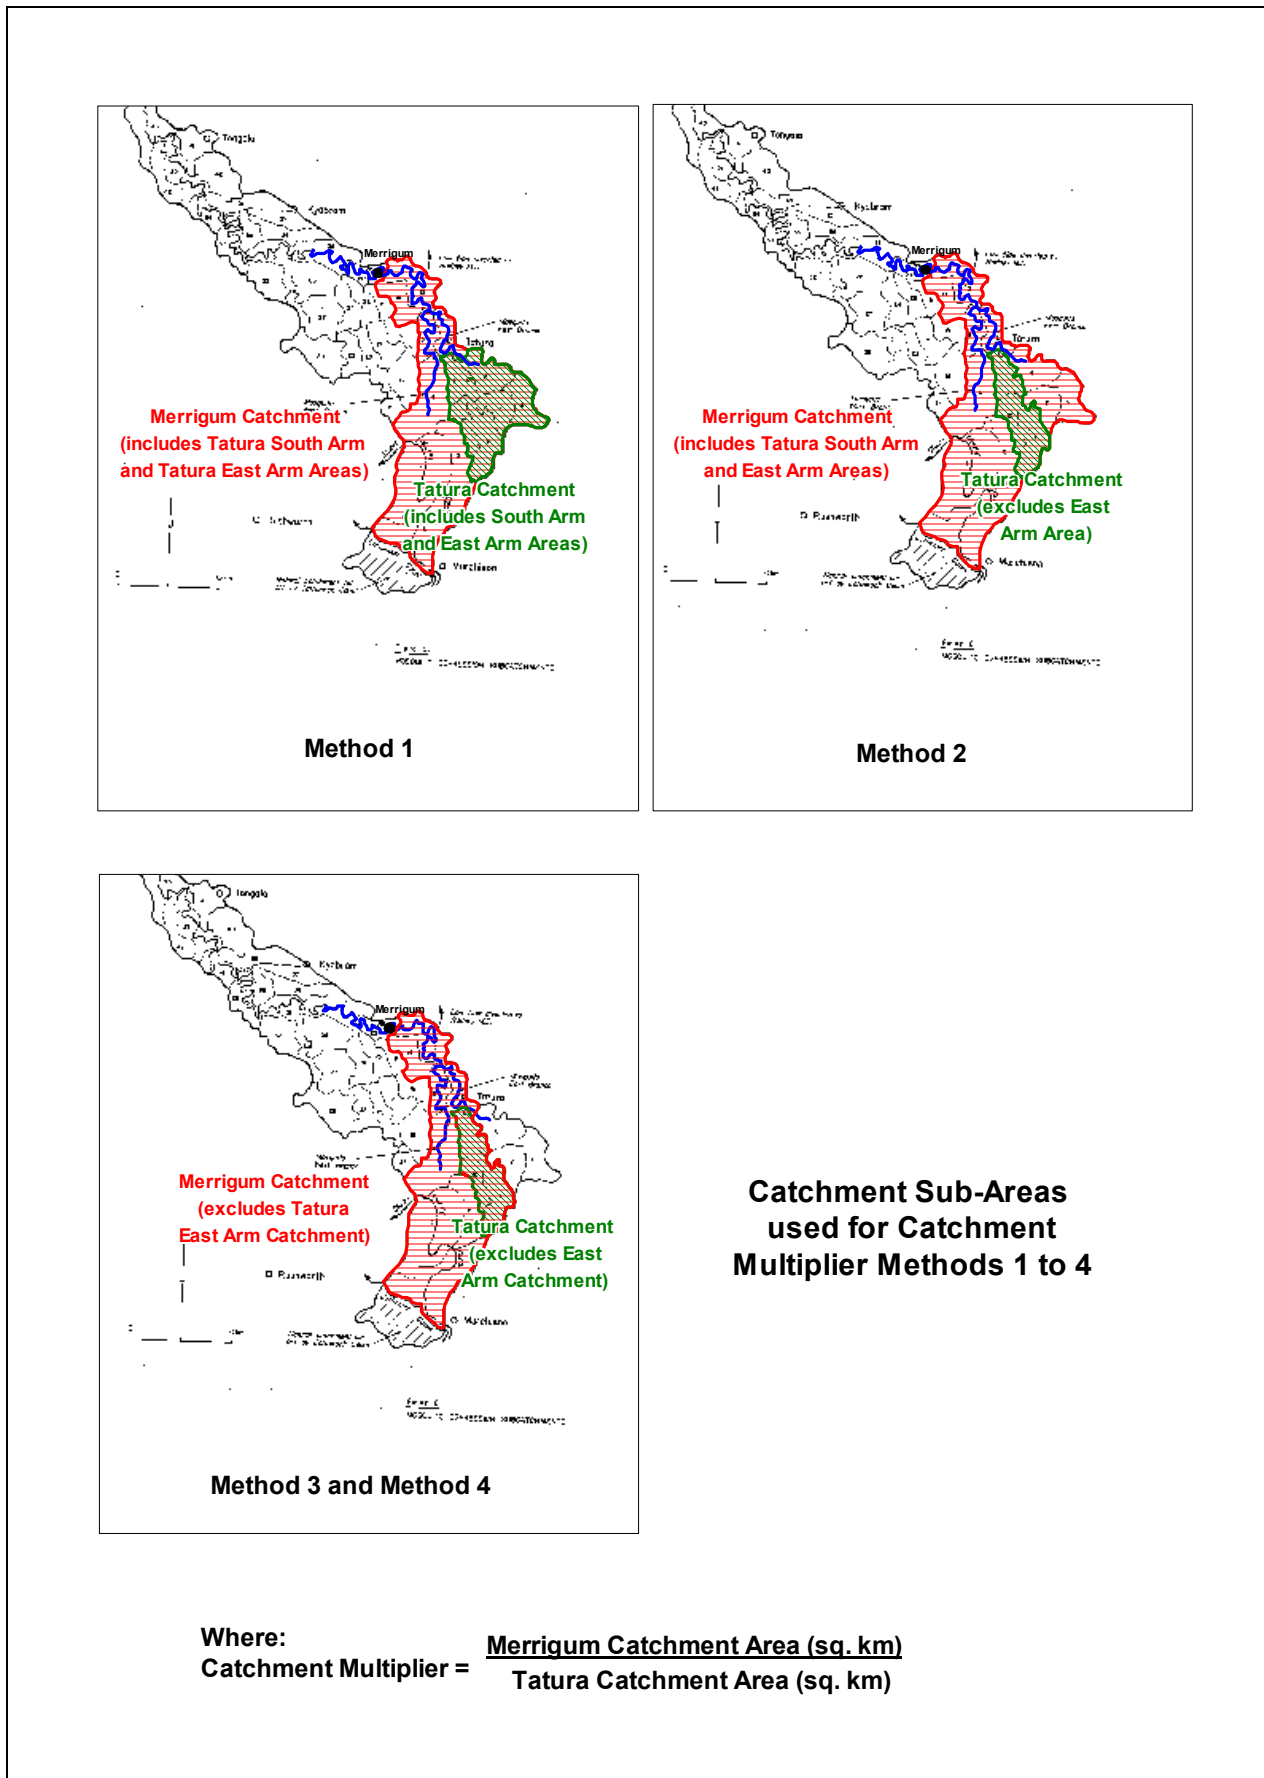
Peak flows at Merrigum have been determined below by translating modelled peak flows at Tatura using four different catchment multipliers or area-weighted factors. Four factors were calculated to demonstrate the sensitivity of the calculations to the underlying assumptions. The factors are discussed in more detail below. A diagram of the catchments used in each of the four methods is illustrated in Figure 3-2.

Figure 3-2 Catchment Multiplier Method

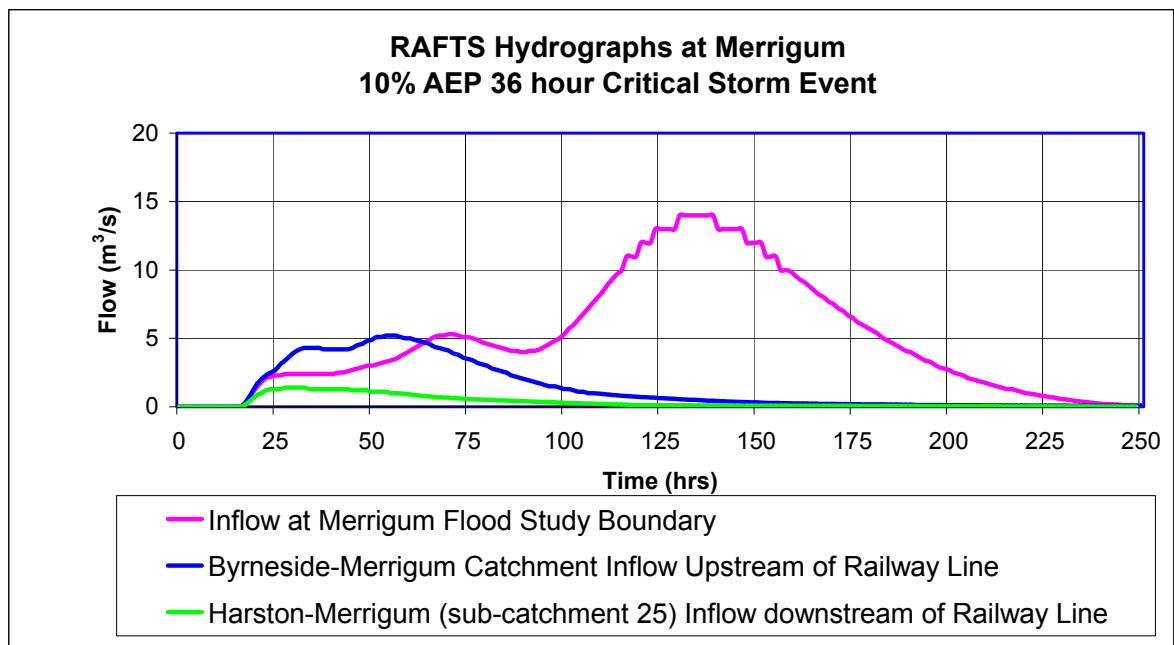
Figure 3-3 10-year ARI Hydrographs at Merrigum

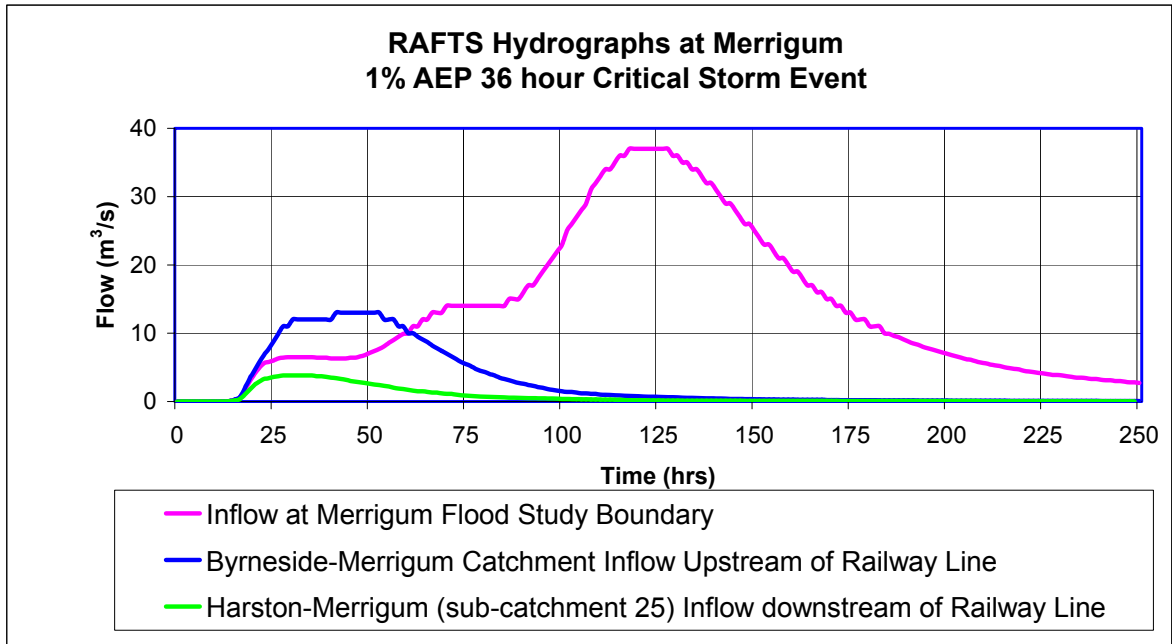
Figure 3-4 100-year ARI Hydrographs at Merrigum

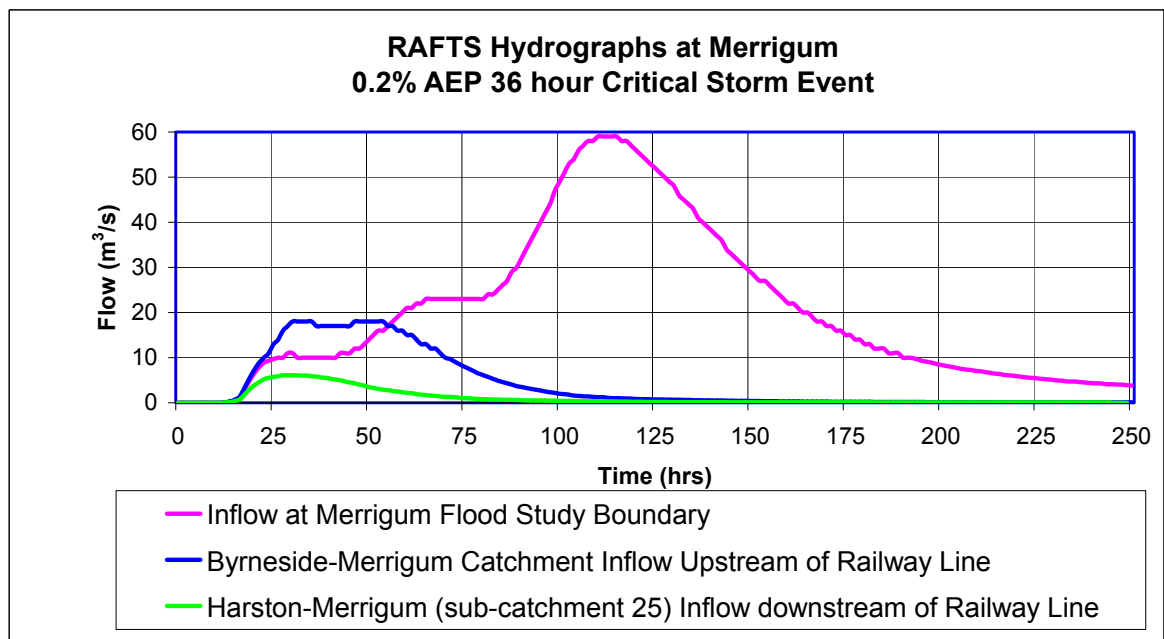
Figure 3-5 500-year ARI Hydrographs at Merrigum

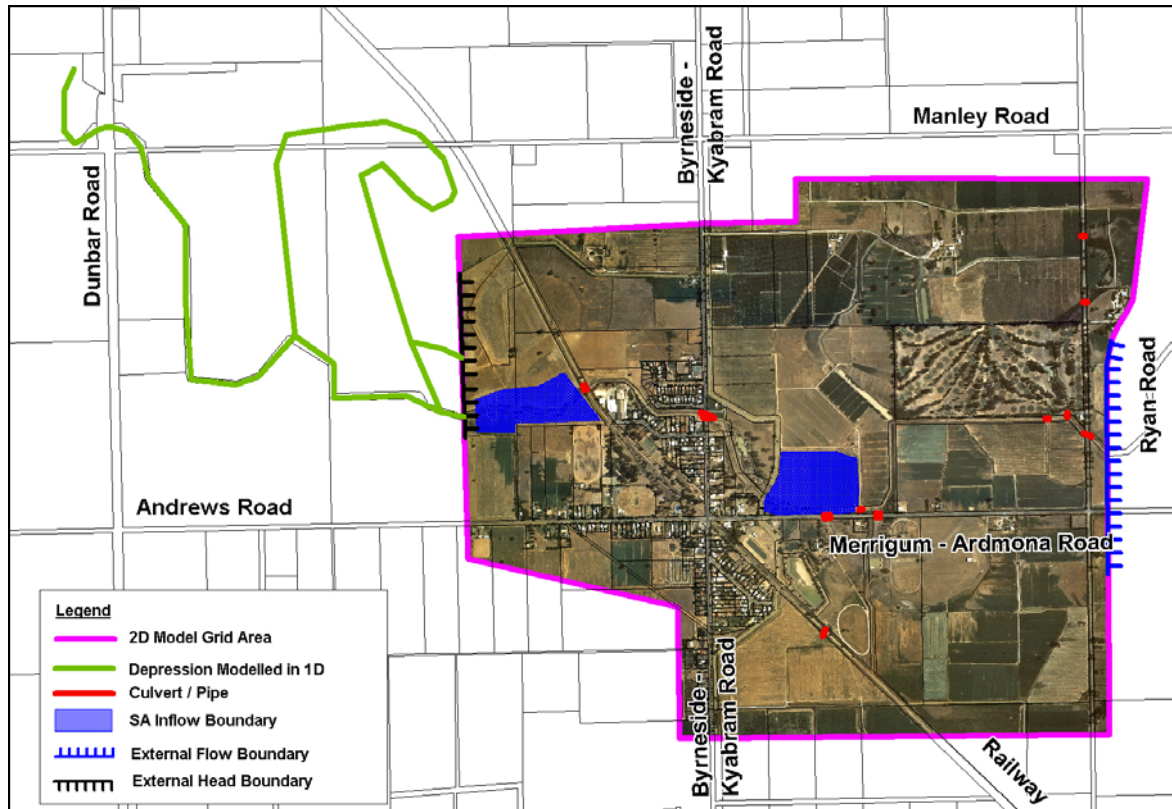
The area encompassed by the model is bounded in the north near Manley Road, the east near Ryan Road, in the south near Fenaughty Road and in the west by near Dunbar Road. The layout of the TUFLOW model for the simulation of flood flows in Merrigum is illustrated in Figure 4-1.

Figure 4-1 2D Hydraulic Model Layout

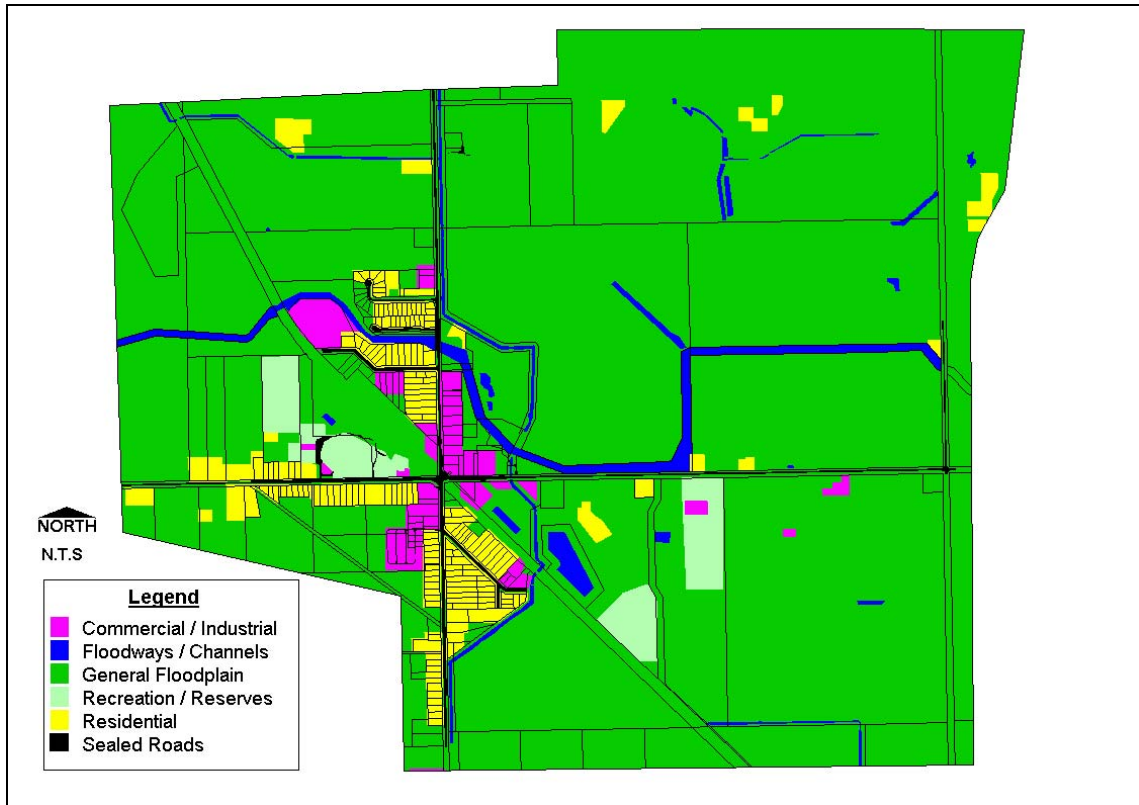
Roughness parameters for the model (Table 4-1) were developed using a combination of data from the GSCC planning scheme, aerial photography and field inspections carried out by WBM. Manning's Roughness Coefficient (n) distribution for the model area is shown in Figure 4-2.

Figure 4-2 Manning's 'n' Distribution

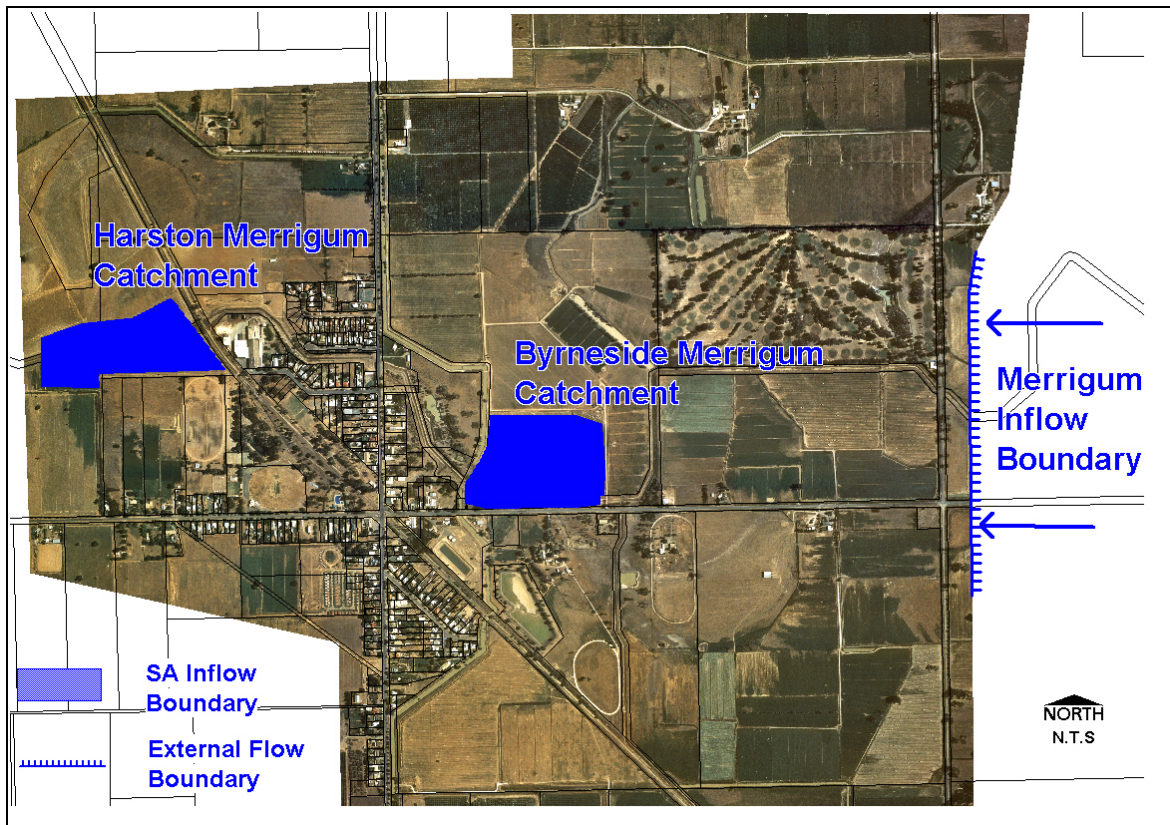
Flows for the model boundary conditions were provided as part of hydrological assessment, Section 3.6. Inflows to the Merrigum model occur as external flow boundary conditions (i.e. runoff from areas outside the model domain). The key inputs to the model, as referred to in the hydrological assessment, are:

- Merrigum (upstream study boundary);
- Byrneside Merrigum catchment (upstream of Railway Line);
- Harston Merrigum sub-catchment (downstream of Railway Line).

The Byrneside and Harston flow boundaries represent runoff from their respective catchments. The total flows from these catchments were distributed directly over the Mosquito Depression as sub-area rainfall boundaries (SA boundaries), as shown in Figure 4-3. This approach was adopted as the study was principally concerned about flooding from the Mosquito Depression, not local catchments. The flows from these catchments peak much earlier and are much smaller in magnitude than flows in the Mosquito Depression (i.e. the Merrigum Inflow Boundary), hence the adopted approach has no impact on peak flood levels in the Depression.

Figure 4-3 Boundary Condition Configuration

The downstream boundary condition on the 1D section of the model, near Dunbar Road, was adopted as a stage-discharge curve. The curve was developed using an approximated cross-section from available contour information, as well as typical ground slopes in the area. Sensitivity testing showed that peak water levels in the 2D study area were largely independent of the water level adopted near Dunbar Road

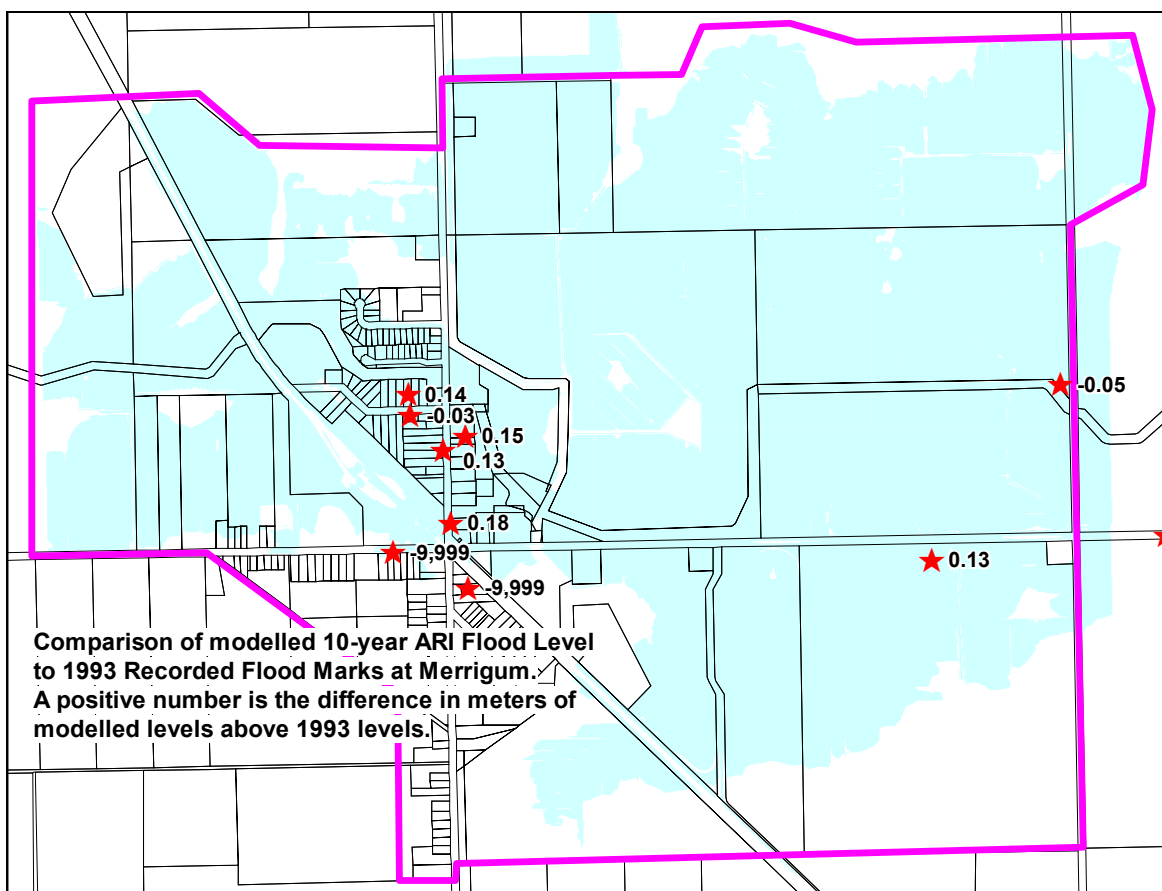
Figure 5-1 Comparison of Modelled 10-year ARI Peak Flood Levels and October 1993 Flood Marks*

* Note: A difference of 9,999 denotes that the surveyed flood mark is outside the modelled flood extent.

As a general observation, the discrepancy between modelled and flood mark levels is still within the accuracies that can be expected given changed floodplain conditions since 1993, the photogrammetric DEM accuracy (i.e. ± 0.10 to 0.15m), and the uncertainty in recalling anecdotal flood level marks and associated inaccuracies in their survey ($\pm 0.05\text{m}$).

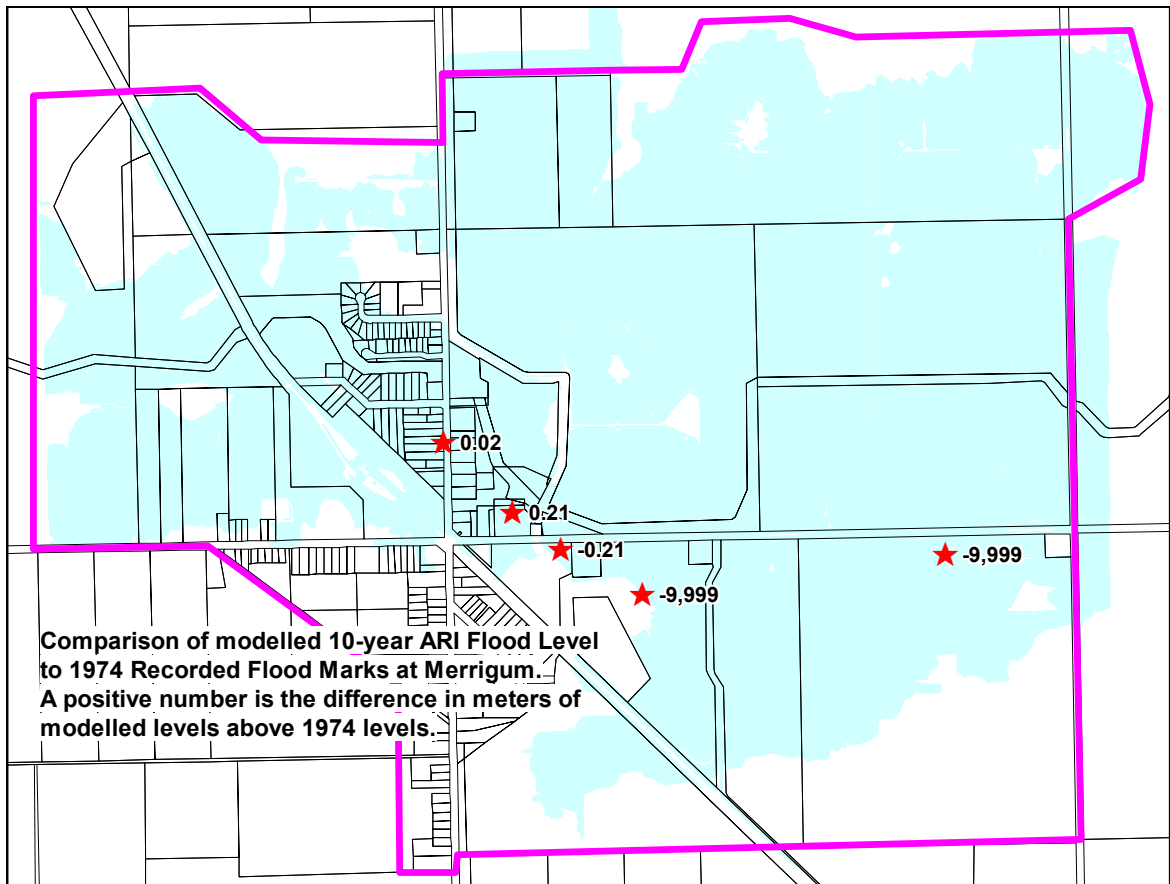
Figure 5-2 Comparison of Modelled 10-year ARI Peak Flood Levels and May 1974 Flood Marks*

* Note: A difference of -9,999 denotes that the surveyed flood mark is outside the modelled flood extent.

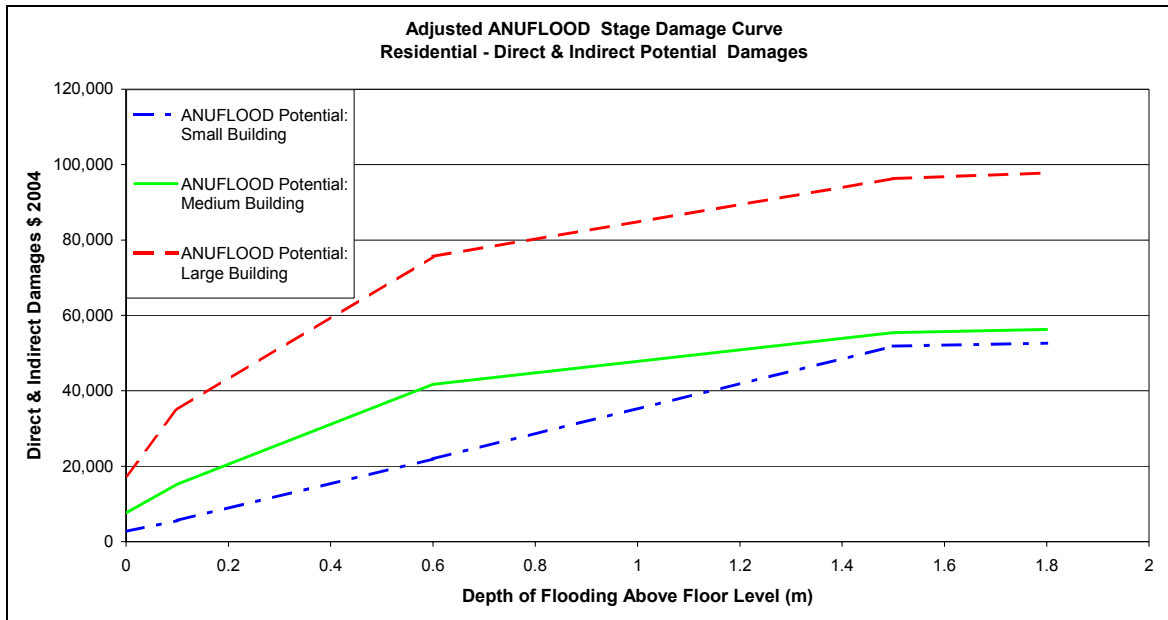
Figure 6-1 shows adjusted ANUFLOOD potential damages for residential above floor flooding. Table 6-2 and Table 6-3 show potential and adjusted actual damages estimated for Merrigum respectively.

Figure 6-1 Residential Stage Damage Curve for Merrigum

Flood damage assessment using ANUFLOOD involves use of building floor and flood level information in conjunction with ANUFLOOD residential stage damage curves. Residential stage-damage ANUFLOOD curves are from the RAM (Rapid Appraisal Method) report (NRE, 2000). Non-residential ANUFLOOD stage-damage curves are from a journal paper titled “Flood Damage Estimation – A review of urban stage-damage curves and loss functions” (Smith, 1994). For comparison purposes, damages have also been estimated using the RAM method but are not discussed in any detail here.

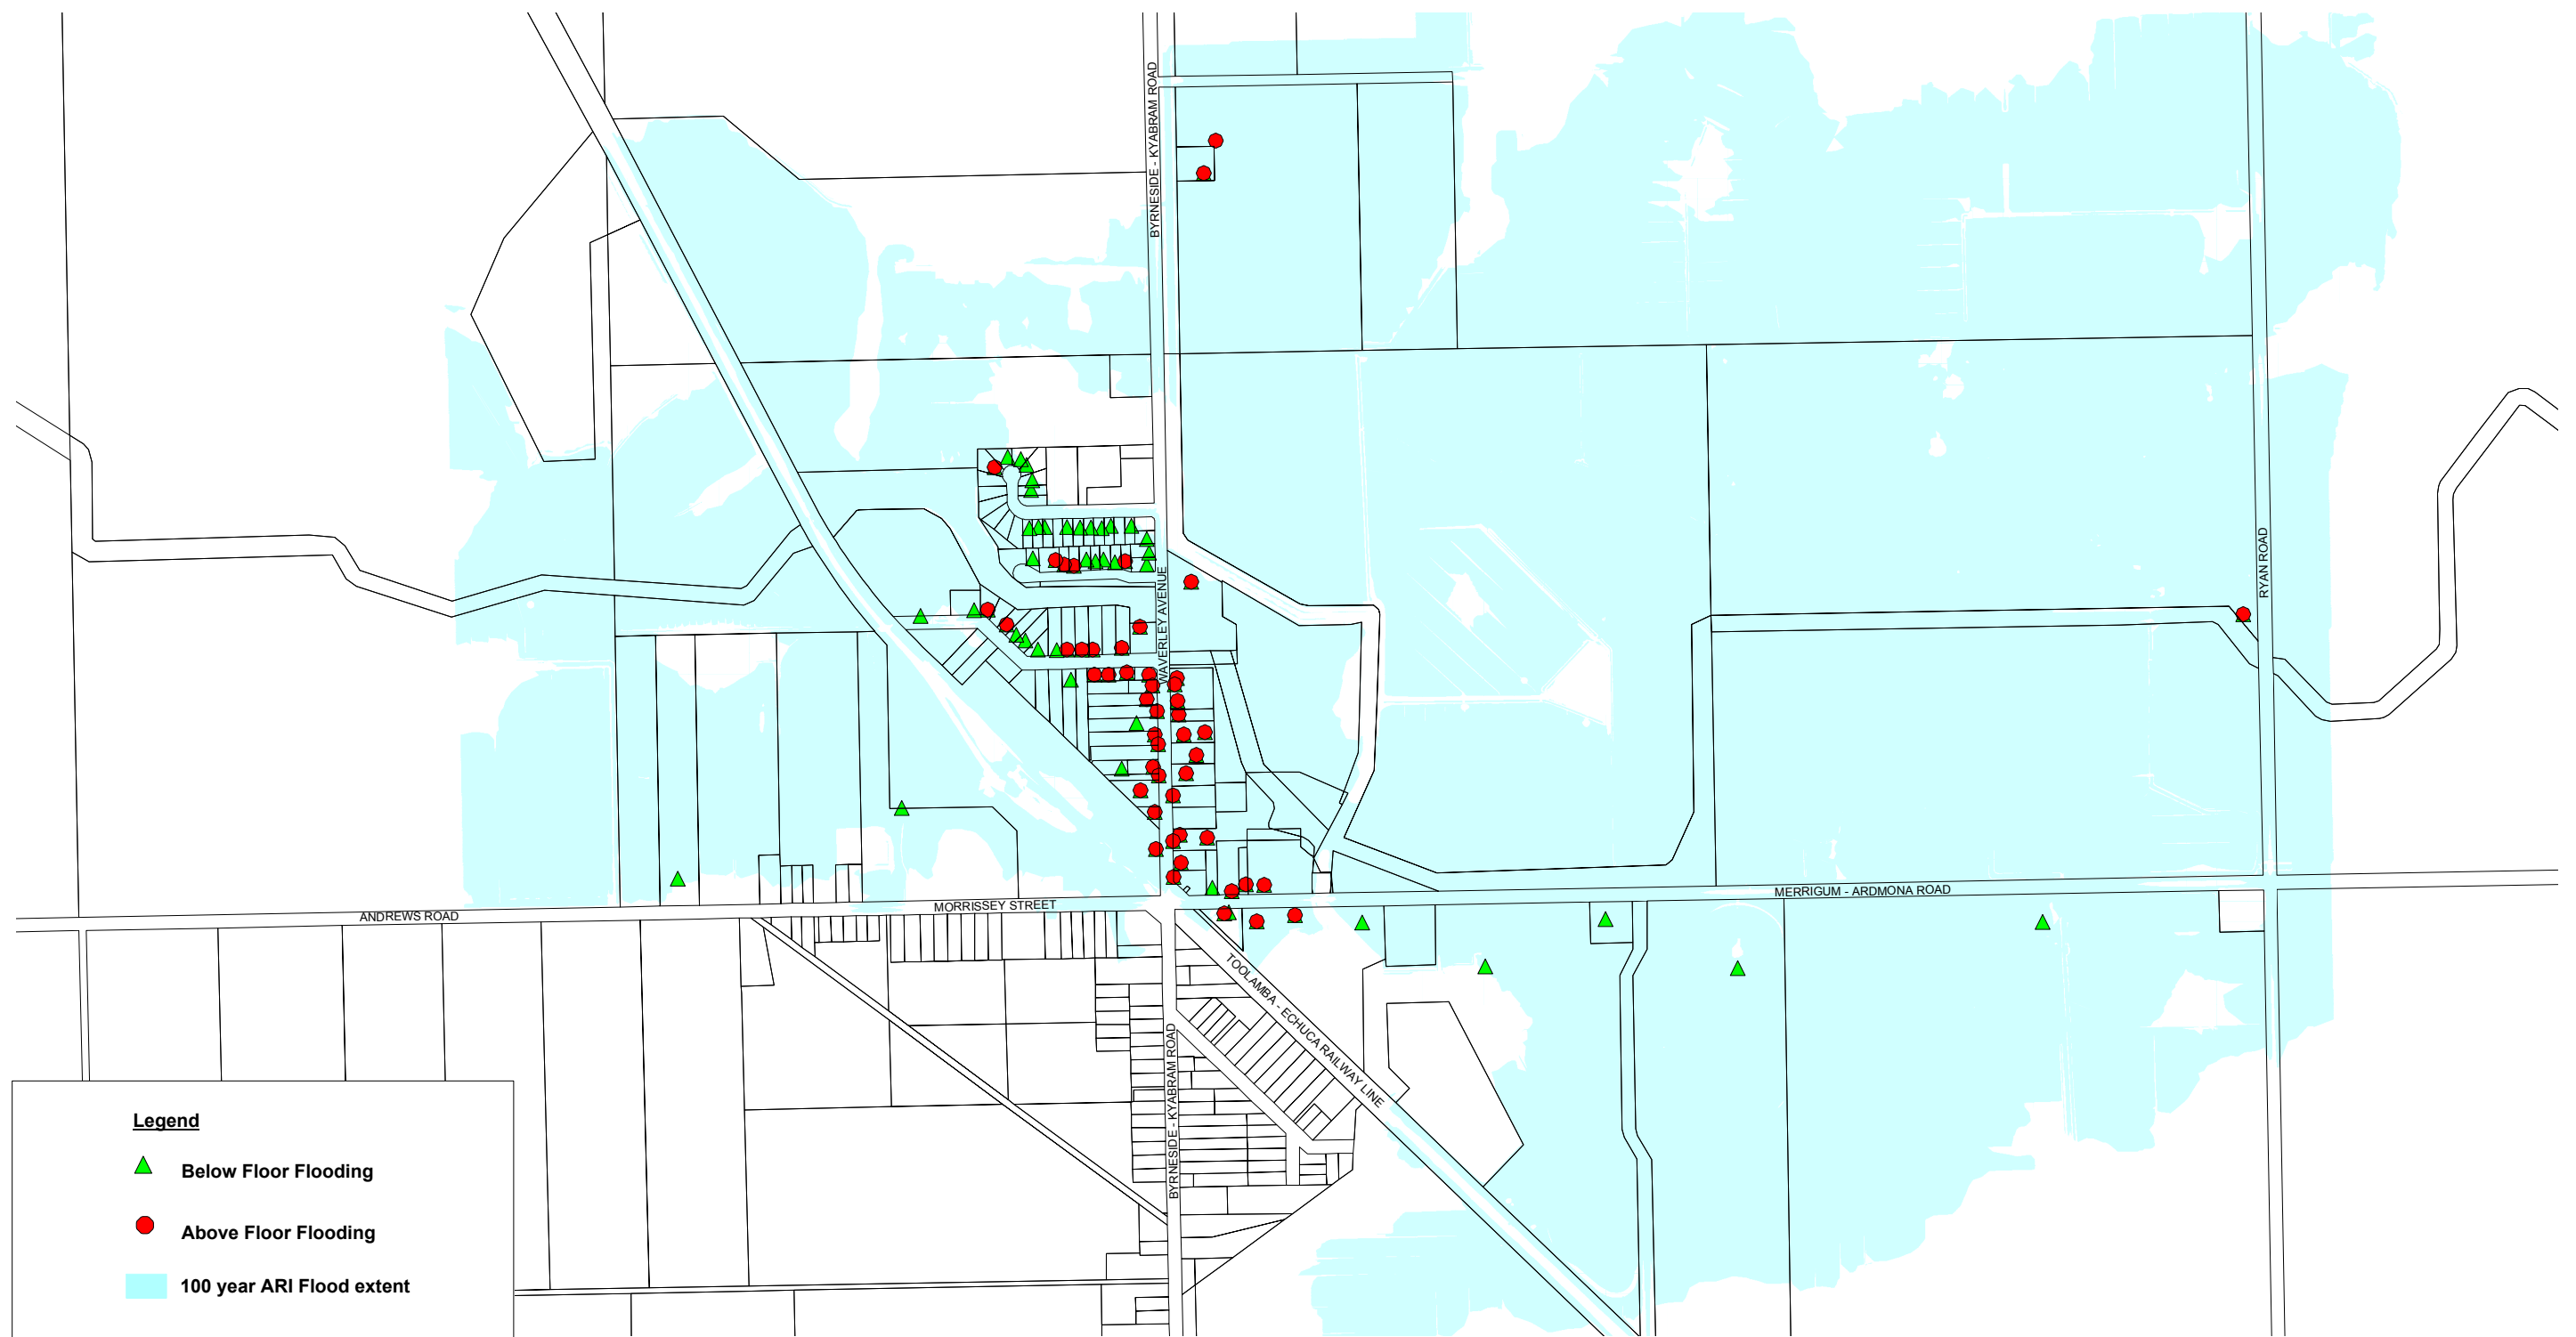
Figure 6-2 Distribution of Above and Below Floor Inundation - 100 year ARI Event

Floor level and natural surface data (Refer to Section 2.2.3) was compared to flood levels generated by TUFLOW to determine the depth of property inundation. The comparison indicates above floor level inundation of a significant number of properties. In total, of the 215 floor levels surveyed, 73 were inundated above floor level by the modelled 1 in 100-year ARI event. It should be noted that this damage assessment is for flooding resulting from the main Mosquito Depression only and does not include properties that may be inundated by flooding from local catchments.

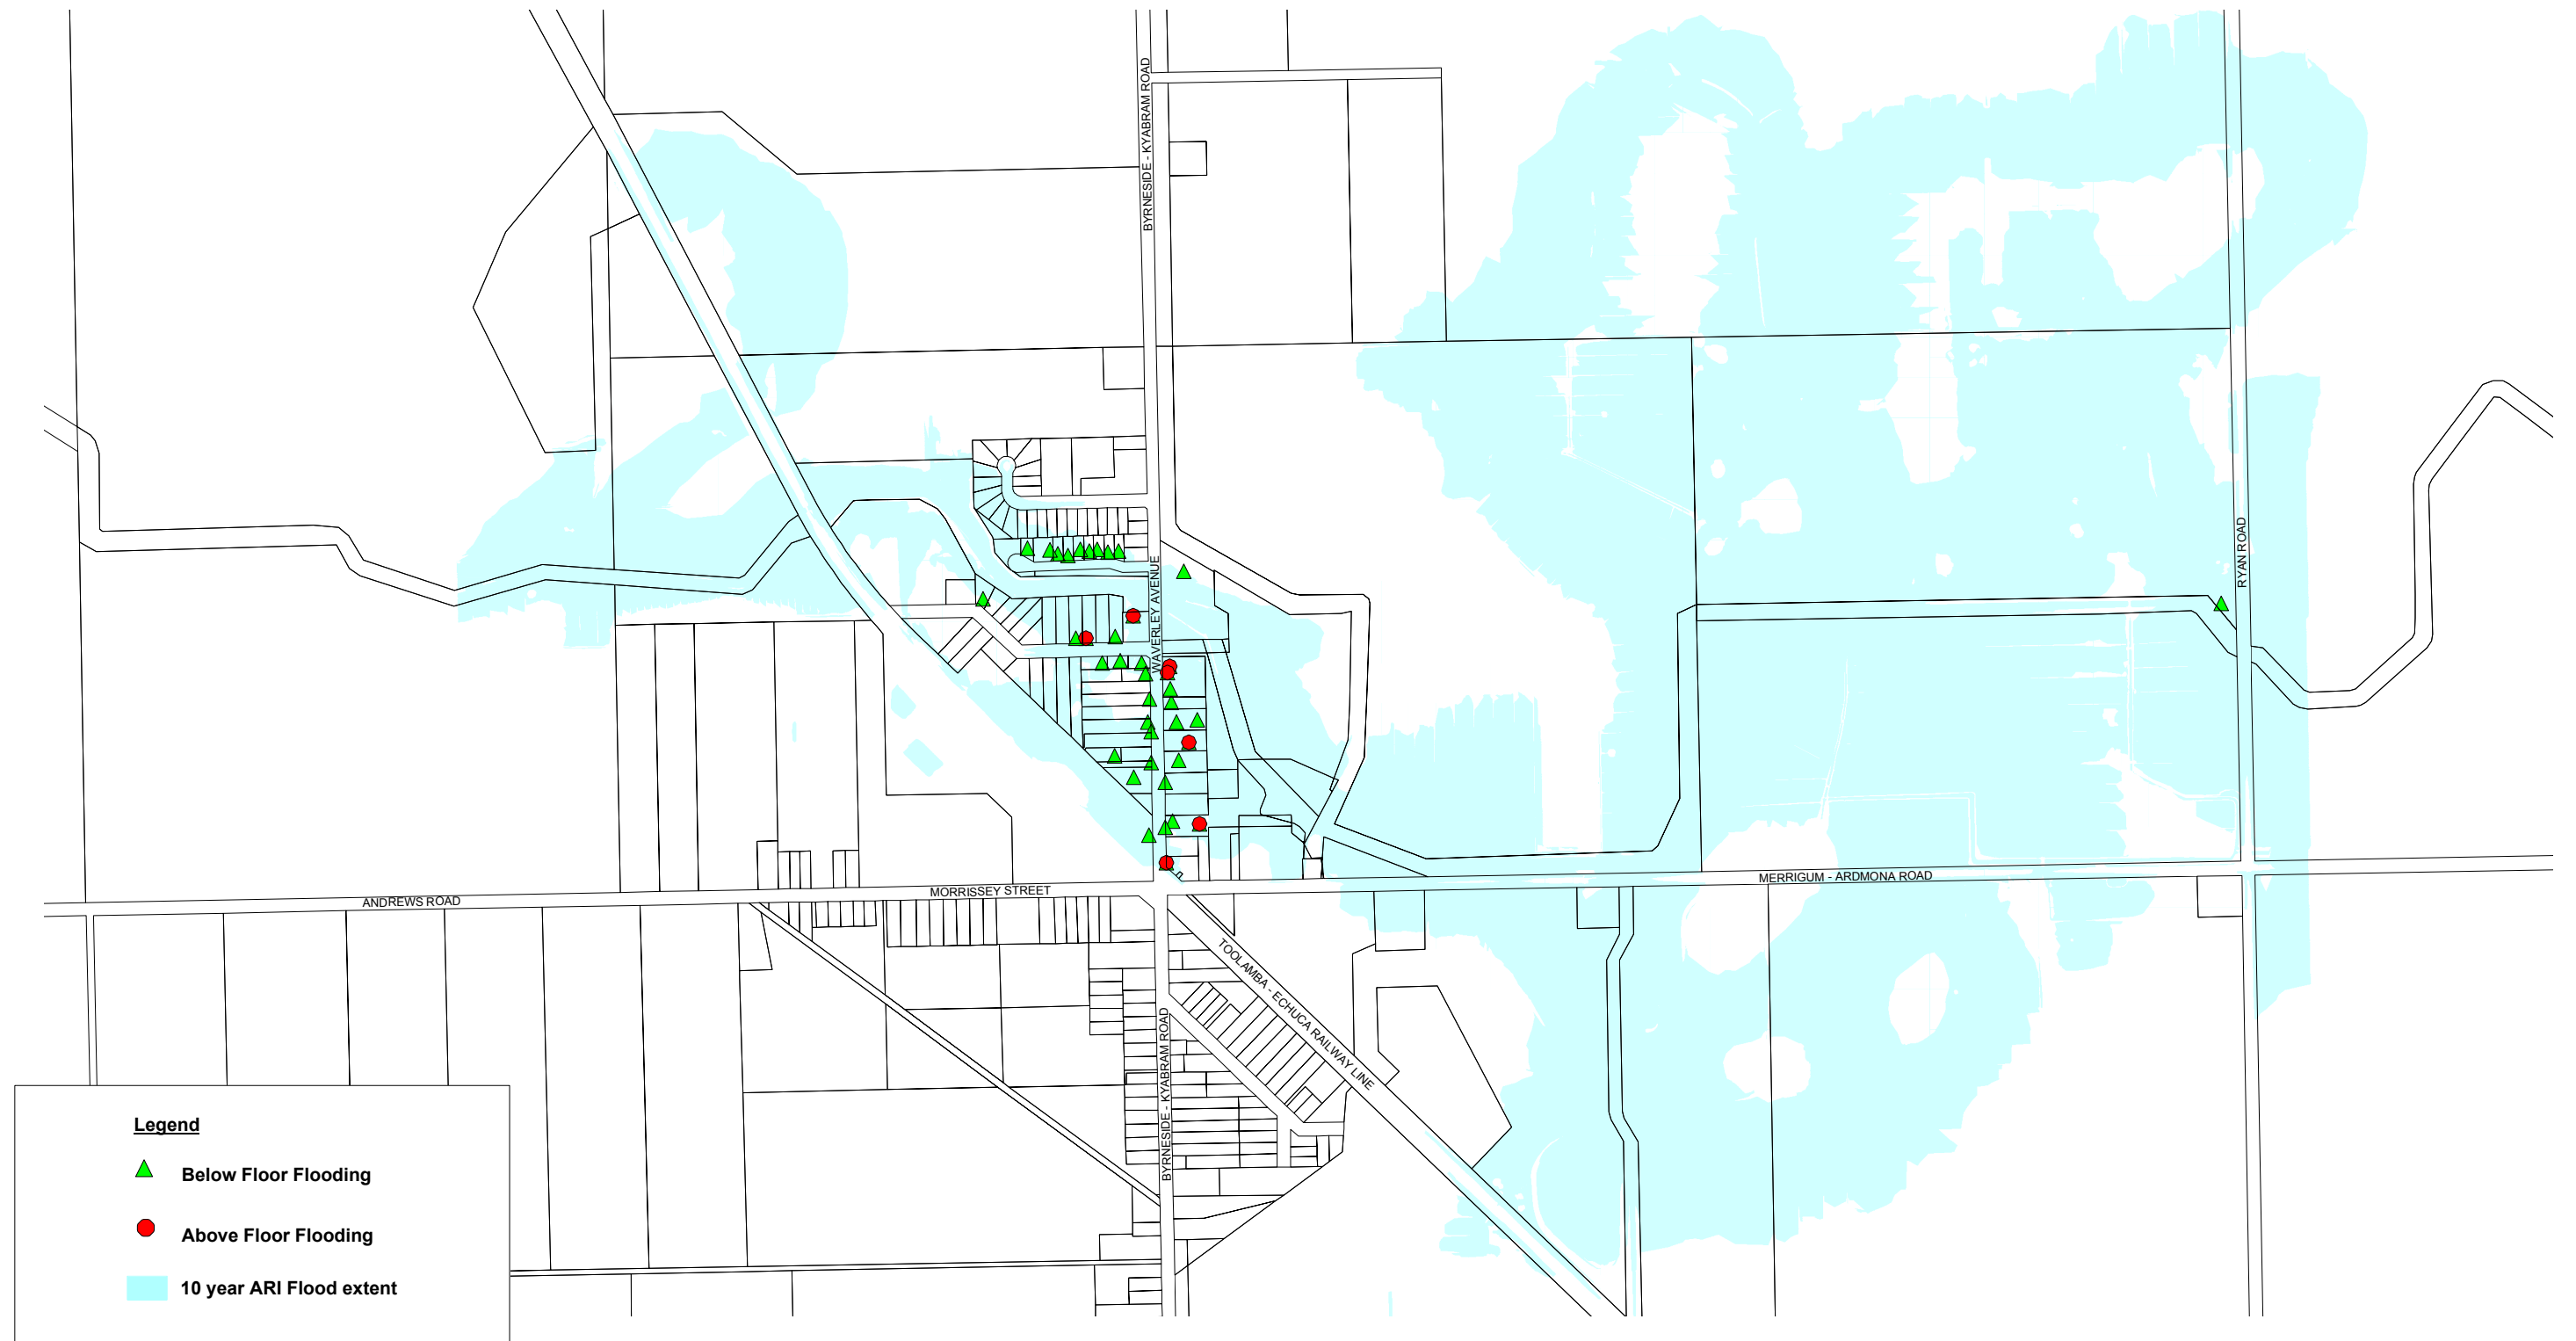
Figure 6-3 Distribution of Above and Below Floor Inundation - 10 year ARI Event

Numbers of buildings inundated above floor levels for a specified depth increment are indicated in Table 6-5. The damage curve for the existing condition is presented in Figure 6-3.

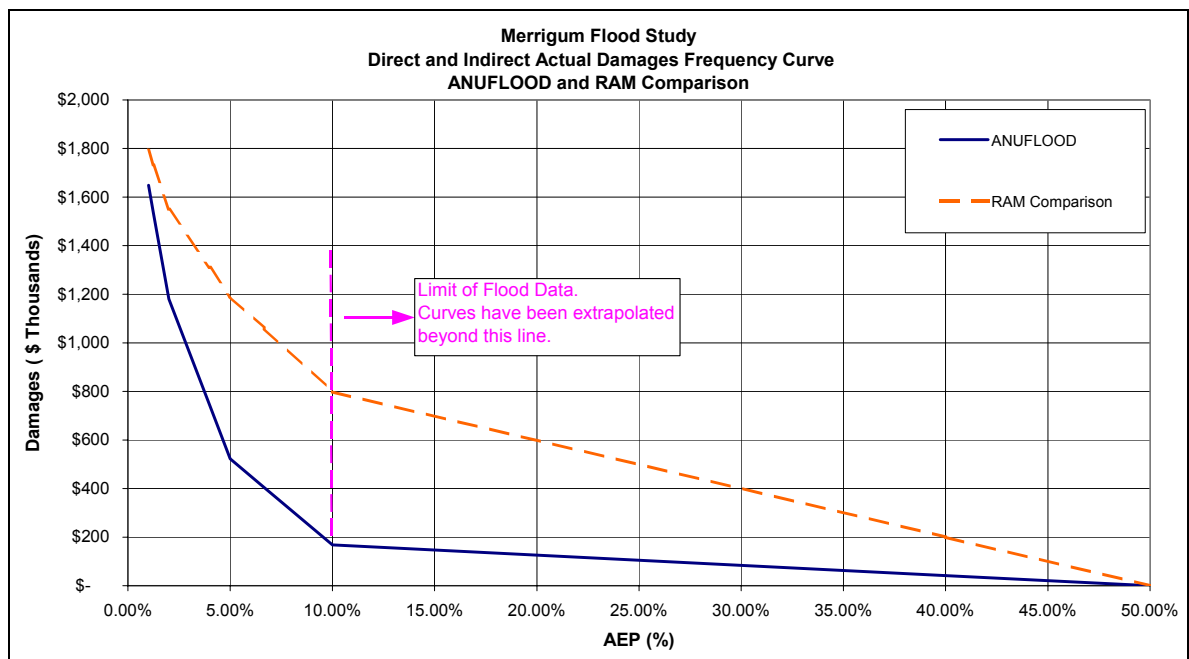
Flood damages were estimated using the ANUFLOOD method for the 10, 20, 50 and 100-year ARI design flood events. The Average Annual Damage (AAD) estimate due to flooding at Merrigum is \$92,000. For comparison purposes, the RAM estimate of AAD is \$257,000. Given that ANUFLOOD uses a more comprehensive methodology than RAM, an estimate of \$92,000 AAD should be adopted for Merrigum.

Figure 6-4 ANUFLOOD Damages Curve
