**MERRIGUM FLOOD STUDY
GREATER SHEPPARTON**

FINAL REPORT

September 2005

| Synopsis: | This report documents hydrologic and hydraulic modelling, results of a community flood questionnaire, damage assessment and inundation mapping for the township of Merrigum, located adjacent to the Mosquito Depression, 24 km west of Shepparton. The report focuses on the determination of flood levels and flood extents within the township and associated floodplain areas for a range of flood events. | |

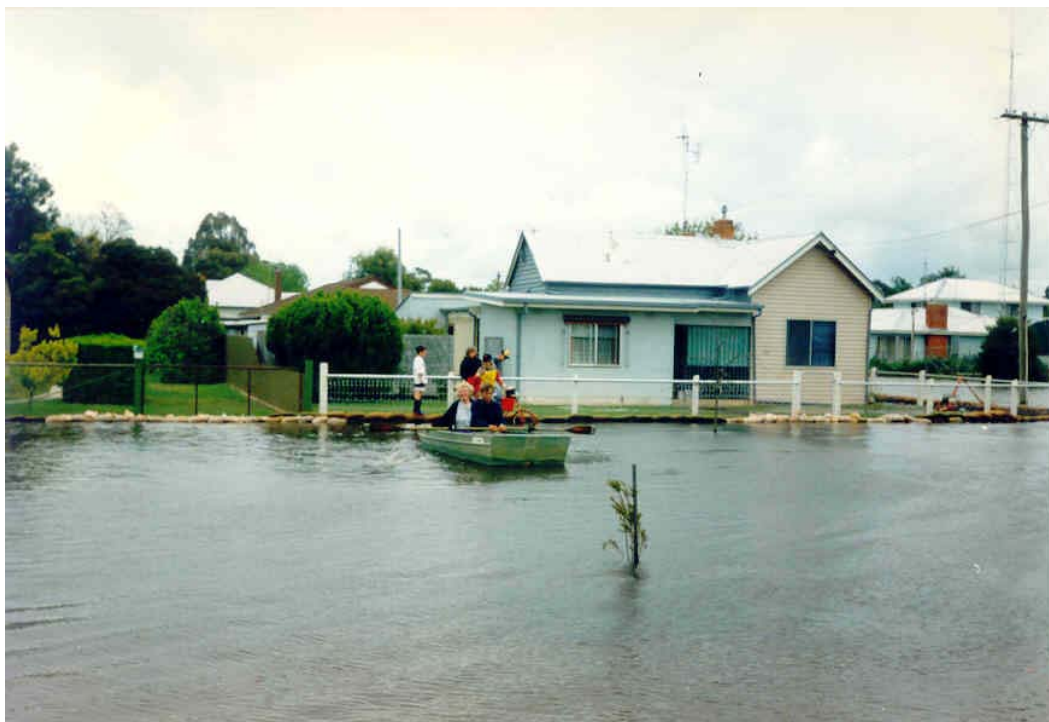
Waverley Avenue Flooding 1993

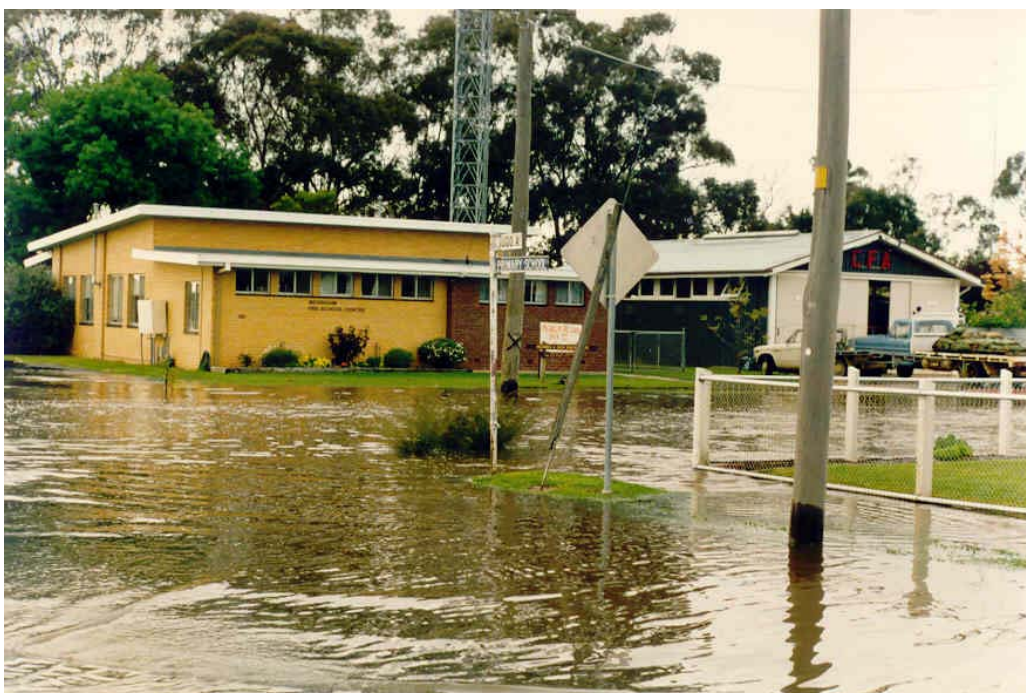
Flooding at corner of Judd & Waverley Avenues - 1993

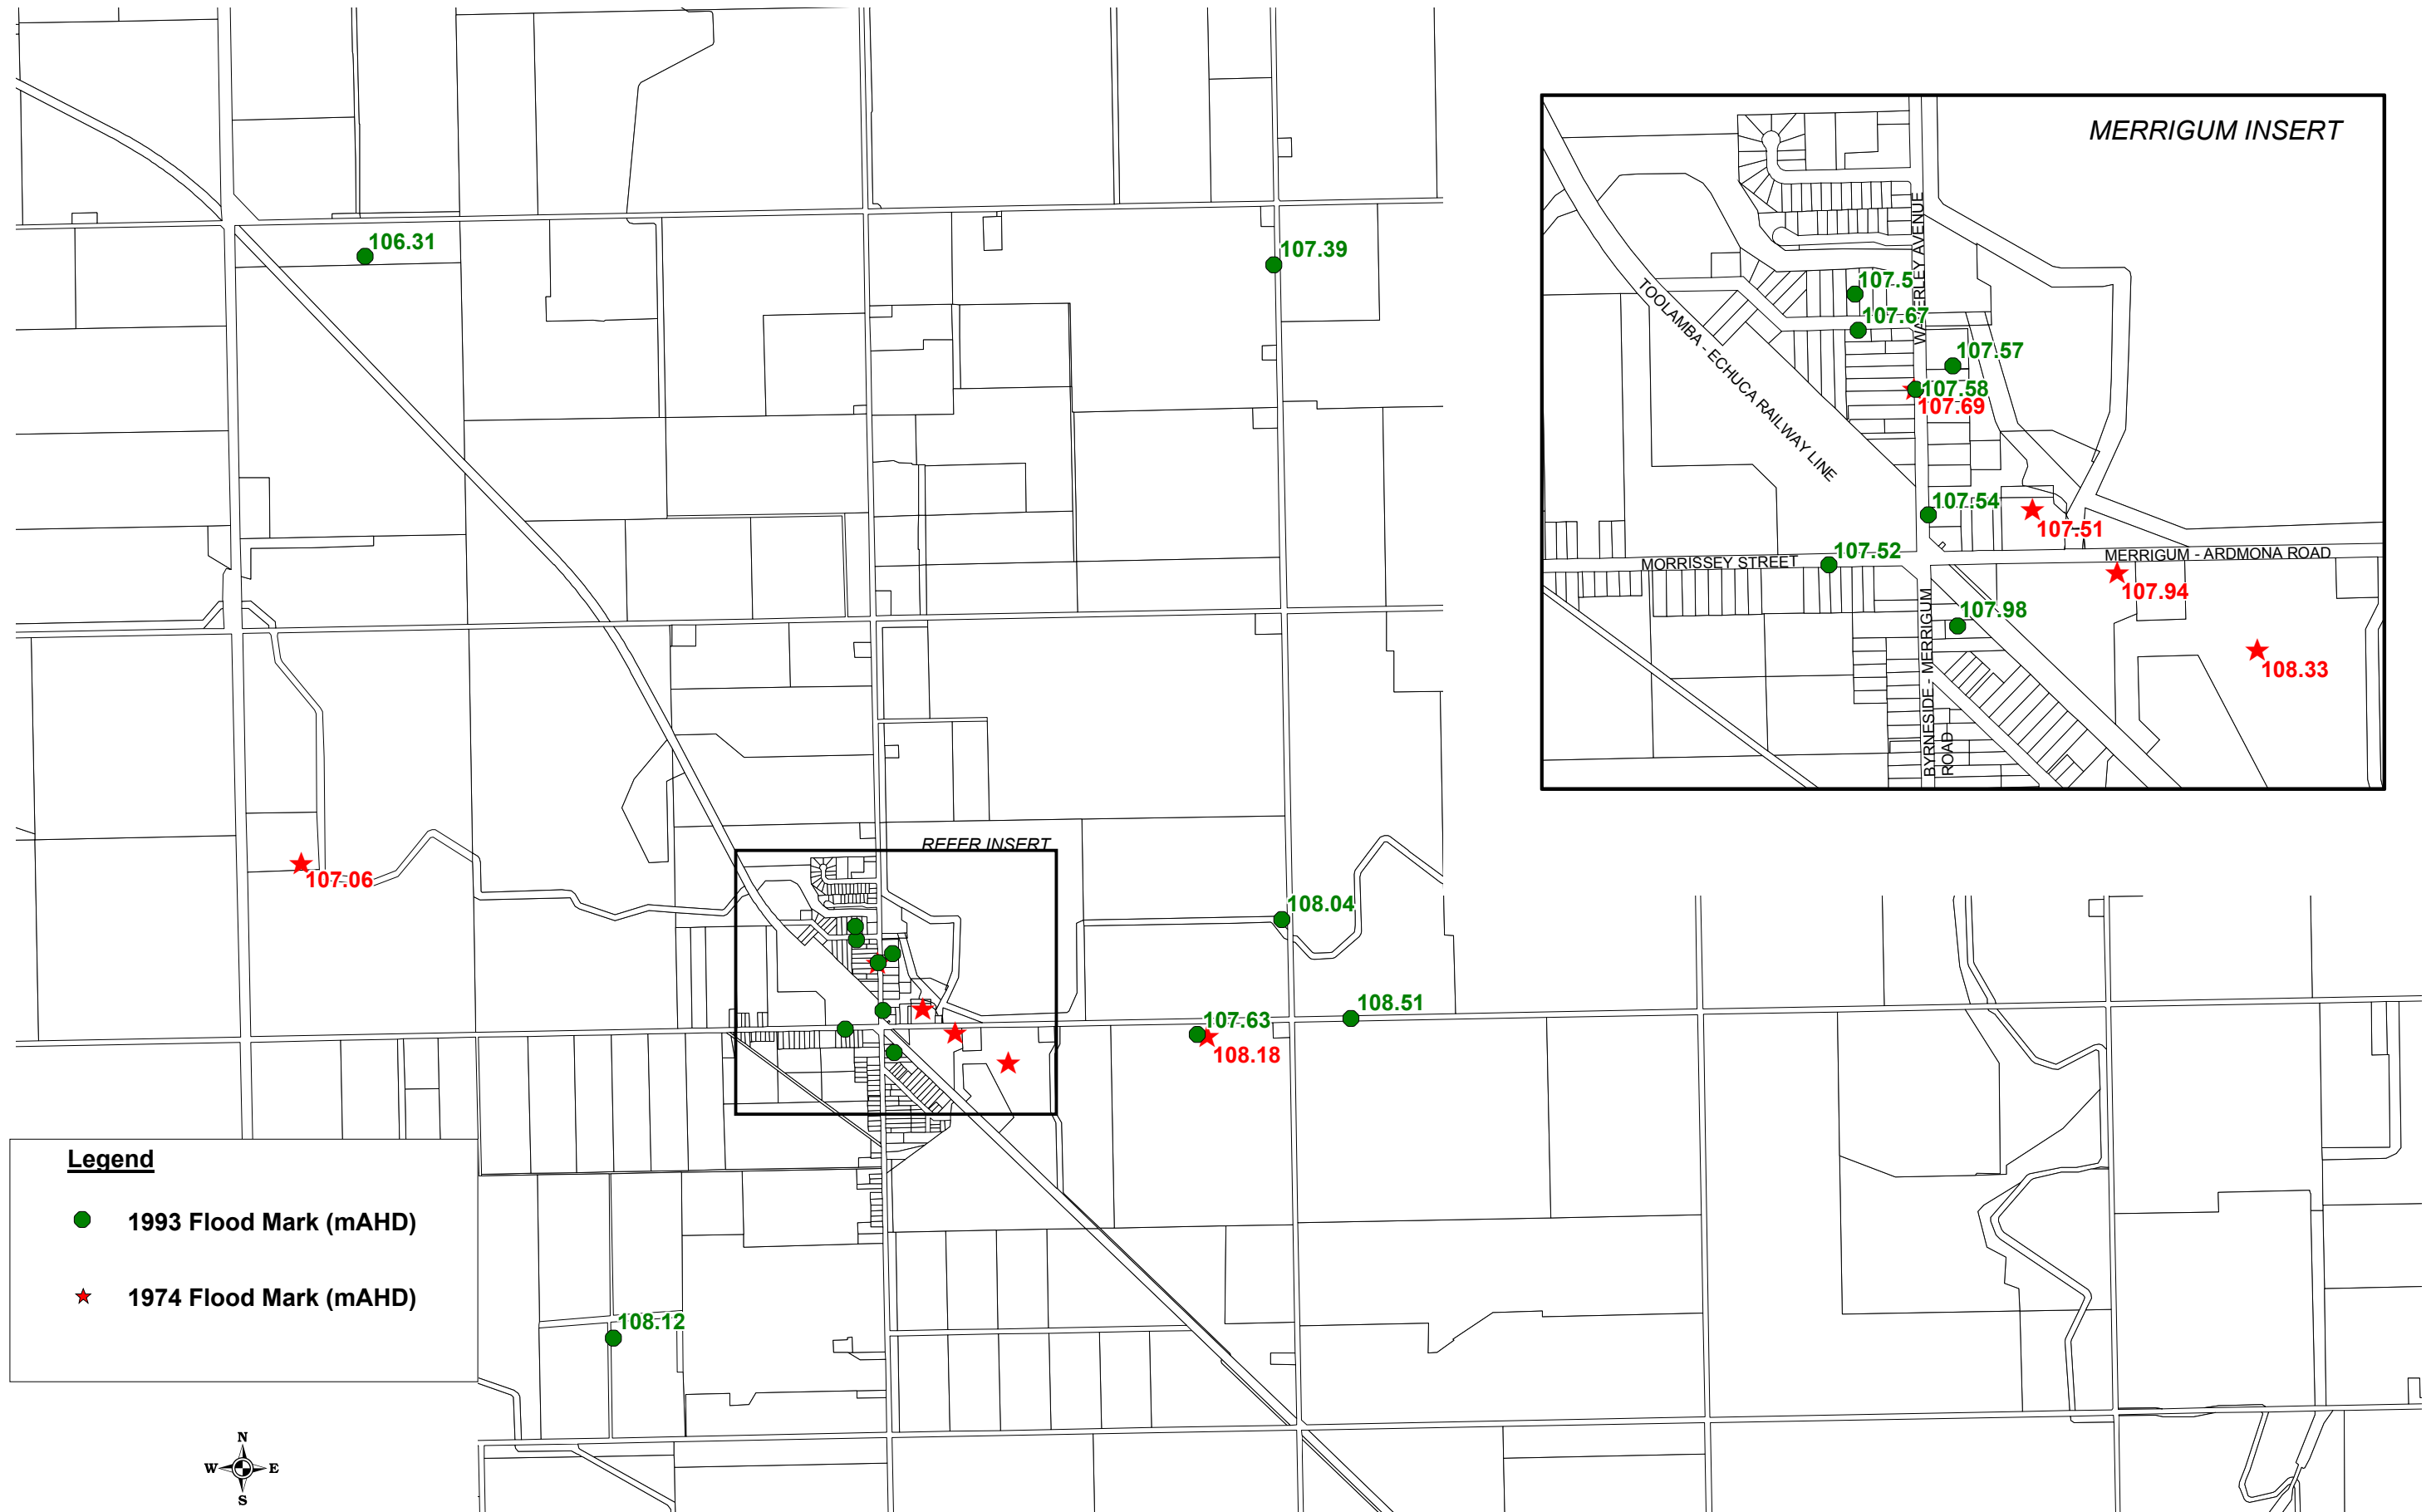
Distribution of Historical Flood Marks for the Mosquito Depression at Merrigum
