# Murchison Flood Mapping Study Report

**May 2014**

| Project Name | Murchison Flood Mapping Study |
| Client | Goulburn Broken CMA & Greater Shepparton City Council |

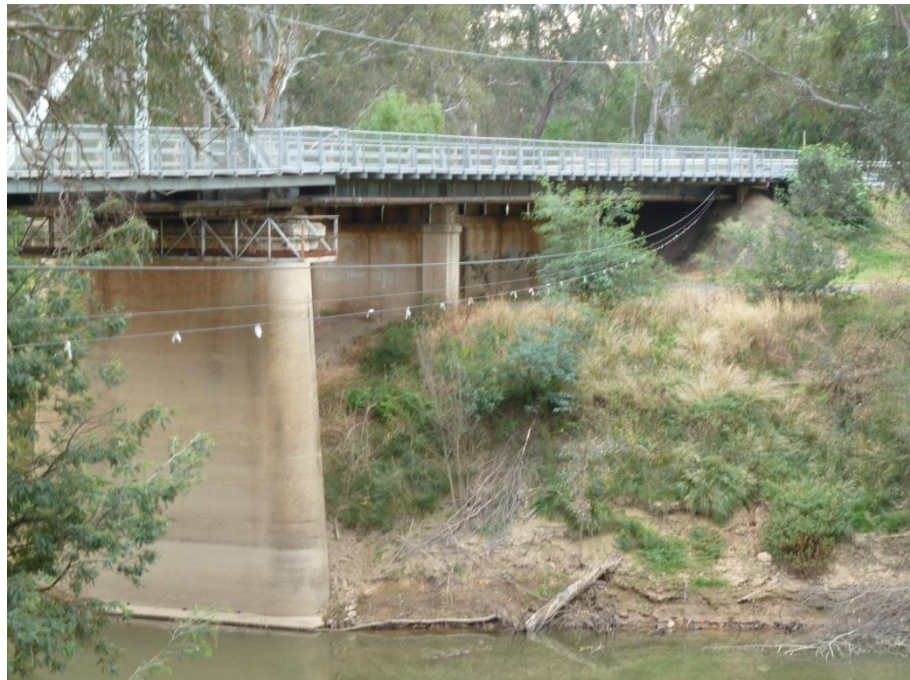
**Cover Photo:** Upstream view of the Bendigo-Murchison Road bridge over the Goulburn River – Photo courtesy of the Goulburn Broken CMA

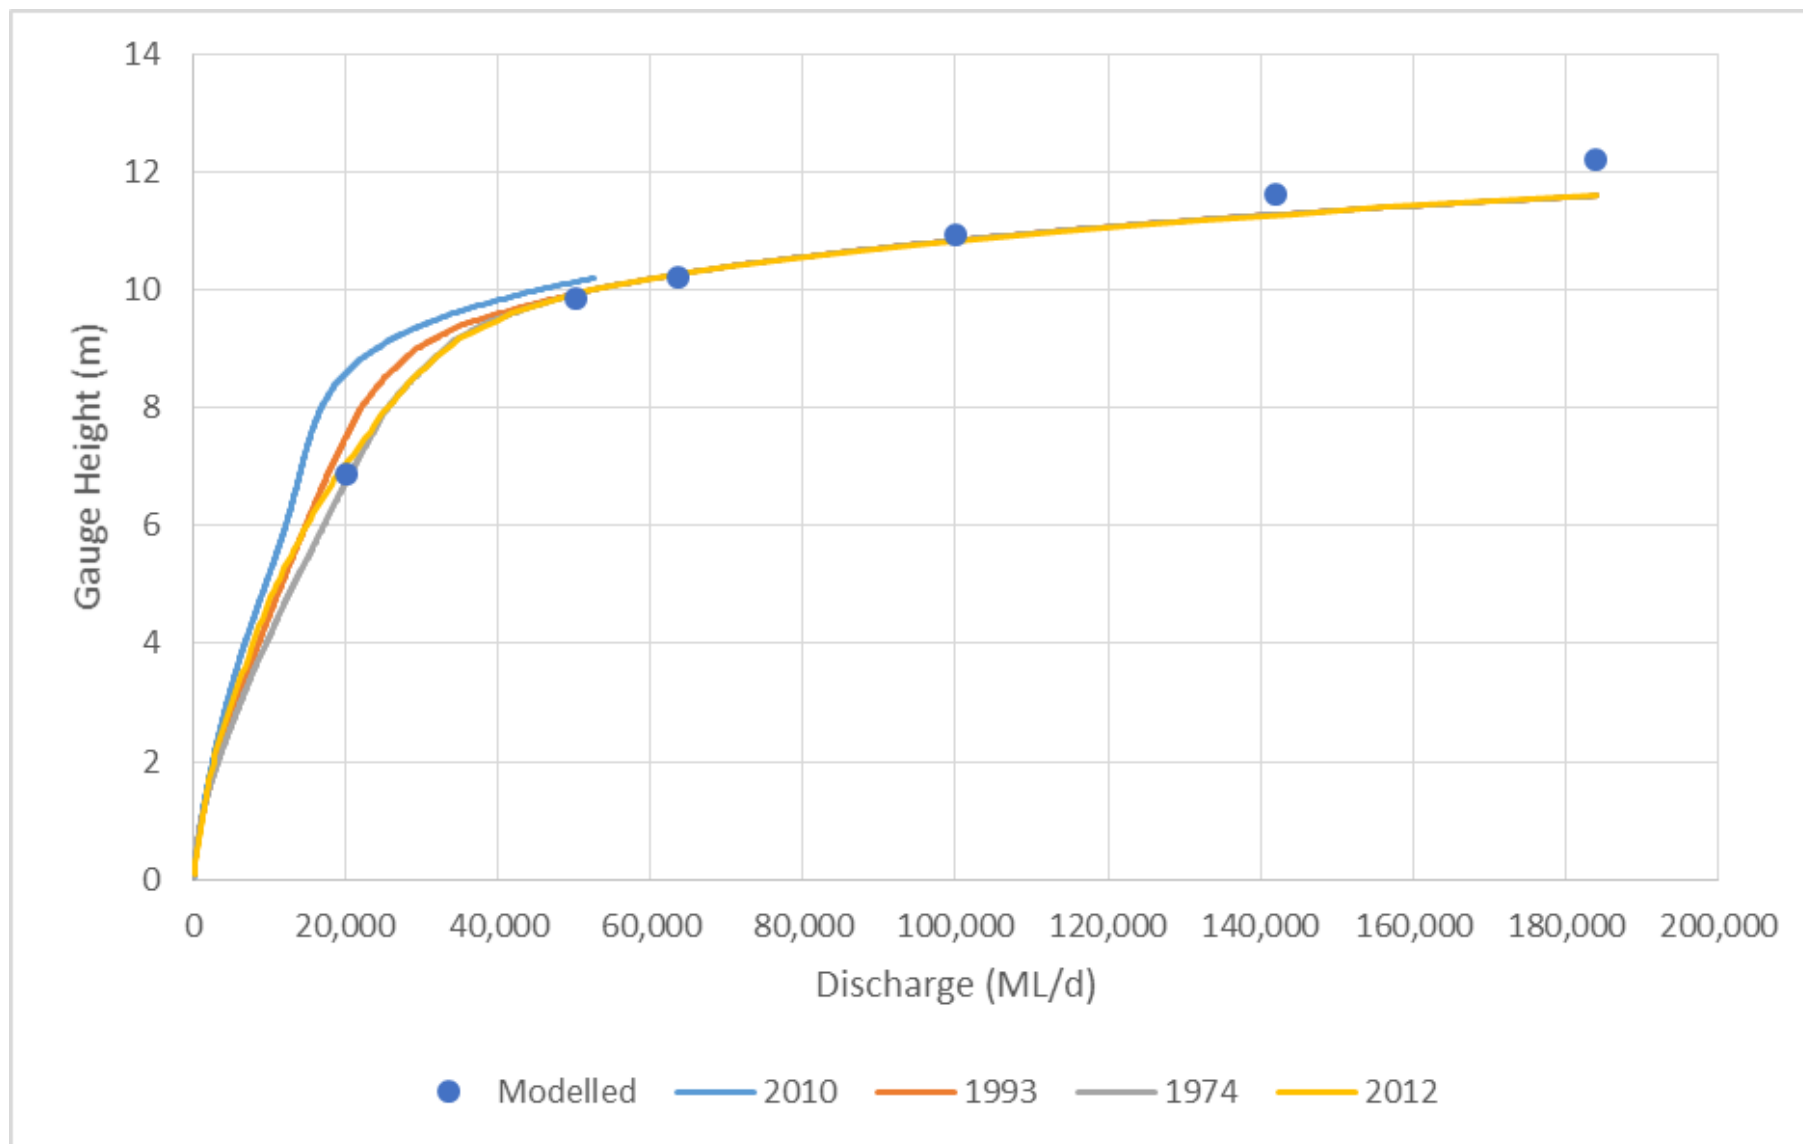
Figure 3-5 Modelled results versus current and historic rating curves

The water levels predicted by the model at the gauge site for each flow are shown in Table 3-6. **Error! Reference source not found.** The level for the 20,000 ML/d flow was 0.16 m lower than the current rating curve, however it was well within the envelope formed by the historic rating curves. The modelled levels were within 0.1 m of the current rating curve for flows from 50,000 to 100,000 ML/d. Above this flow, the modelled levels started to diverge from the rating curve, with the modelled level for a flow of 184,000 ML/d being 0.62 m higher than the rating curve.

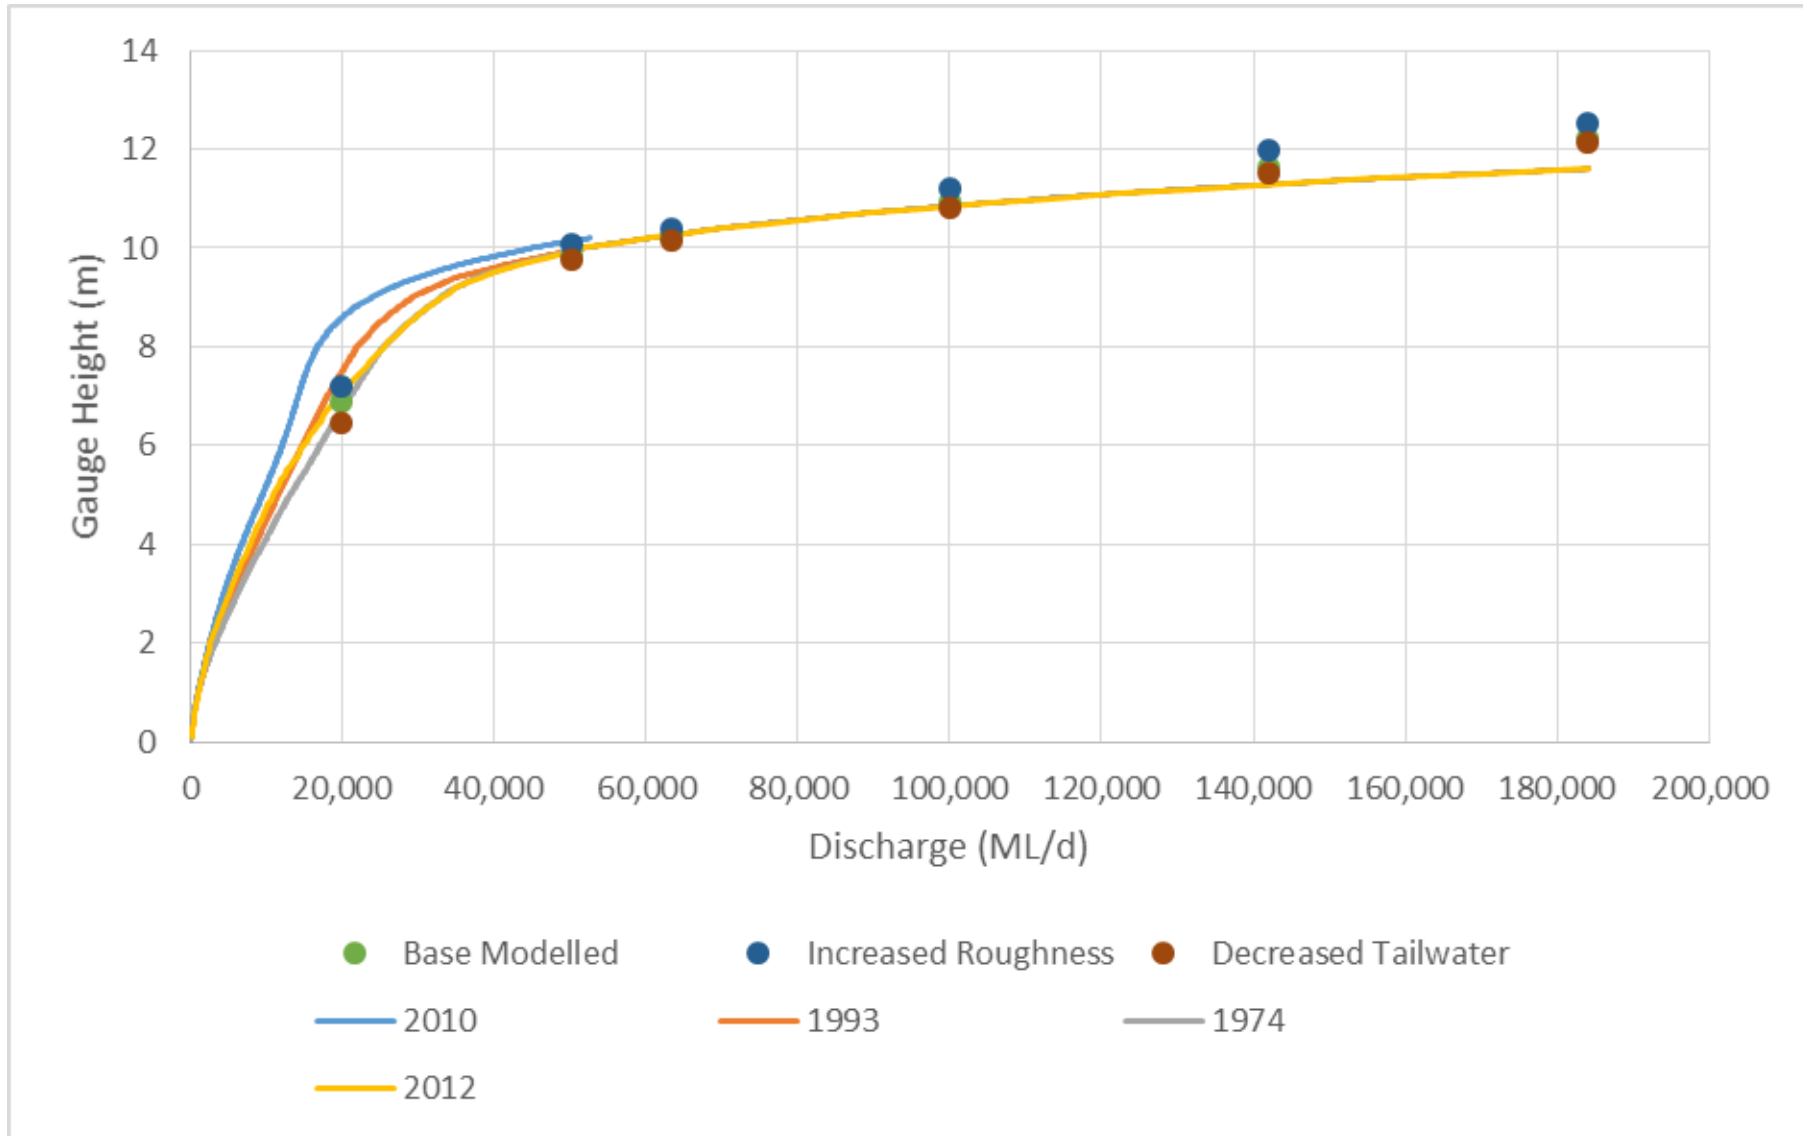
Figure 3-6 Sensitivity test results versus base modelled results and current and historic rating curves

The modelled water level at the gauge was found to be moderately sensitive to roughness over the full range of flows, with water levels raised by 0.18 to 0.35 m due to increased roughness.

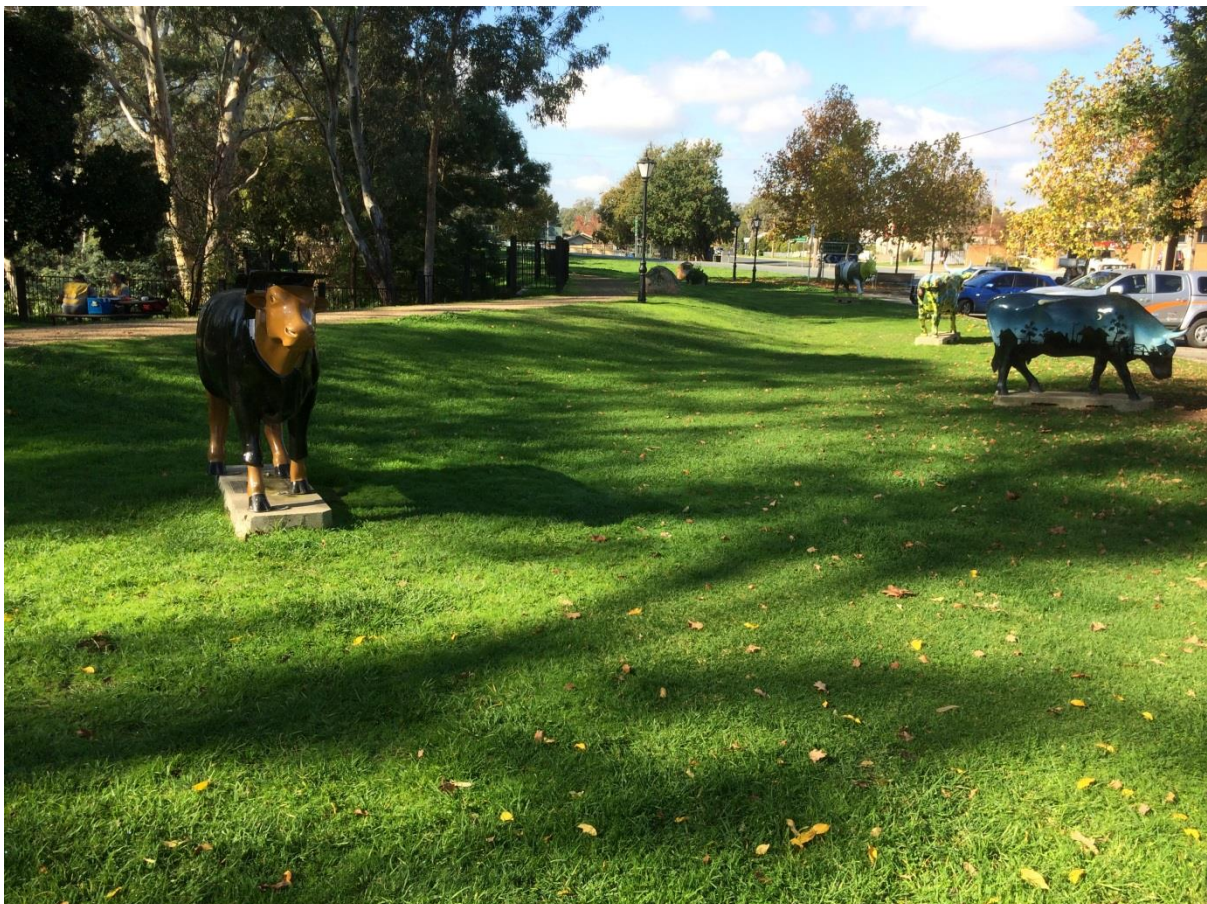
**Figure 4-4 View of levee in Murchison Township looking east along Stevenson Street**

The levee just downstream of the Bendigo-Murchison Road bridge provides protection from river flooding. This levee has a minimum crest elevation of 121.04 m AHD. The 1% AEP has a water level near the levee of 120.43 m AHD, which means the levee has a freeboard of 610 mm for the 1% AEP event. The 1916 event had a water level of 120.73 m AHD near the levee, giving a freeboard of 310 mm.

- This levee provides adequate protection for the town, no upgrades are required.

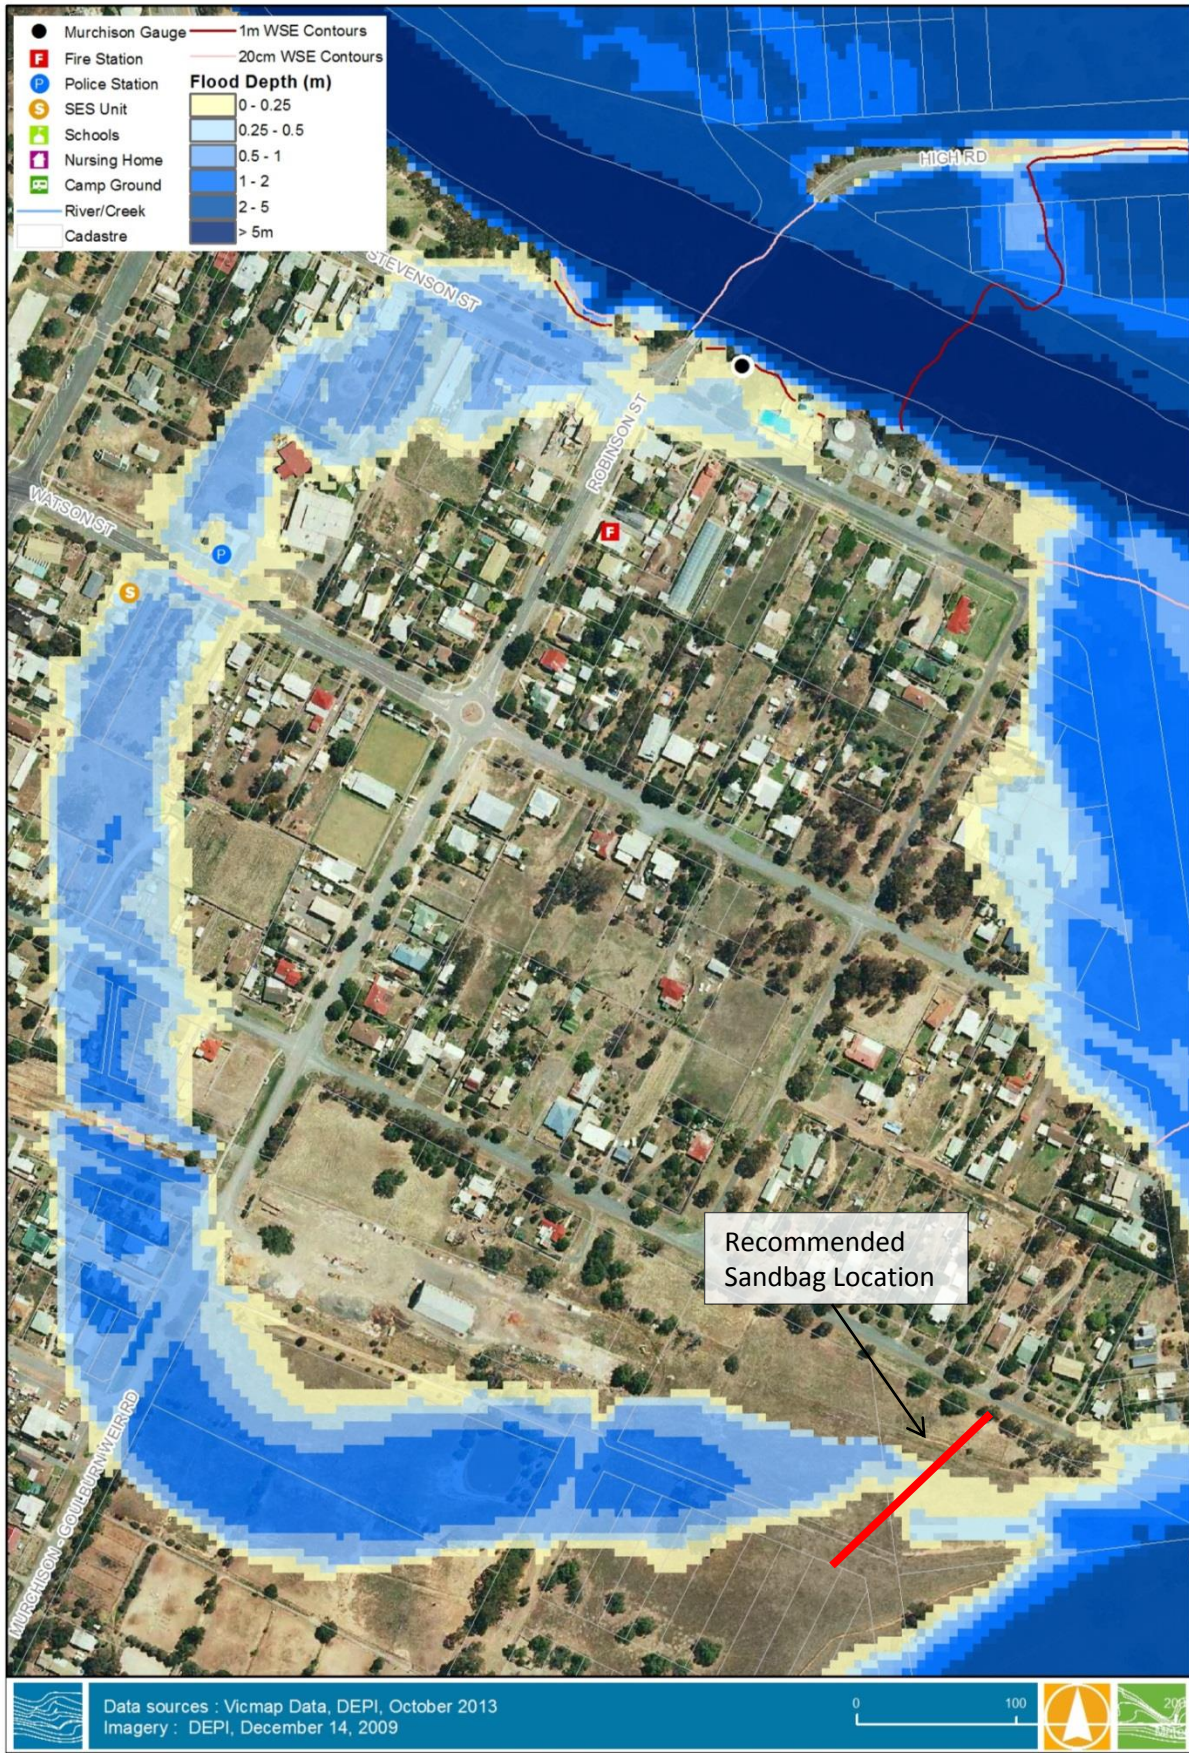
**Figure 4-6 Recommended Sandbagging Location for Extreme Flood Events**

For the largest modelled event, the hydraulic model shows a flow path through the western side of Murchison. The source of this flow path is due to a breakout from the Goulburn River upstream of town through a shallow depression. Given the long lead times prior to a Goulburn River flood in Murchison, there is time to coordinate sandbagging of this breakout to prevent flooding through town.

For the largest modelled event, the hydraulic model shows a flow path through the western side of Murchison. There is a potential for inundation of several properties through the town during this very large event. The source of this flow path is due to a breakout from the Goulburn River upstream of town through a shallow depression. Given the long lead times prior to a Goulburn River flood in Murchison, there is time to coordinate sandbagging of this breakout to prevent flooding through town. Figure 4-6 shows the recommended sandbagging location at the upstream end of the flow path. This location appears to be on private land, therefore an arrangement with the landholder will need to be agreed ahead of time. It is also suggested that this mitigation scenario be modelled and if found to have no adverse impact on surrounding properties then a permanent low level inexpensive earthen bund could be considered to permanently block this flow path.

- Investigate the impact of a permanent earthen bund.
