Numurkah Floodplain Management Study and Plan Study Report

November 2017

Project Name	Numurkah Floodplain Management Study and Plan
Client	Moira Shire Council
Client Project Manager	Andrew Close
Water Technology Project Manager	Julian Skipworth
Report Authors	Julian Skipworth
Job Number	2638-01
Report Number	R03 v09
Document Name	Final Study Report

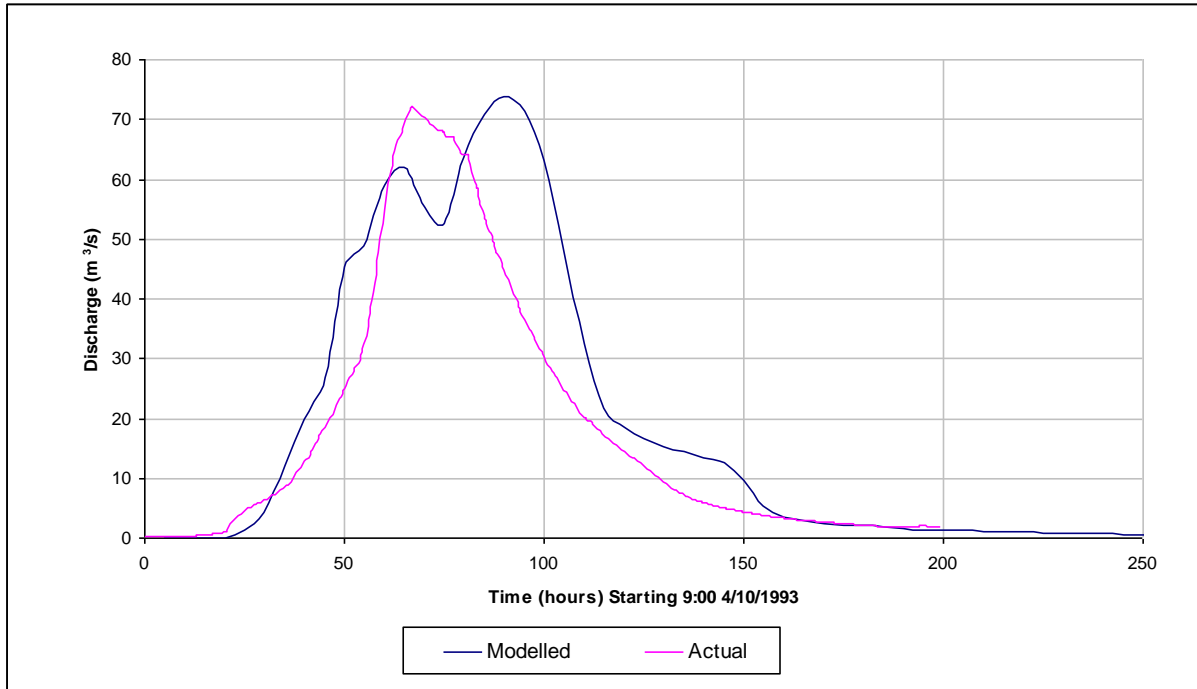
Figure 2-5 RAFTS Calibration – October 1993 at Katamatite (taken from SMEC 2005 report)

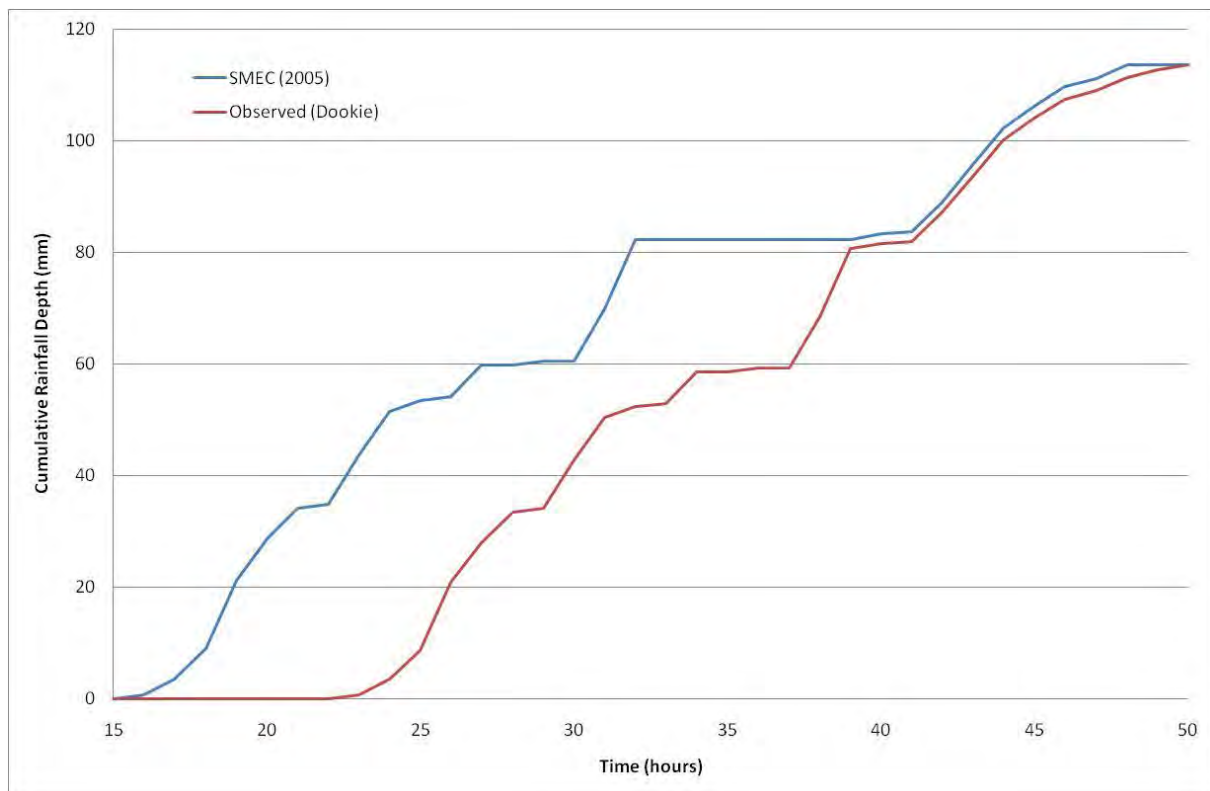
Figure 2-9 Comparison of temporal patterns from 1993

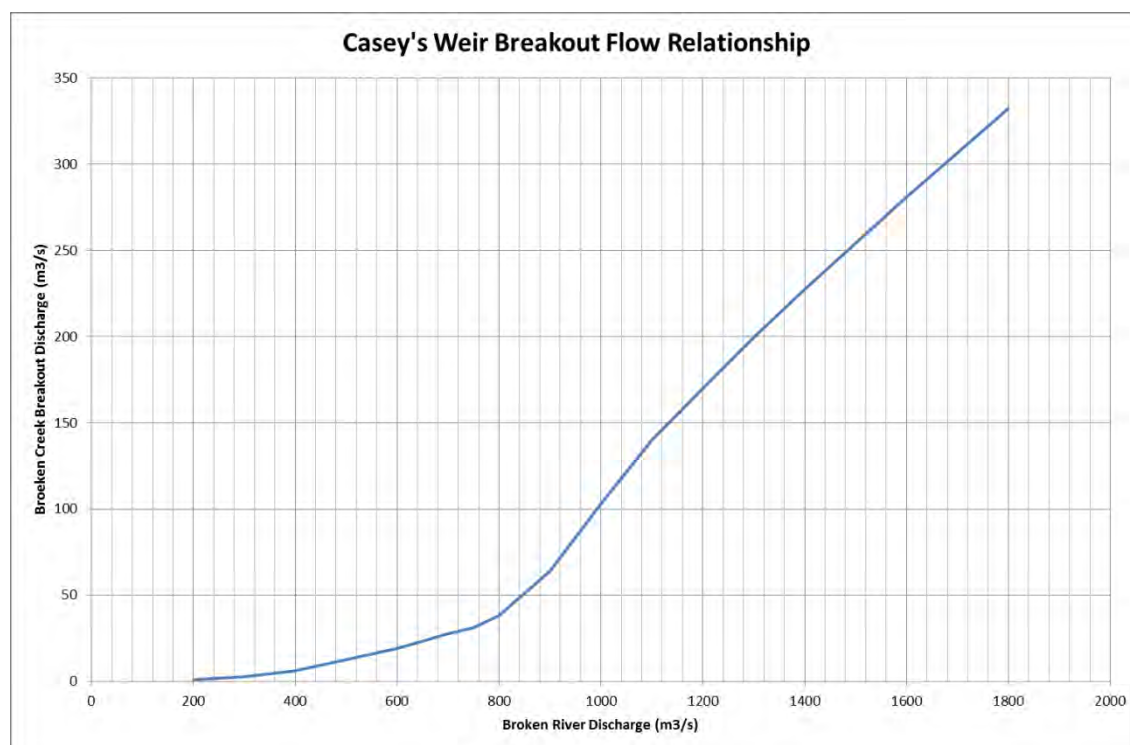
Figure 4-3 Casey' Weir Breakout Broken River/Broken Creek Flow Relationship

It should also be noted that the revised breakout relationship is likely to be less accurate at lower flows due to the grid size used and the comparative size of the low flow channel at Casey's Weir. More detailed modelling would be required to improve the accuracy of the low flow relationship.

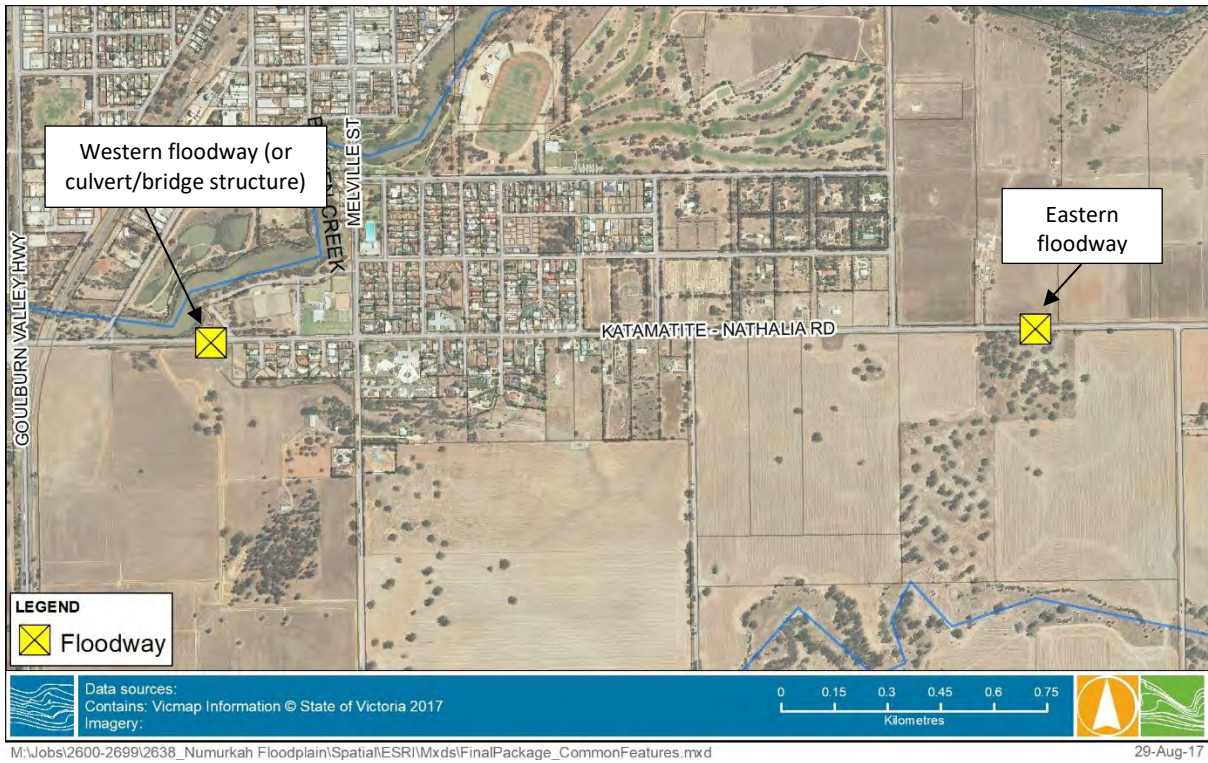
Figure 12-29 Location of Katamatite-Nathalia Road floodways
