Report

Shepparton Mooroopna 1% AEP Flood Mapping Project

Greater Shepparton City Council

24 August 2021

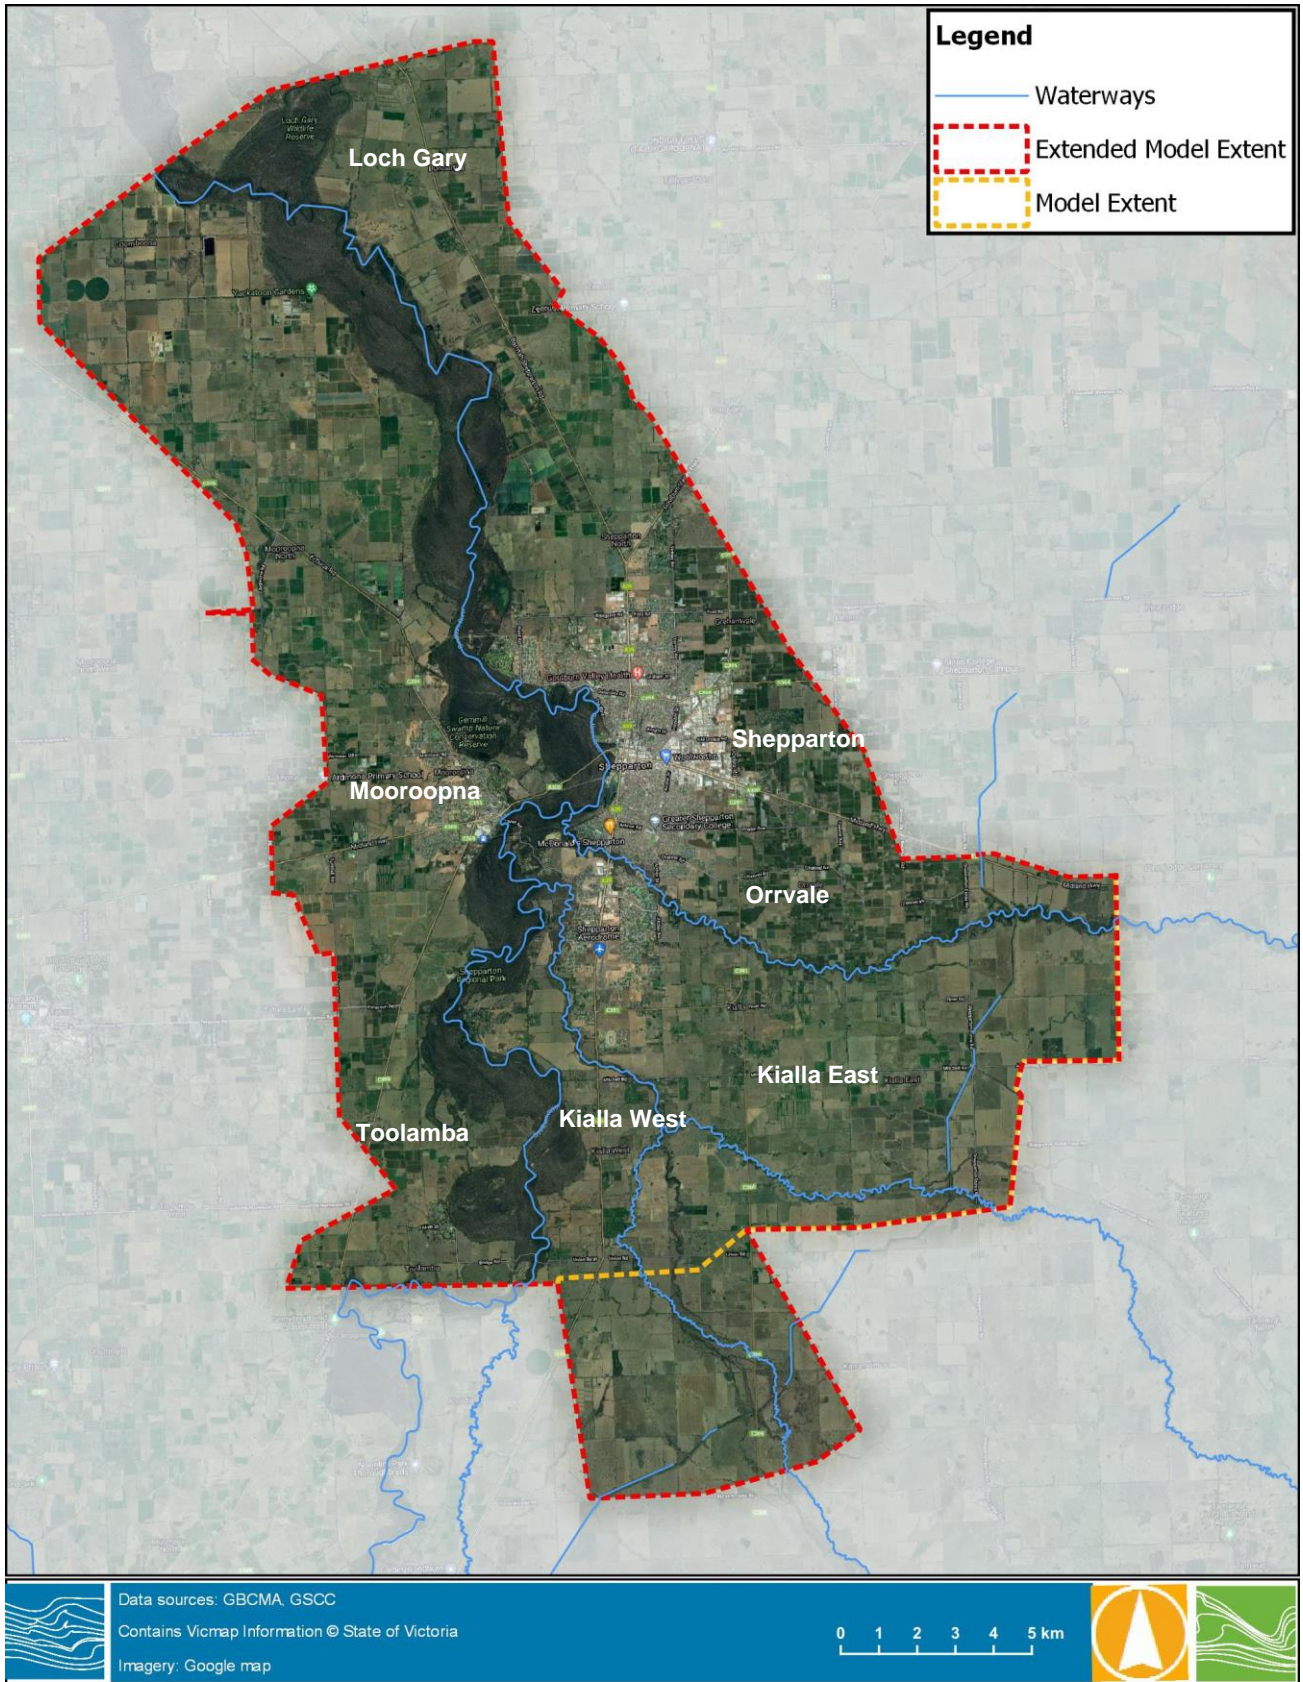
FIGURE 2-1 HYDRAULIC MODEL EXTENT

Shepparton and Mooroopna are situated on the Goulburn River at the confluence with the Broken River and Seven Creeks. The study area extended upstream of Shepparton to Toolamba and downstream of Shepparton to Loch Garry on the Goulburn River, upstream of Shepparton to Kialla East on the Broken River and upstream of Shepparton to Kialla West on Seven Creeks. Figure 2-1 shows the hydraulic model and flood mapping extent used for the 1% AEP mapping. The Seven Creeks inflow boundary was placed upstream of the East Goulburn Main Channel for the Climate Change analysis (Section 6).

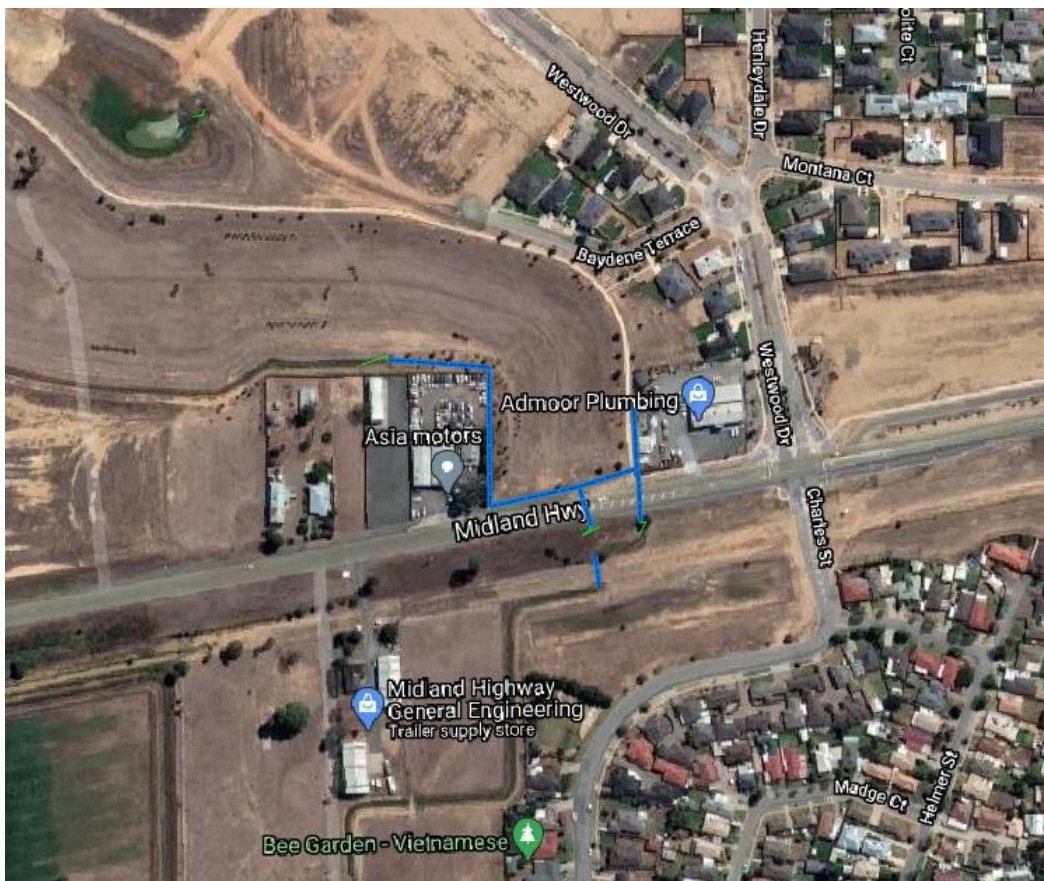
FIGURE 3-2 2014 REGIONAL FLOODWAY WORKS IN MIDLAND HIGHWAY

In addition, GSCC provided design plans for works in Kialla that discharge stormwater from a residential development to Waterbird Creek and works on Midland Highway completed in 2014 as part of the Regional Floodway Works. Pipes were added to the model as shown in Figure 3-2.

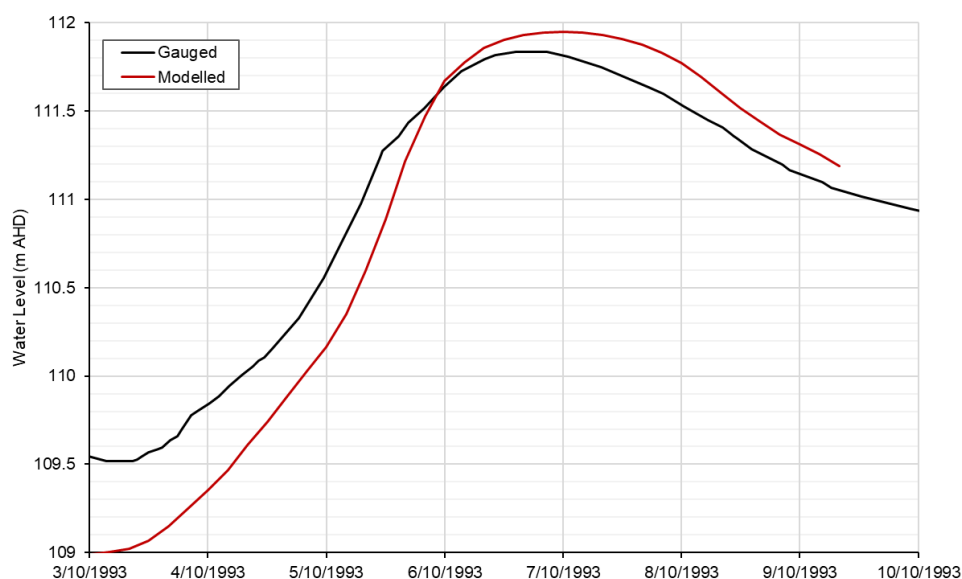
FIGURE 4-1 MODELLED AND GAUGED WATER LEVELS FOR THE GOULBURN RIVER AT SHEPPARTON (1993)

The overall trend showed the modelled flood levels had no bias higher or lower than the surveyed flood levels and were predominately well within the satisfactory error interval expected for model calibration. Comparison with the previous calibration suggests there are several calibration points along the Broken River floodplain which are now lower than the previous calibration. This is due to the fact that the previous calibration utilised a LiDAR data set that was lowered by 100mm. The updated LiDAR used for the current study matches feature survey much closer in this area. Figure 4-1 below shows a plot of the water level at the Goulburn River at Shepparton gauge, comparing the model results to gauged data. The graph shows the rising and falling limbs of the modelled hydrograph are well represented within the model, and the peak elevation is approximately 110 mm higher than the gauged data.

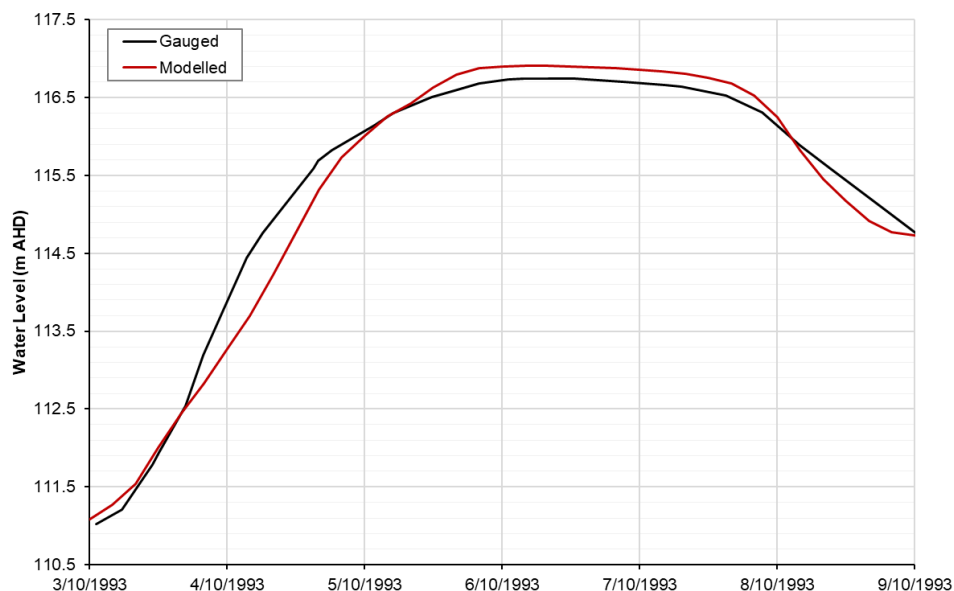
FIGURE 4-2 MODELLED AND GAUGED WATER LEVELS FOR THE BROKEN RIVER AT ORRVALE (1993)

Figure 4-2 shows the modelled and observed water levels at the Broken River at Orrvale gauge, the graph shows the rising limb of the modelled hydrograph arrives slightly later than the gauged data, the peak elevation is well represented in the model, despite overestimating the peak by 157 mm. There is limited streamflow data for Seven Creeks at Kialla West for the 1993 flood event. A 36-hour period which shows the peak passing the gauge was captured, and is shown against the modelled flood levels in Figure 4-3. The model has the peak slightly delayed, however appears to represent the gauged hydrograph shape well.

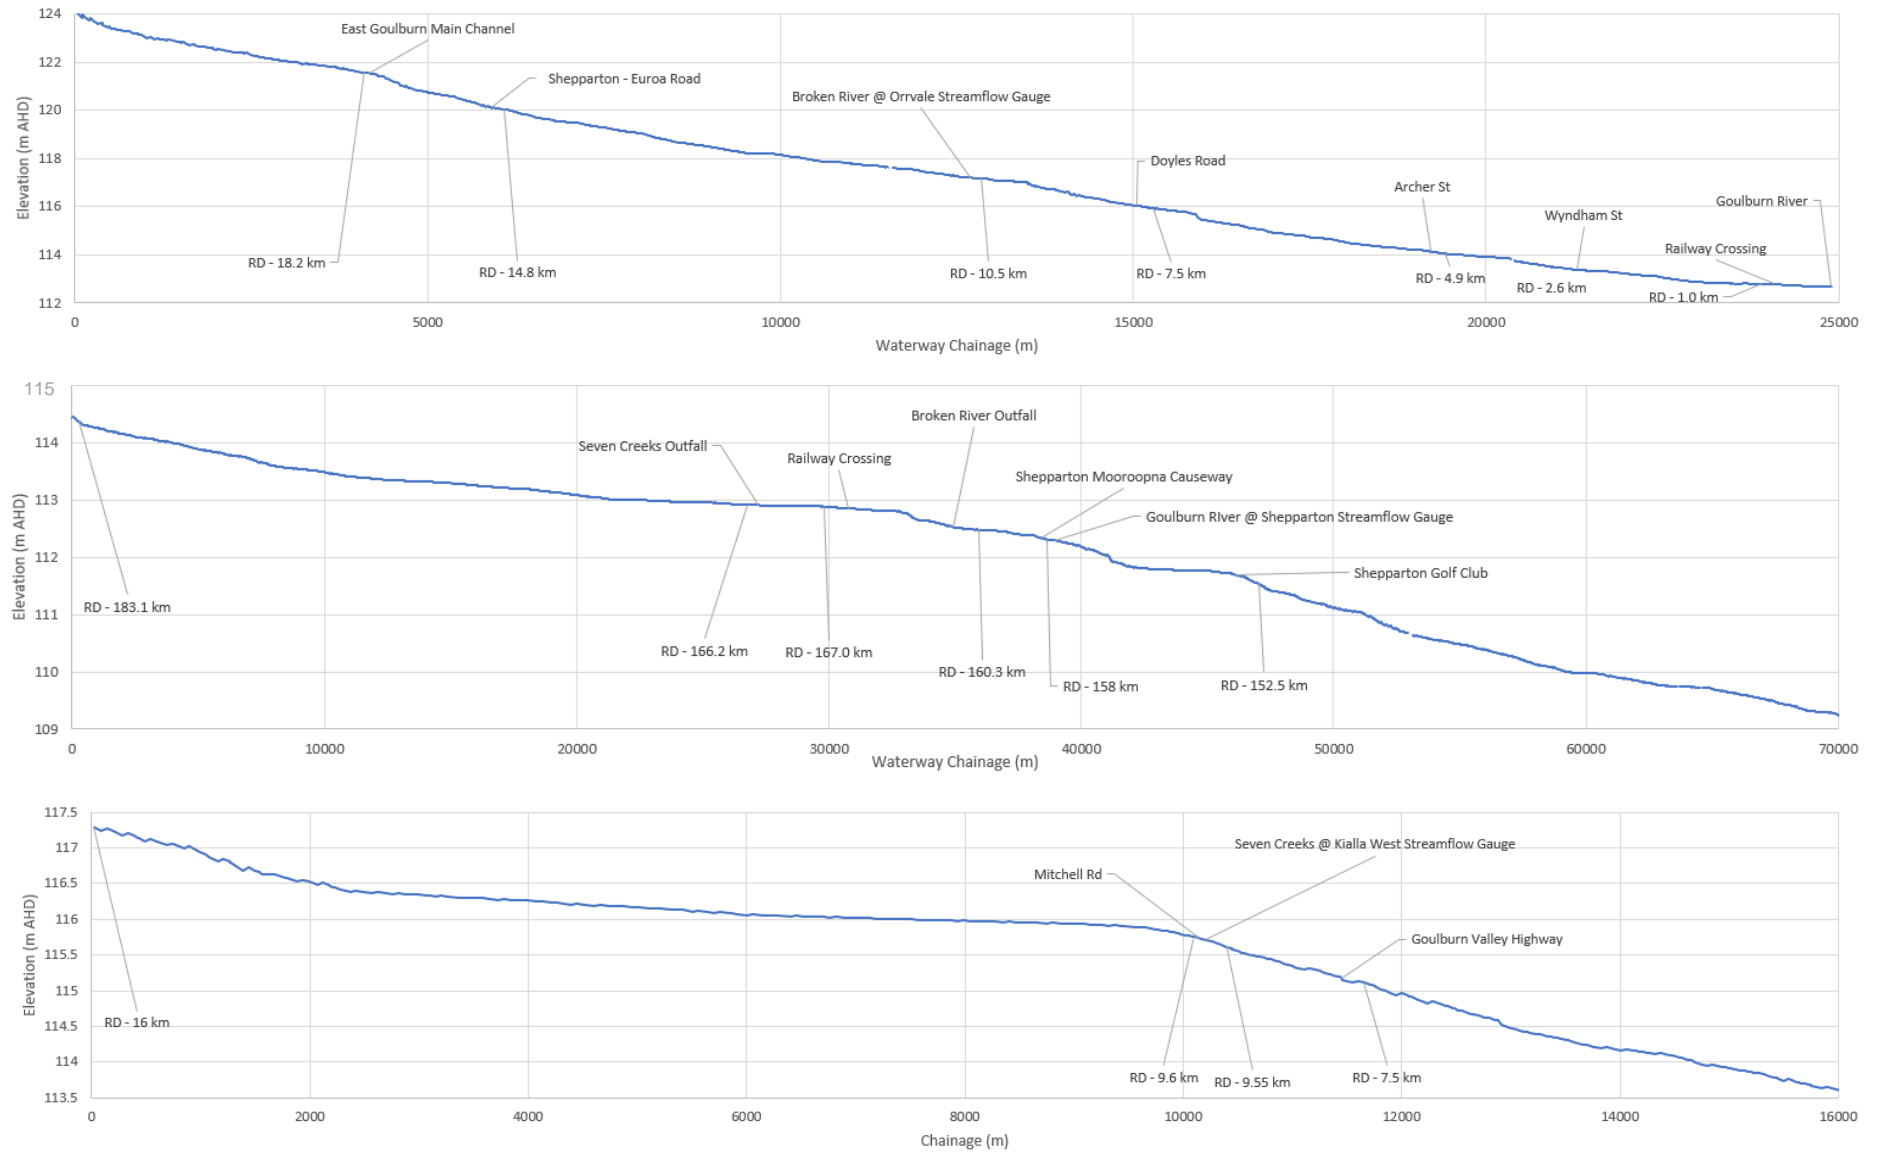
FIGURE 4-6 WATER SURFACE PROFILES – 1993 FLOOD EVENT (FROM TOP: BROKEN RIVER, GOULBURN RIVER, SEVEN CREEKS)

The modelled flood extent matched observations, gauged river heights and aerial photographs very well, and was deemed an acceptable calibration result. Figure 4-6 shows the water surface profiles along the three main waterways for the 1993 flood event. These are plotted with the chainage distance of the waterway along the x – axis and the running distances (provided by the GBCMA) have also been included at key features along the waterways.

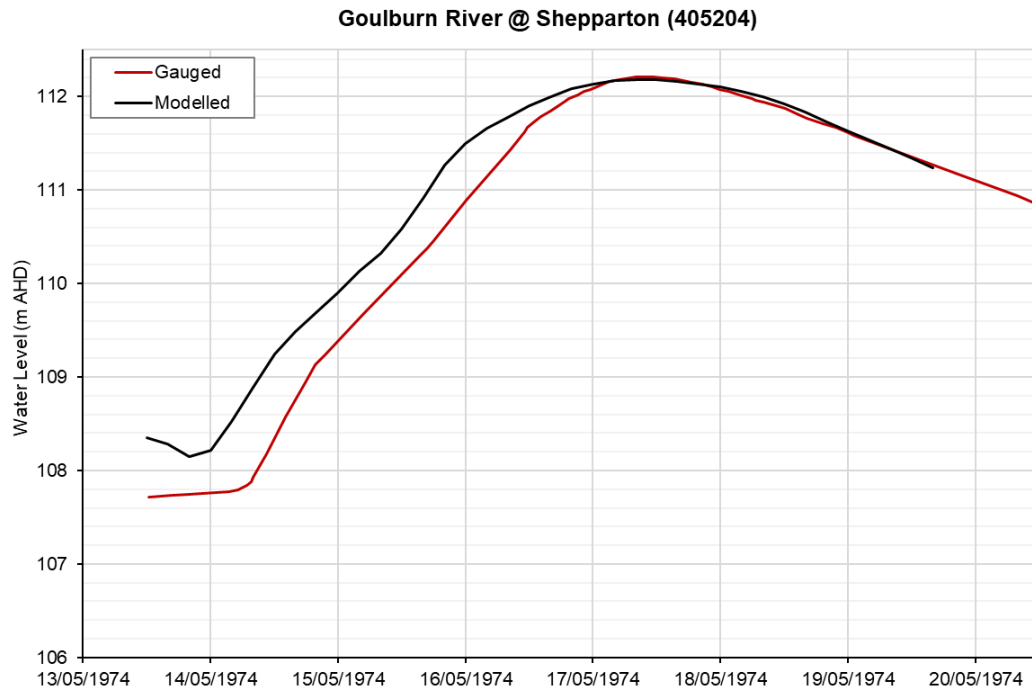
FIGURE 4-7 MODELLED AND GAUGED WATER LEVELS (GOULBURN RIVER AT SHEPPARTON) 1974

Figure 4-7 shows a comparison of modelled and observed water levels at the Goulburn River at the Shepparton gauge. The graph show the rising limb of the modelled hydrograph arrives slightly earlier than the gauged data, but matches the rate of rise extremely well. The peak elevation is approximately 28 mm lower than the gauged data, and the falling limb recedes at a very similar rate to that gauged.

Due to the distance between upstream gauge locations and the upstream extent of the model, the timing of inflow hydrographs involved estimated timing for the three river systems. A much closer match between the modelled and observed 1974 data has been achieved by making the following changes to the inflow hydrograph timings from the Shepparton-Mooroopna Flood Mapping and Flood Intelligence Study:

- Moving the Goulburn River inflows back 6-hours.
- Moving the Broken River inflows forwards 7-Hours.

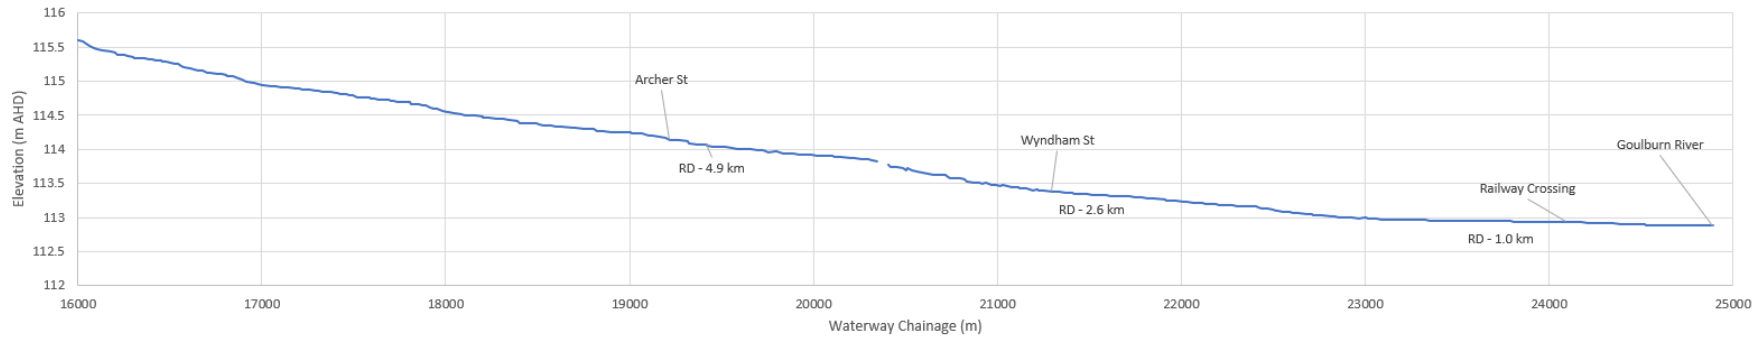
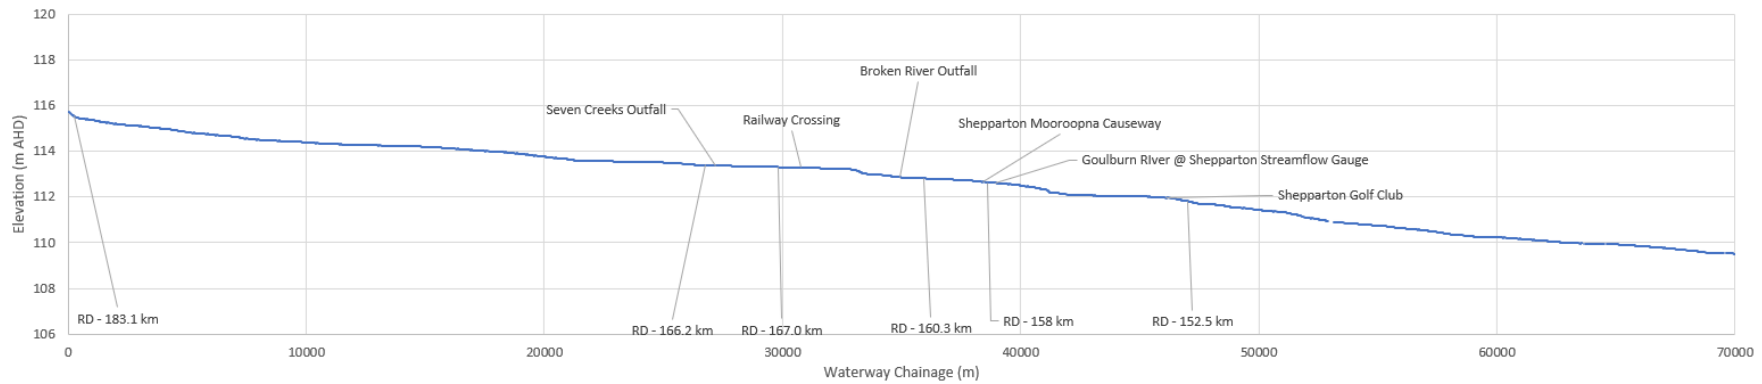
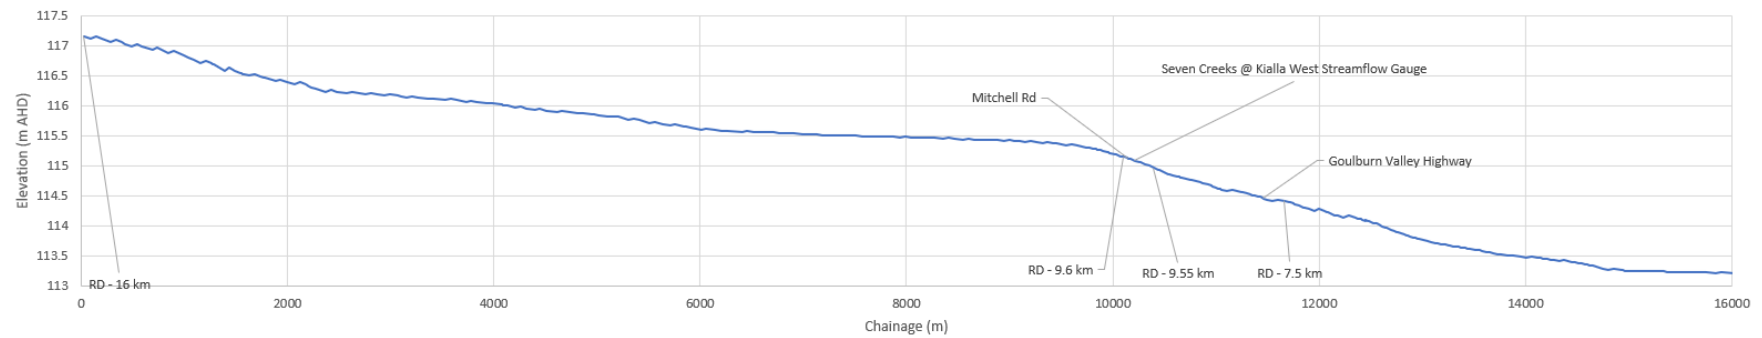
FIGURE 4-10 WATER SURFACE PROFILE – 1974 MODELLED FLOOD EVENT (FROM TOP: BROKEN RIVER, GOULBURN RIVER, SEVEN CREEKS)

Figure 4-10 shows the water surface profiles along the three main waterways for the 1974 flood event. These are plotted with the chainage distance of the waterway along the x – axis and the running distances (provided by the GBCMA) have also been included at key features along the waterways.

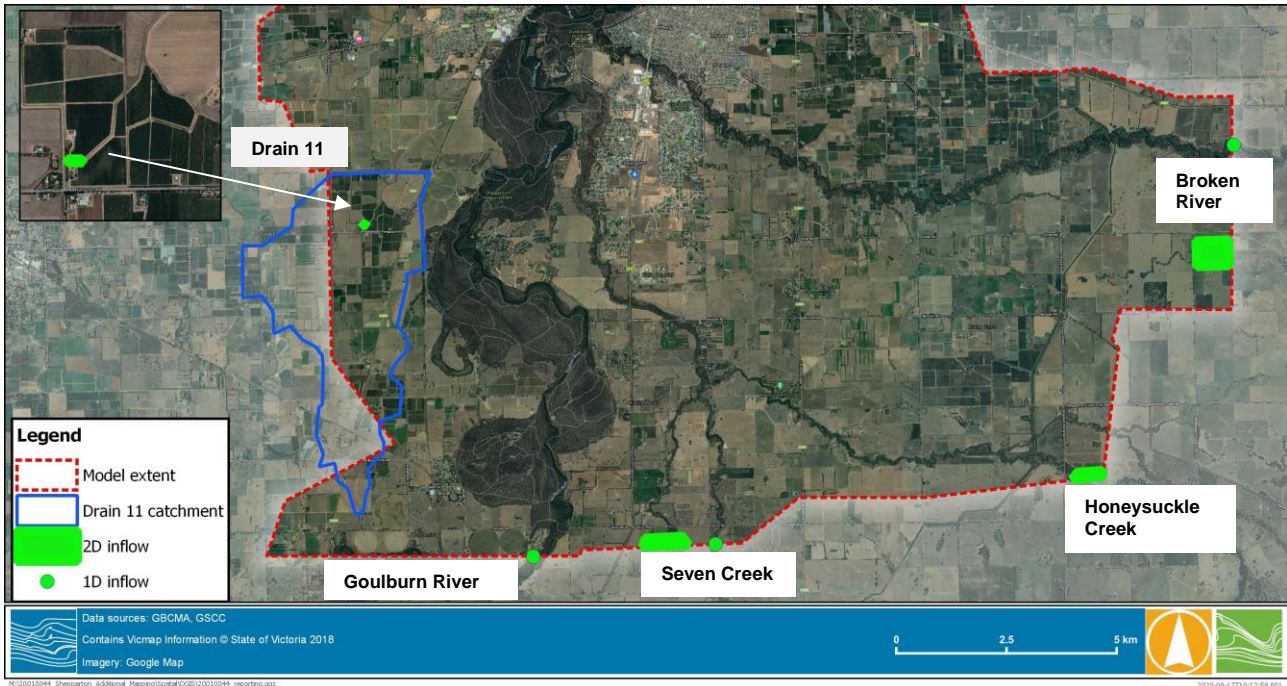
FIGURE 5-1 HYDRAULIC MODEL BOUNDARIES

The Ardmona Drain 11 (south of Mooroopna) was identified as an additional inflow to be included to the hydraulic model since the completion of the modelling for the 2019 flood study. The 1% AEP flow was taken from the Goulburn Valley Freight Logistics Link Flood Assessment³ in which a hydraulic analysis was undertaken for the Drain 11 catchment based on earlier hydrology developed by GHD in 2009⁴. Locations of the hydraulic model input flows are shown in Figure 5-1.

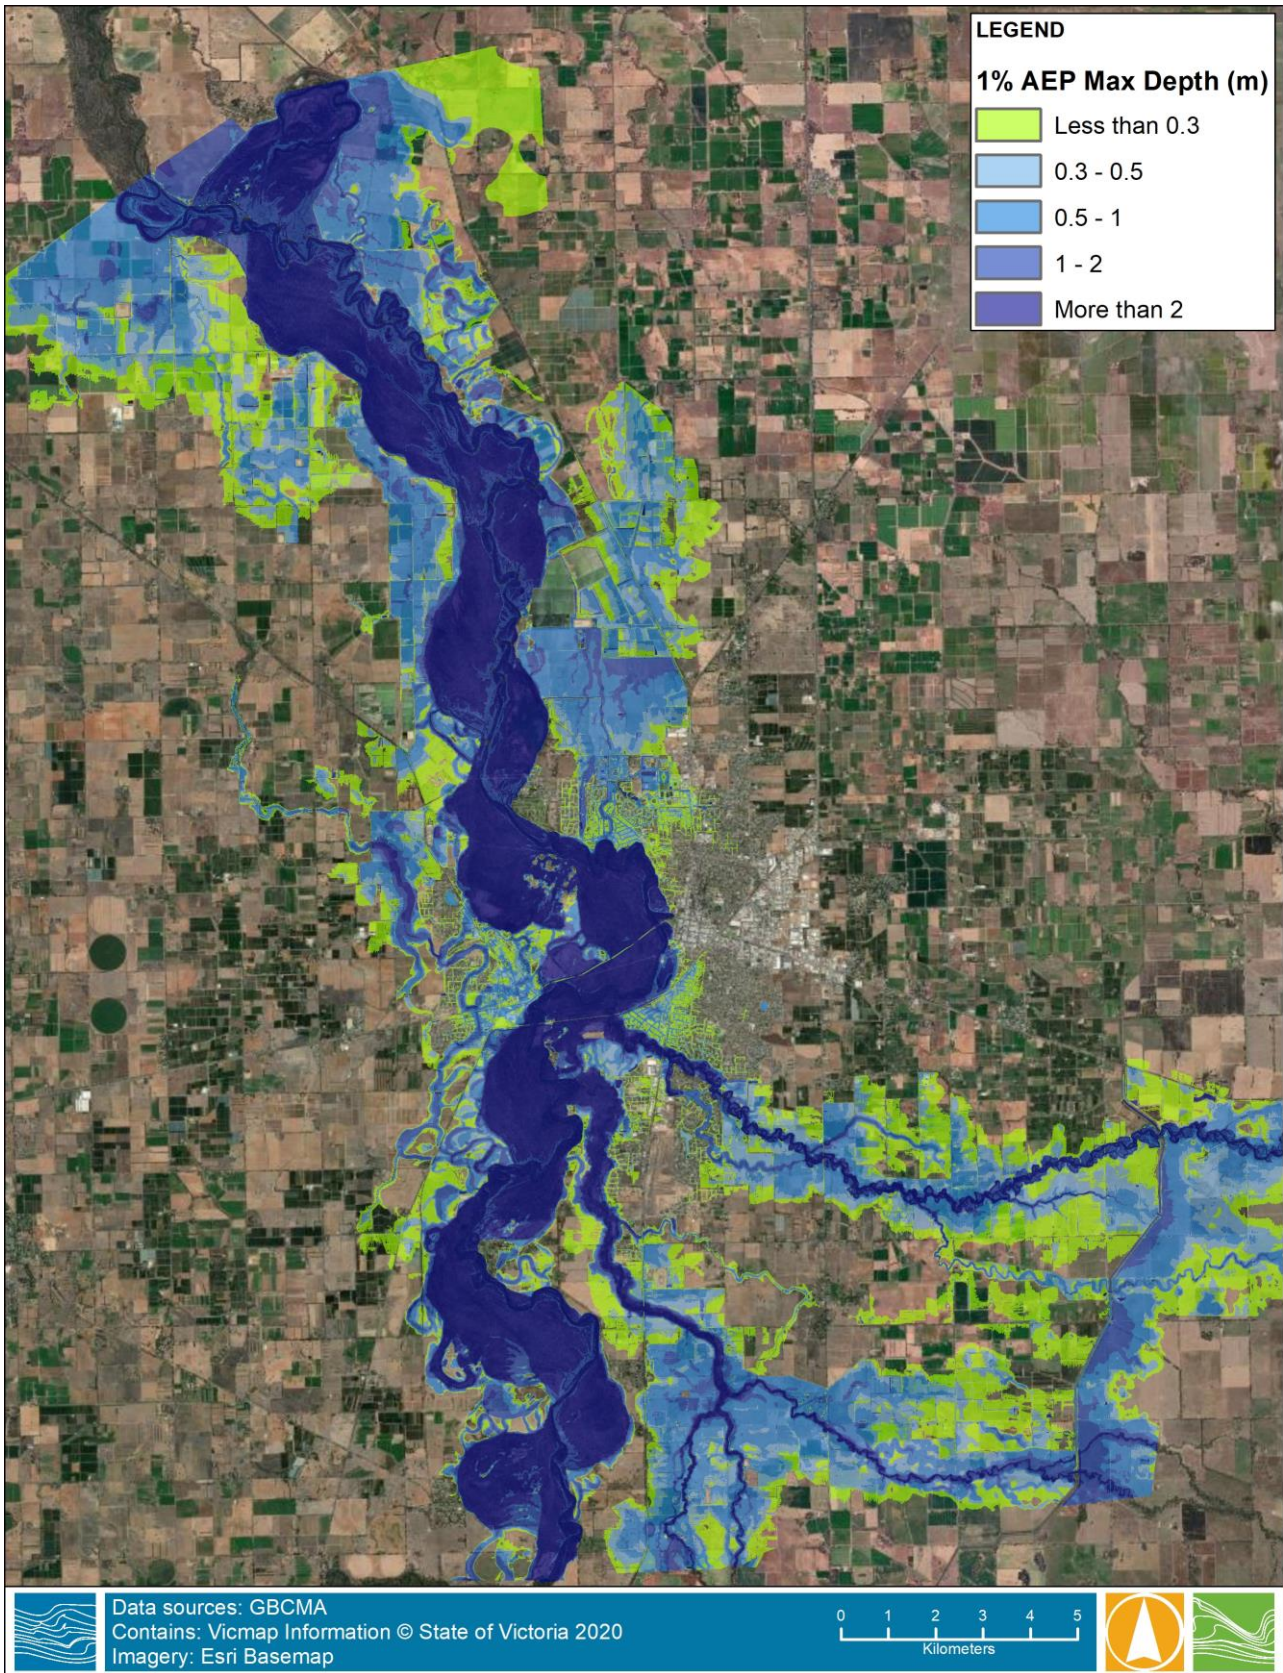
FIGURE 5-2 1% AEP FLOOD DEPTH

Following updates to the hydraulic model and the flood hydrology review, flood mapping using TULFOW – HPC (at a 5 x 5 m grid) was produced for the study area. The 1% AEP Goulburn River dominant and the 1% AEP Broken River dominant events were simulated. Flood modelling results were spliced to produce the maximum depth, velocity, water surface elevation and depth x velocity product for mapping and the preparation of flood zone and overlay controls. The following section shows the key flood maps produced from the modelling covering the TUFLOW extent. Final flood modelling outputs were clipped to downstream of the East-Goulburn Main Channel. Figure 5-2 and Figure 5-3 display mapping of flood depth and water surface elevation respectively for the updated modelling. The combined 1% AEP Water Surface Profile is shown in Figure 5-3.

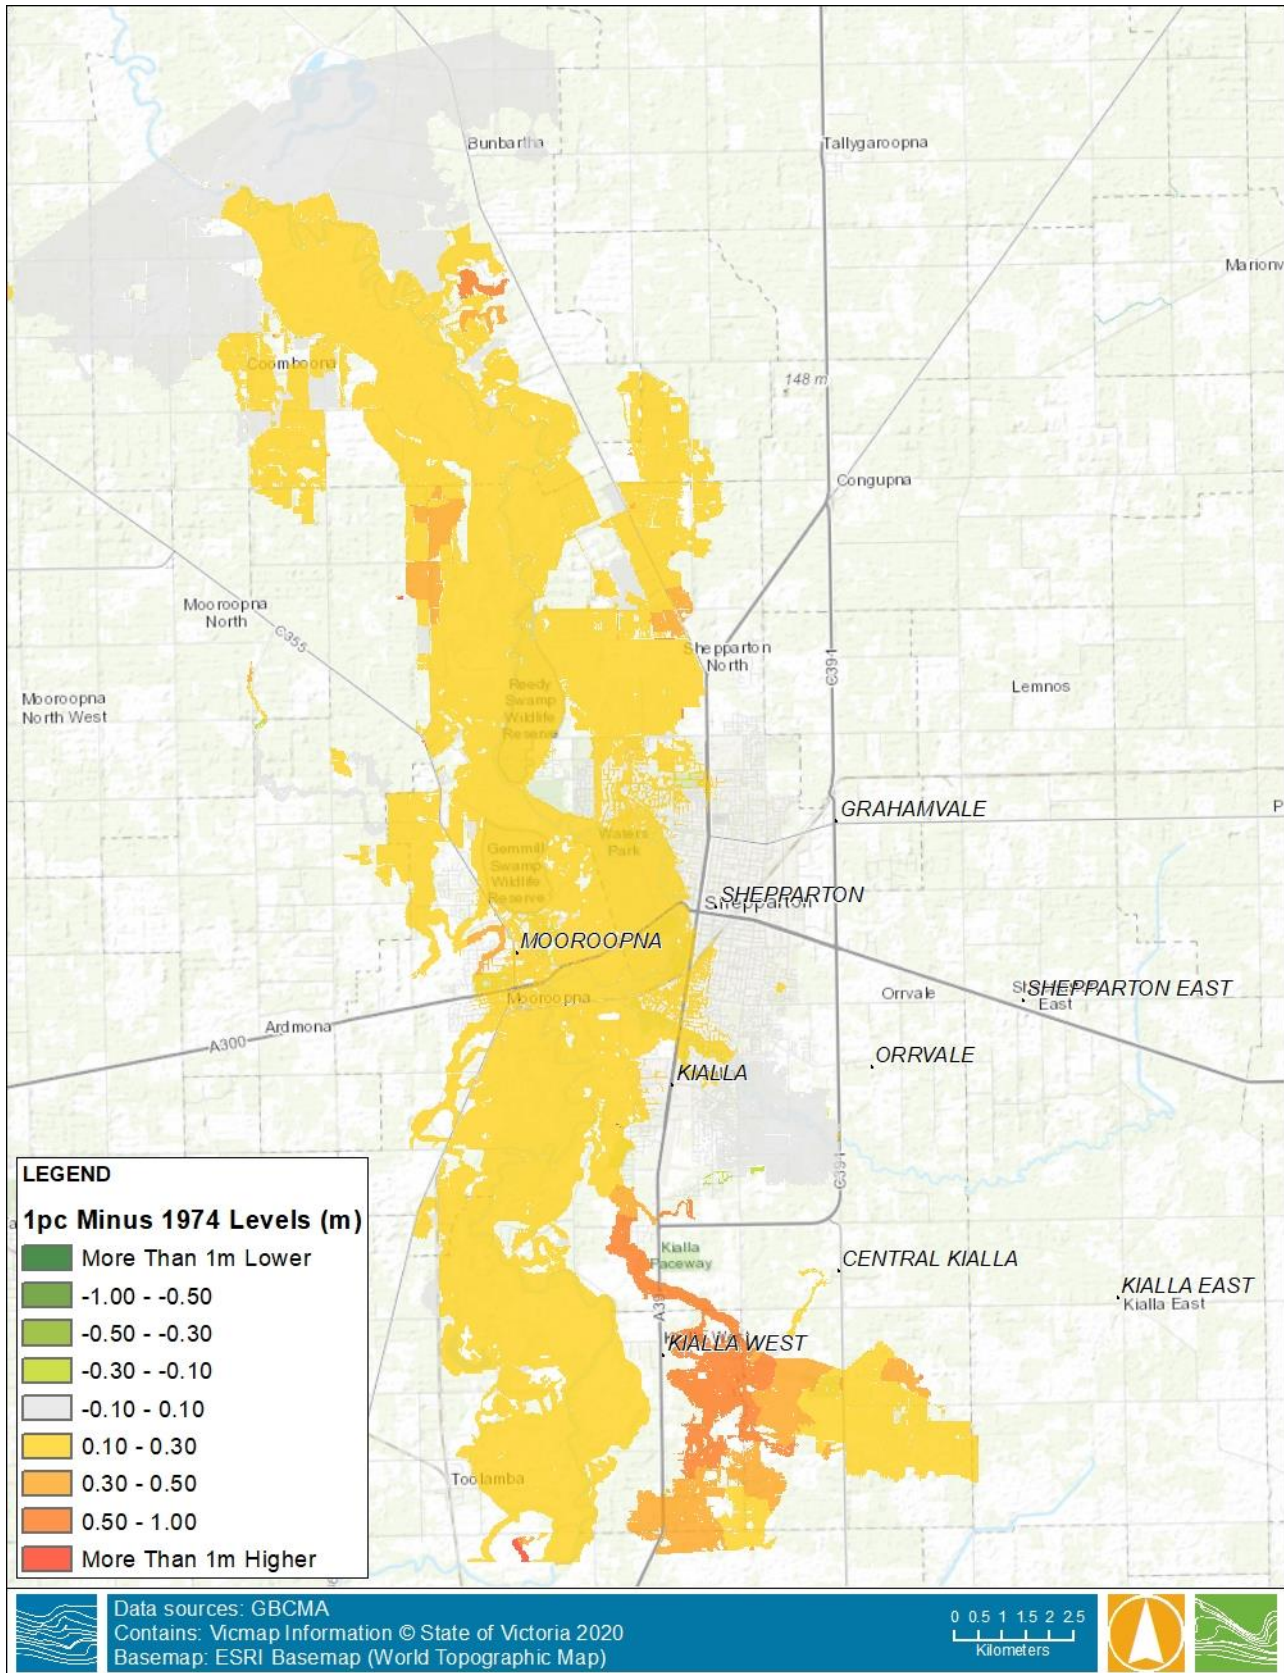
FIGURE 5-4 1% AEP FLOOD LEVELS MINUS 1974 MODELLED LEVELS

Comparison of the design flood levels to previous events can be used to further validate the design modelling. A comparison of the 1% AEP flood levels (combined Goulburn Dominant and Broken/Sevens Dominant) has been compared with two flood events. The two events compared are the 1974 flood event, which was a Goulburn Dominant and considered close to a 1% AEP on the Goulburn River and the 1993 flood event which was a Broken Dominant event and is considered close to a 1% AEP on the Broken River. The comparison plots are shown in Figure 5-4 and Figure 5-5. The results show that for the majority of the study (excluding several isolated areas) the 1% AEP design levels are above the modelled levels for the two historic flood events.

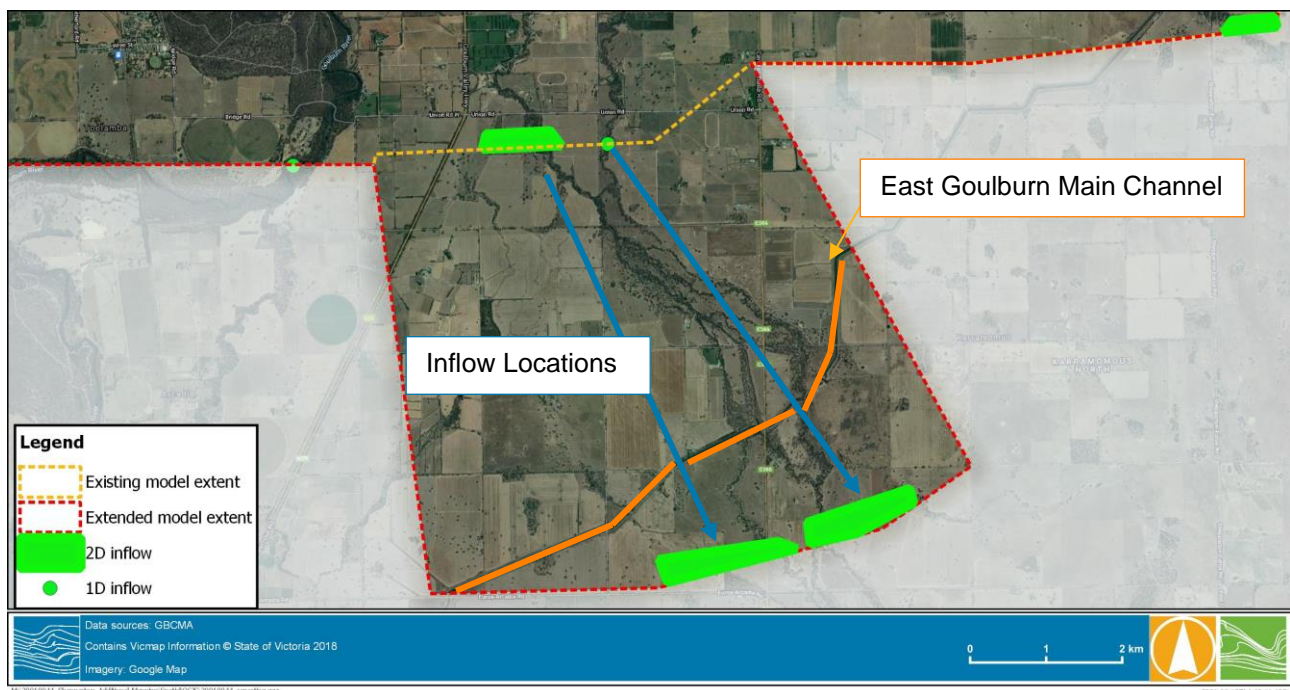
FIGURE 6-1 EXTENDED MODEL BOUNDARY AND INFLOW LOCATIONS AT SEVEN CREEKS

The Flood Frequency Analysis (FFA) undertaken to determine design flow rates at the key gauge locations (Broken River at Orrvale and Seven Creeks at Kialla West) do not take into account the impact of such a hydraulic control, nor does the hydrology modelled as part of the HARC investigation. The FFA undertaken as part of the Shepparton-Mooroopna Flood Mapping and Intelligence Study (2019) showed the 1993 flood event was close to a 1% AEP event on the Broken River and Seven Creeks system which provides a high degree of certainty for flows up to that magnitude. The identification of the impact of the hydraulic control on higher flows suggests that the 0.5% AEP should be placed upstream of the EGMC.

Given the Broken River and Honeysuckle Creek inflow locations are located upstream of the EGMC, the Seven Creeks inflows were also placed upstream for the Climate Change modelling.

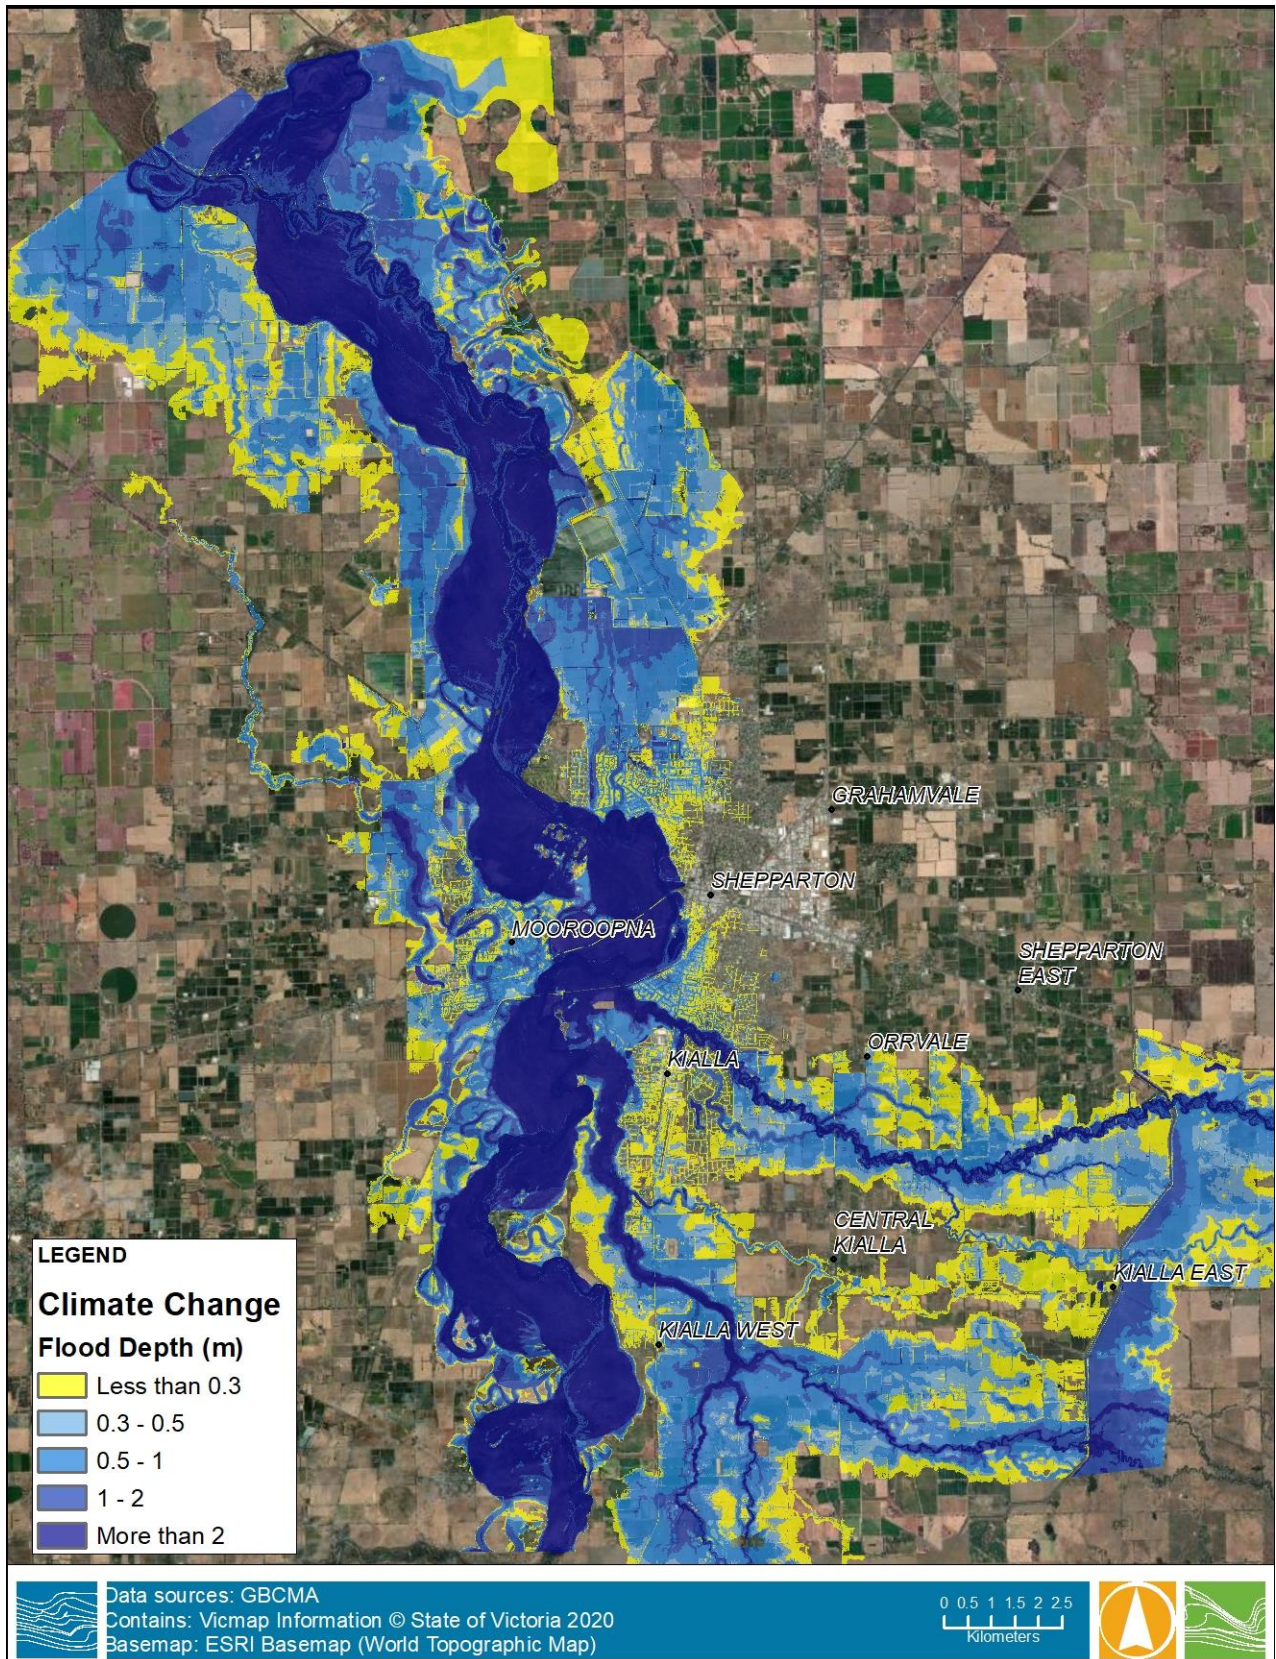
FIGURE 6-3 CLIMATE CHANGE FLOOD DEPTH

Changes to the peak flood levels at the three key gauge locations under climate change conditions are summarised in Table 6-3 and Table 6-4. Hydraulic modelling results show a broad increase in peak flood levels across the study area of around 100-150 mm (Figure 6-2) for the combined results (i.e. maximum of Goulburn dominant and Broken/Seven dominant). Higher increases are shown along the Seven Creeks system between the Goulburn River and Goulburn Valley Highway where the floodplain is confined due to irrigation and drainage infrastructure, these areas also have a slight increase in flood extent. Peak flood depths and water surface elevations are shown in Figure 6-3 and Figure 6-4.

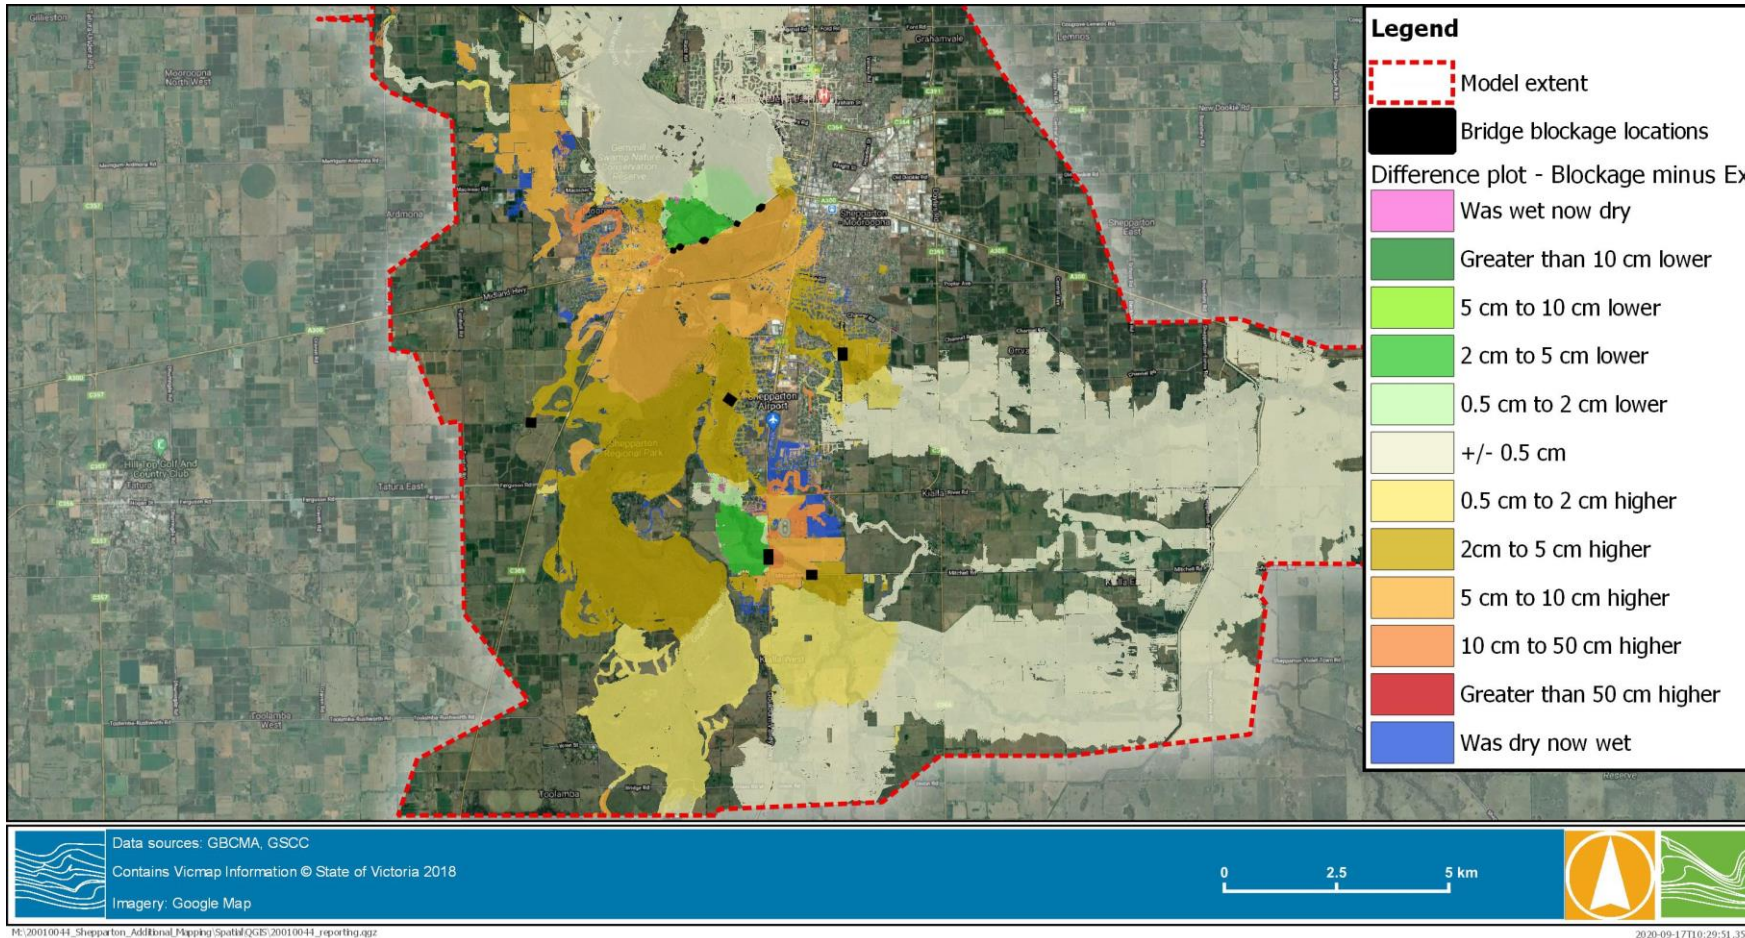
FIGURE 7-1 DIFFERENCE PLOT BRIDGE BLOCKAGE ASSESSMENT 1% AEP BROKEN RIVER

The assessment found several bridges had zero likelihood of blockage due to the factors outlined above. As a conservative approach, bridges openings across the Midland Highway Causeway were tested with 50% blockage to assess the potential flood impact. As a further conservative approach, all bridges listed below were blocked at the same time. To identify the impact of bridge blockages on flood risk, both the 1% AEP Goulburn dominant and 1% AEP Broken River dominant events were simulated with the proposed blockage levels. The maximum flood levels were then compared with existing conditions (0% blockage).
