Report

Shepparton Mooroopna 1% AEP Flood Mapping Project

Greater Shepparton City Council

24 August 2021

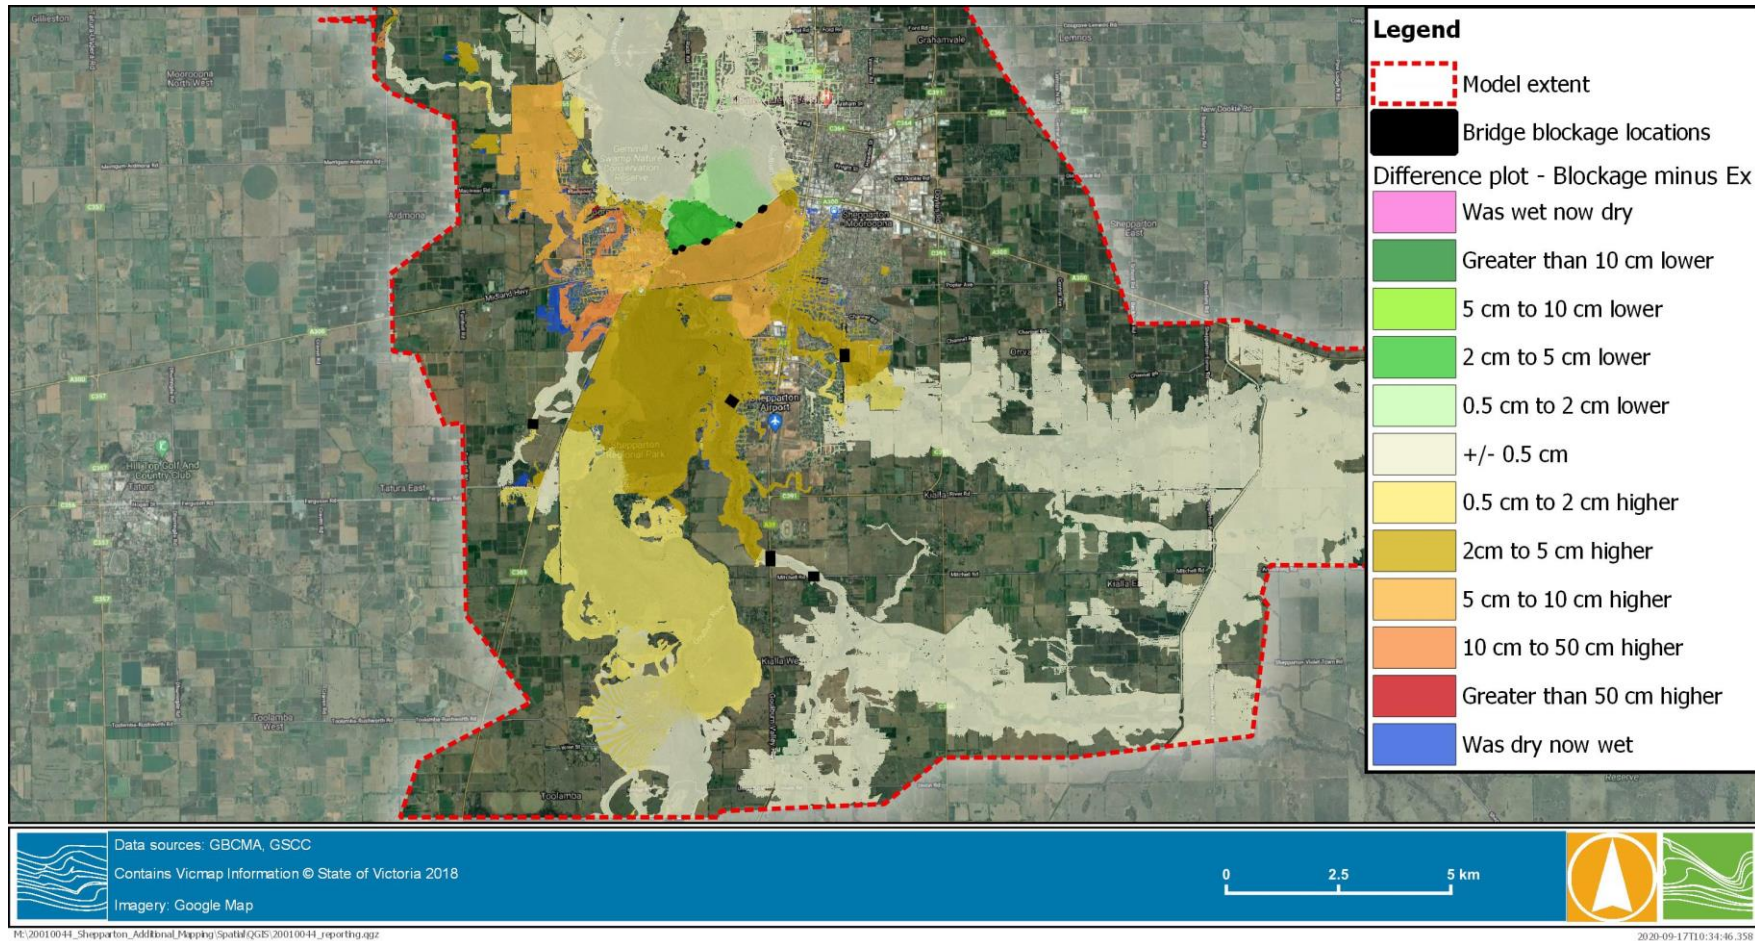
FIGURE 7-2 DIFFERENCE PLOT BRIDGE BLOCKAGE ASSESSMENT 1% AEP GOULBURN RIVER

The assessment found several bridges had zero likelihood of blockage due to the factors outlined above. As a conservative approach, bridges openings across the Midland Highway Causeway were tested with 50% blockage to assess the potential flood impact. As a further conservative approach, all bridges listed below were blocked at the same time. To identify the impact of bridge blockages on flood risk, both the 1% AEP Goulburn dominant and 1% AEP Broken River dominant events were simulated with the proposed blockage levels. The maximum flood levels were then compared with existing conditions (0% blockage).

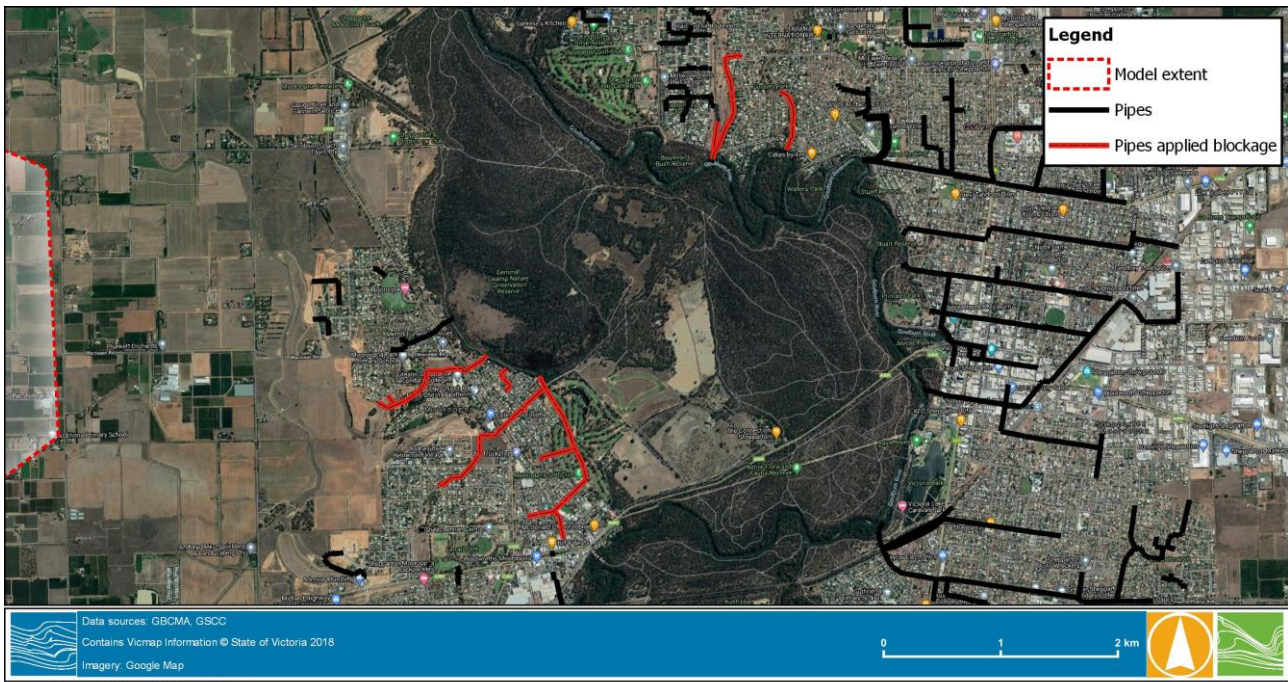
FIGURE 7-3 LOCATIONS OF PIPE BLOCKAGE

A pipe blockage assessment was conducted for several major pipe alignments within the urban areas as shown in Figure 7-3. These pipes were assigned a 100% blockage factor and modelled for a 1% AEP Goulburn River dominant flow. The pipe alignments identified were selected as they provide a connection back to the floodplain from urban areas.

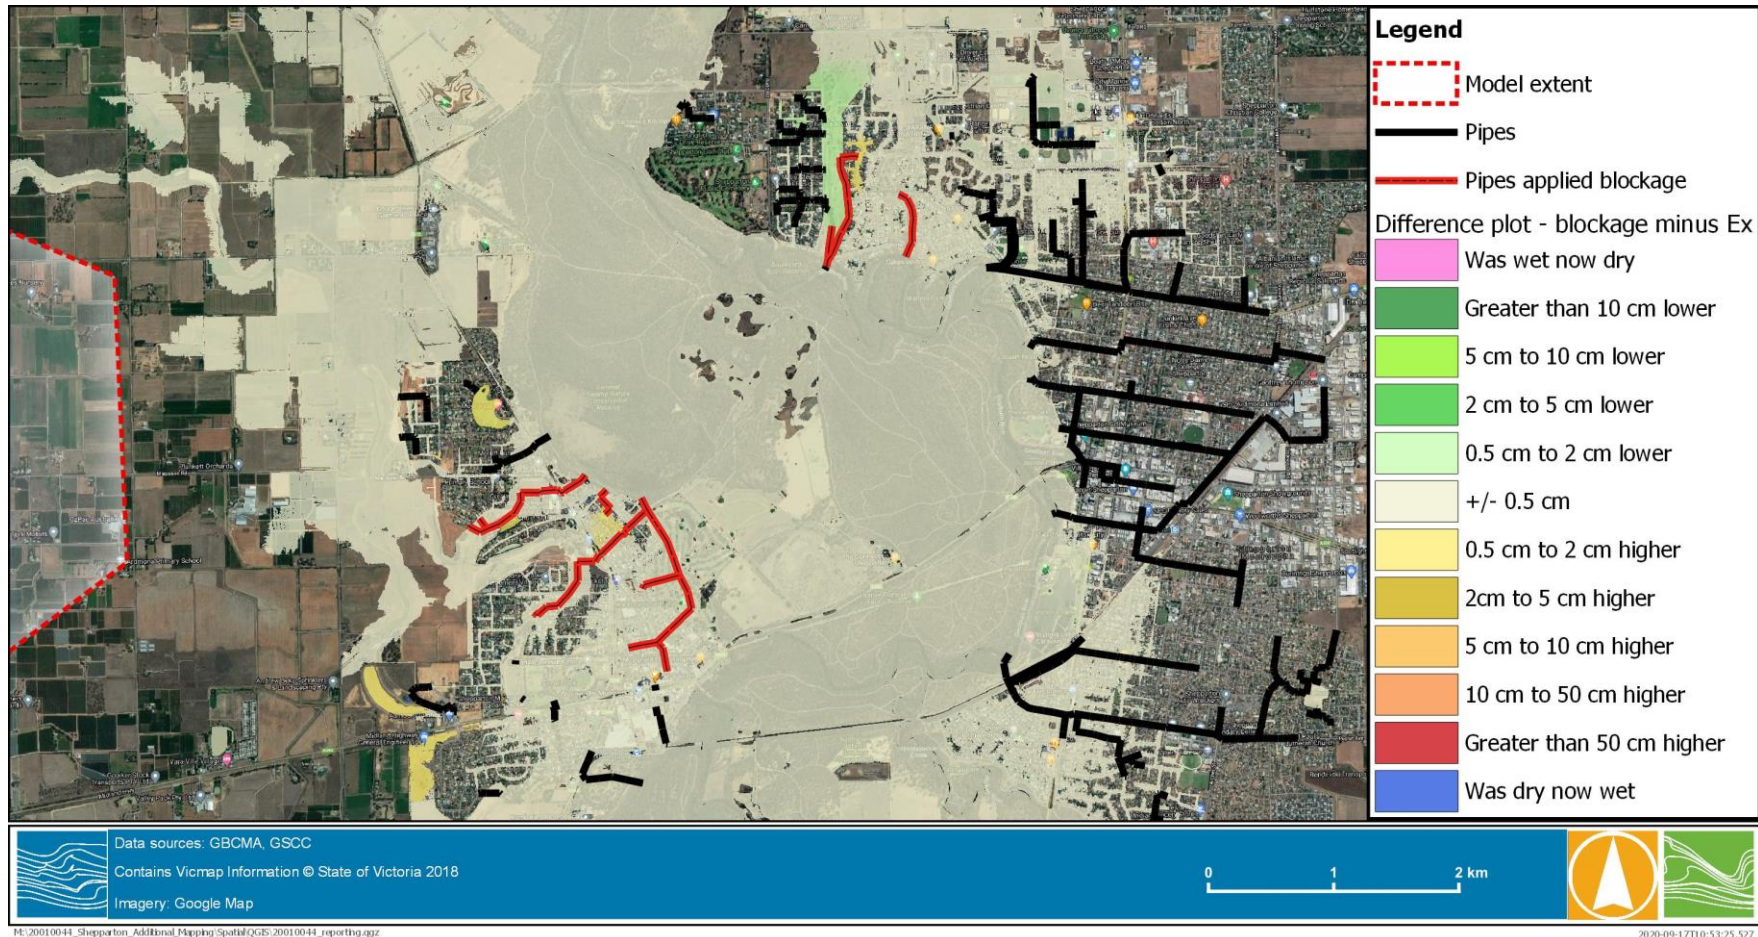
FIGURE 7-4 FLOOD LEVEL DIFFERENCE PLOT (CULVERT BLOCKAGE ASSESSMENT)

Figure 7-4 shows a water level comparison of “blocked” and existing conditions. The comparison shows blockage of these major pipes does not significantly impact peak flood levels. This is a result of the relatively minor capacity of the pipe network in comparison to the overland flow across the floodplain.

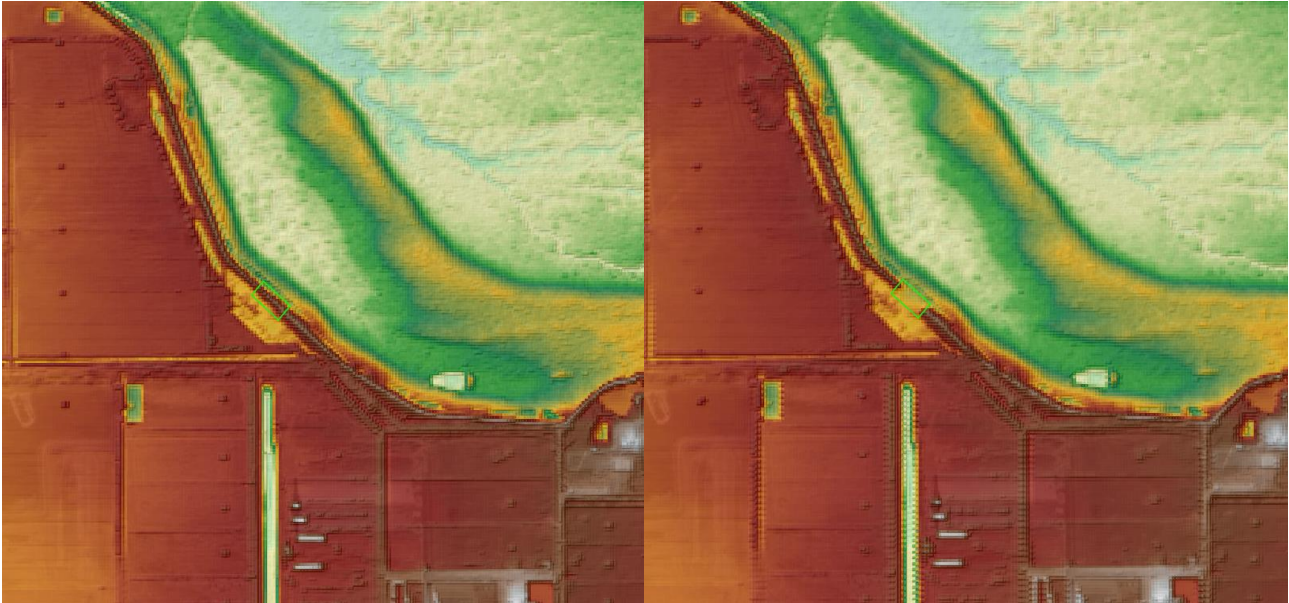
FIGURE 8-2 EXAMPLE OF REMOVAL OF LEVEE – LEFT: BEFORE, RIGHT: AFTER

To model the levee failure condition, the levees at these locations were removed from the topography for a distance of approximately 60 metres. An example of the model topography after removing the levee is shown in Figure 8-2.

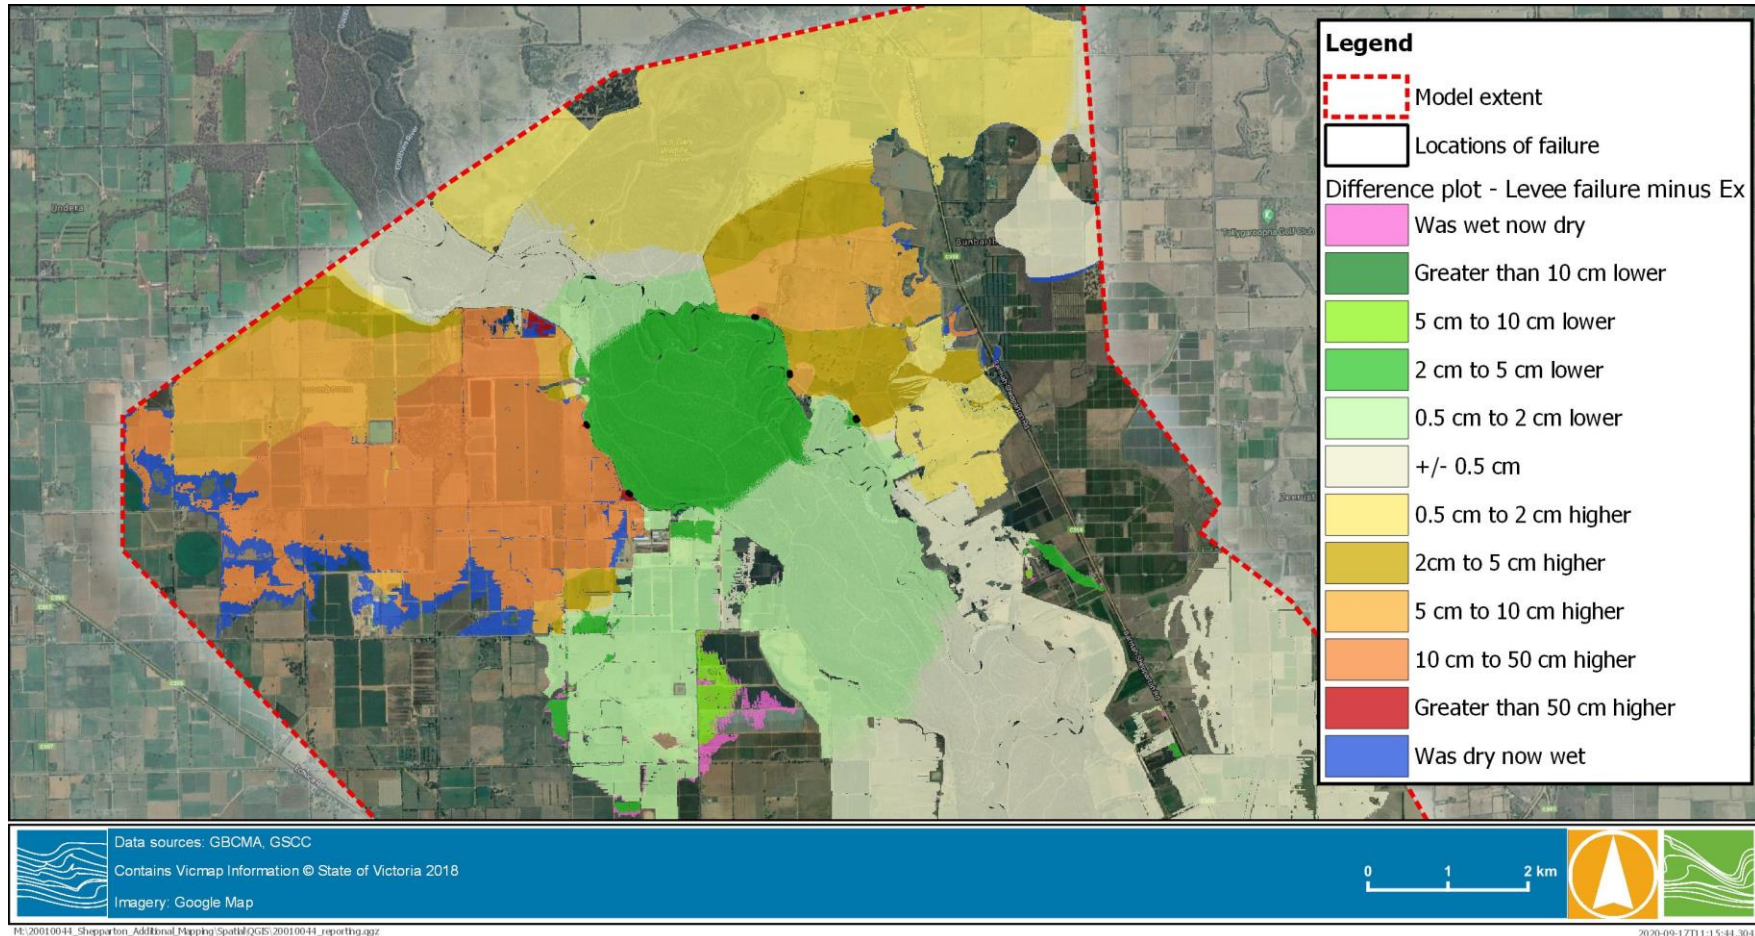
FIGURE 8-3 FLOOD LEVEL DIFFERENCE PLOT – LEVEE FAILURE SCENARIO MODELLING

Figure 8-3 shows a comparison of peak 1% AEP flood levels between the levee failure scenario and existing conditions. A large area of private property has increased in peak flood levels by 20 cm to the west of the Goulburn River while the increase to the east of the Goulburn River side is relatively minor. Results demonstrate the impact of the levee failure at these locations is relatively minor and localised. These levees are overtopped in a 1% AEP event. Levee breaches are likely to show more of a significant impact on flood levels and extents for flood events with flows less than 40,000ML/d.

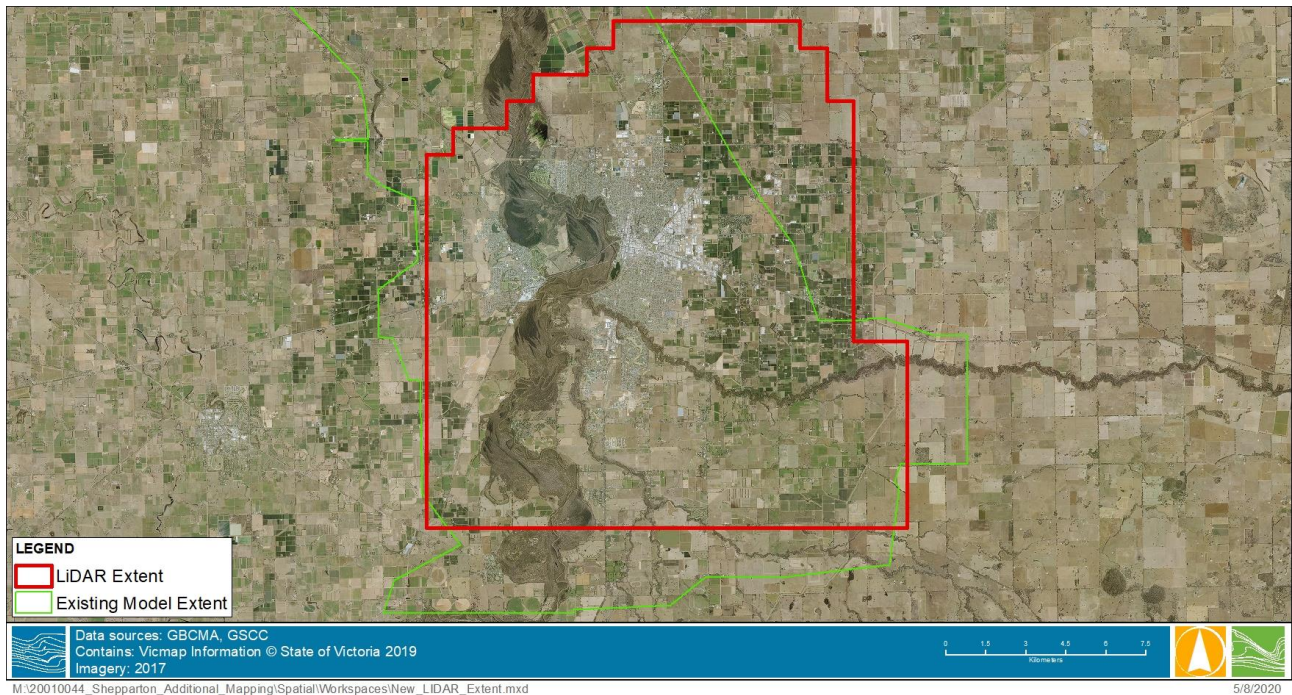
FIGURE 10-1 2019 LiDAR EXTENT

The Goulburn Broken Catchment Management Authority (GBCMA) and the Greater Shepparton City Council (GSCC) were able to secure LiDAR to be flown for the Shepparton and Mooroopna Townships in late 2019. This LiDAR is a significant update on the previously available LiDAR captured in 2011 as part of the Index of Stream Condition (ISC). The LiDAR was captured as part of the Department of Environment, Water, Land and Planning's (DELWP) CIP program. Full metadata and capture details are available via the GBCMA or DELWP. The LiDAR dataset was provided to Water Technology as a 1m resolution Digital Elevation Model (DEM) which covers much of the town as shown in Figure 10-1.

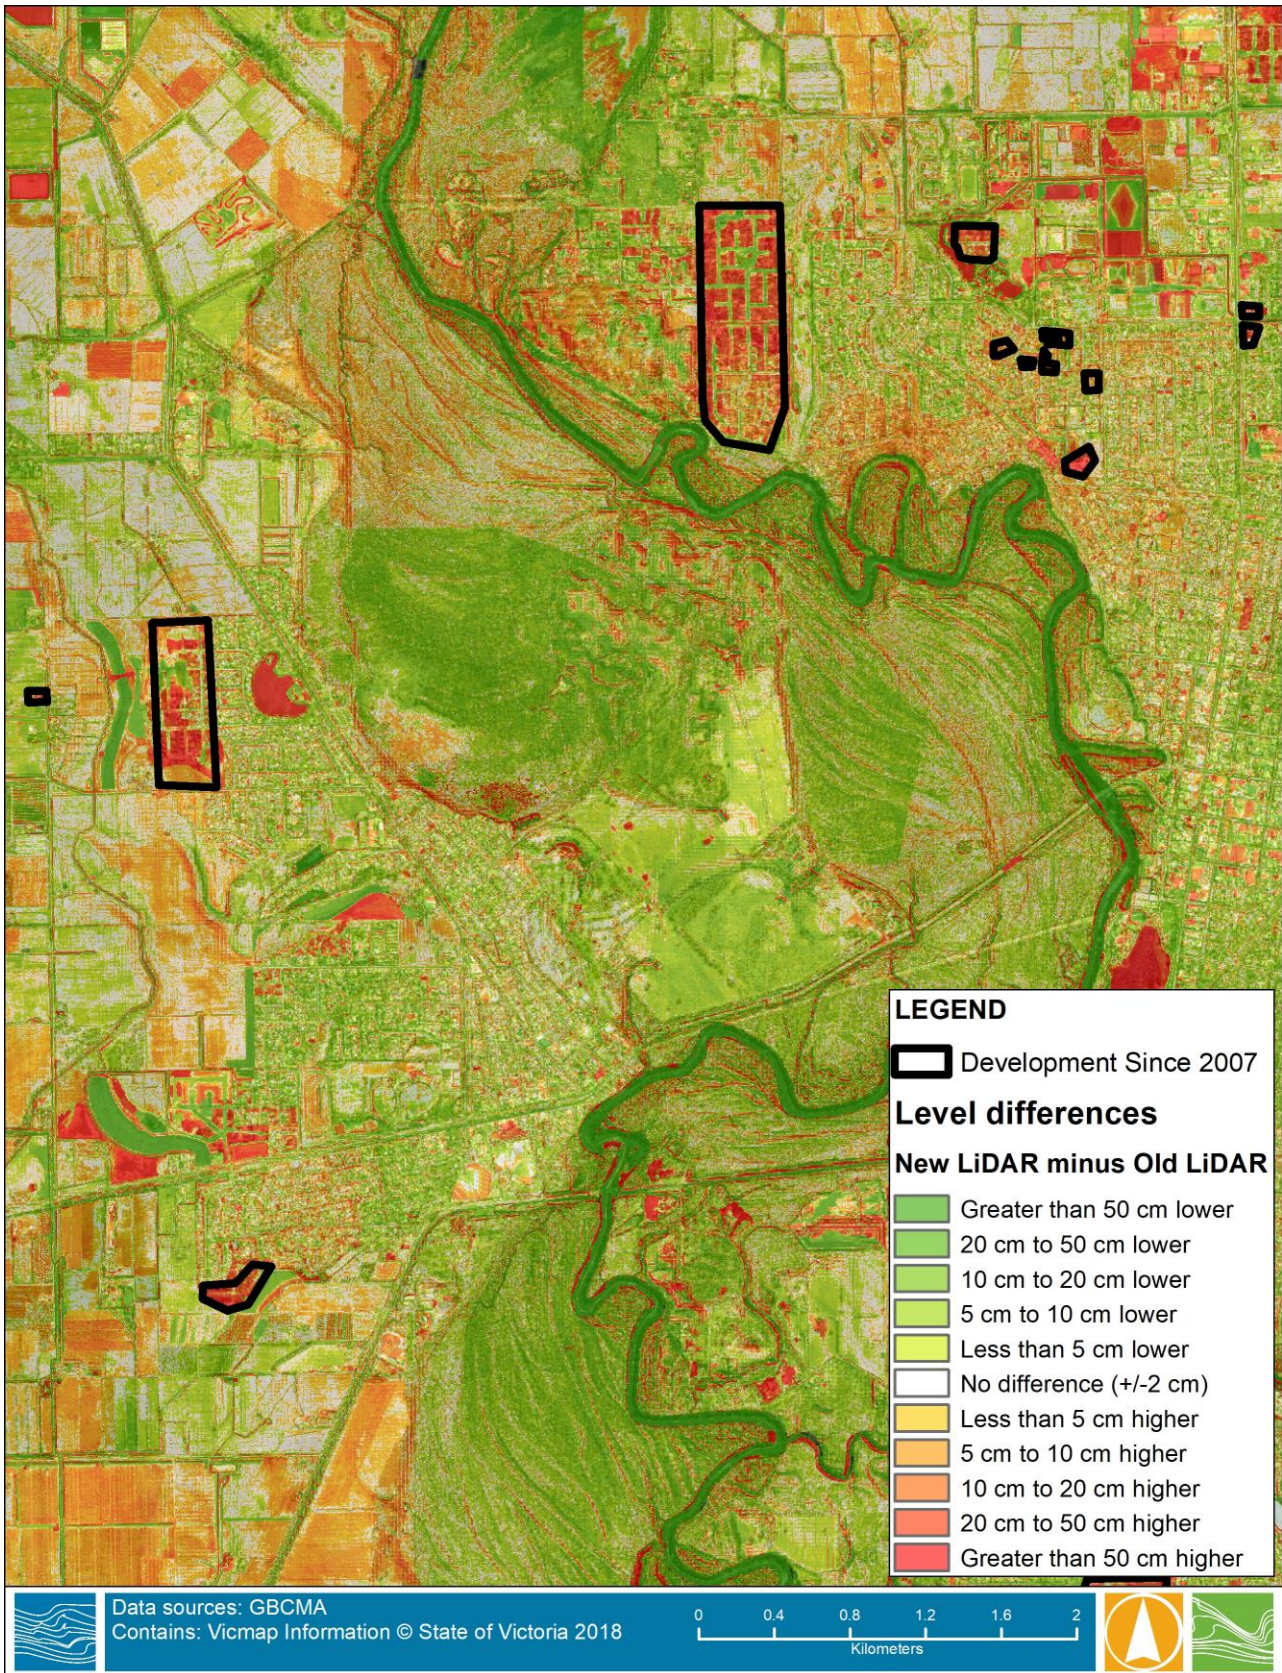
FIGURE 10-4 COMPARISON BETWEEN NEW LIDAR AND OLD LIDAR – NORTH OF MIDLAND HIGHWAY

The new 2019 LiDAR was also compared with the old LiDAR datasets used in previous modelling. Difference plots were created to compare the differences in elevation between new LiDAR and the old LiDAR as displayed in Figure 10-4 and Figure 10-5.

The areas of development since the previous LiDAR was flown (2007 and 2011) identified previously were captured in the new LiDAR. It should be noted that previous LiDAR flown was after a flood event in 2017. It is not surprising to see the new LiDAR shows lower levels at most of the floodplain areas and the river channel than the old LiDAR as the new LiDAR was captured during dry season. As a result, it is believed that the new LiDAR provides better and more accurate representation of the floodplain topographic features.

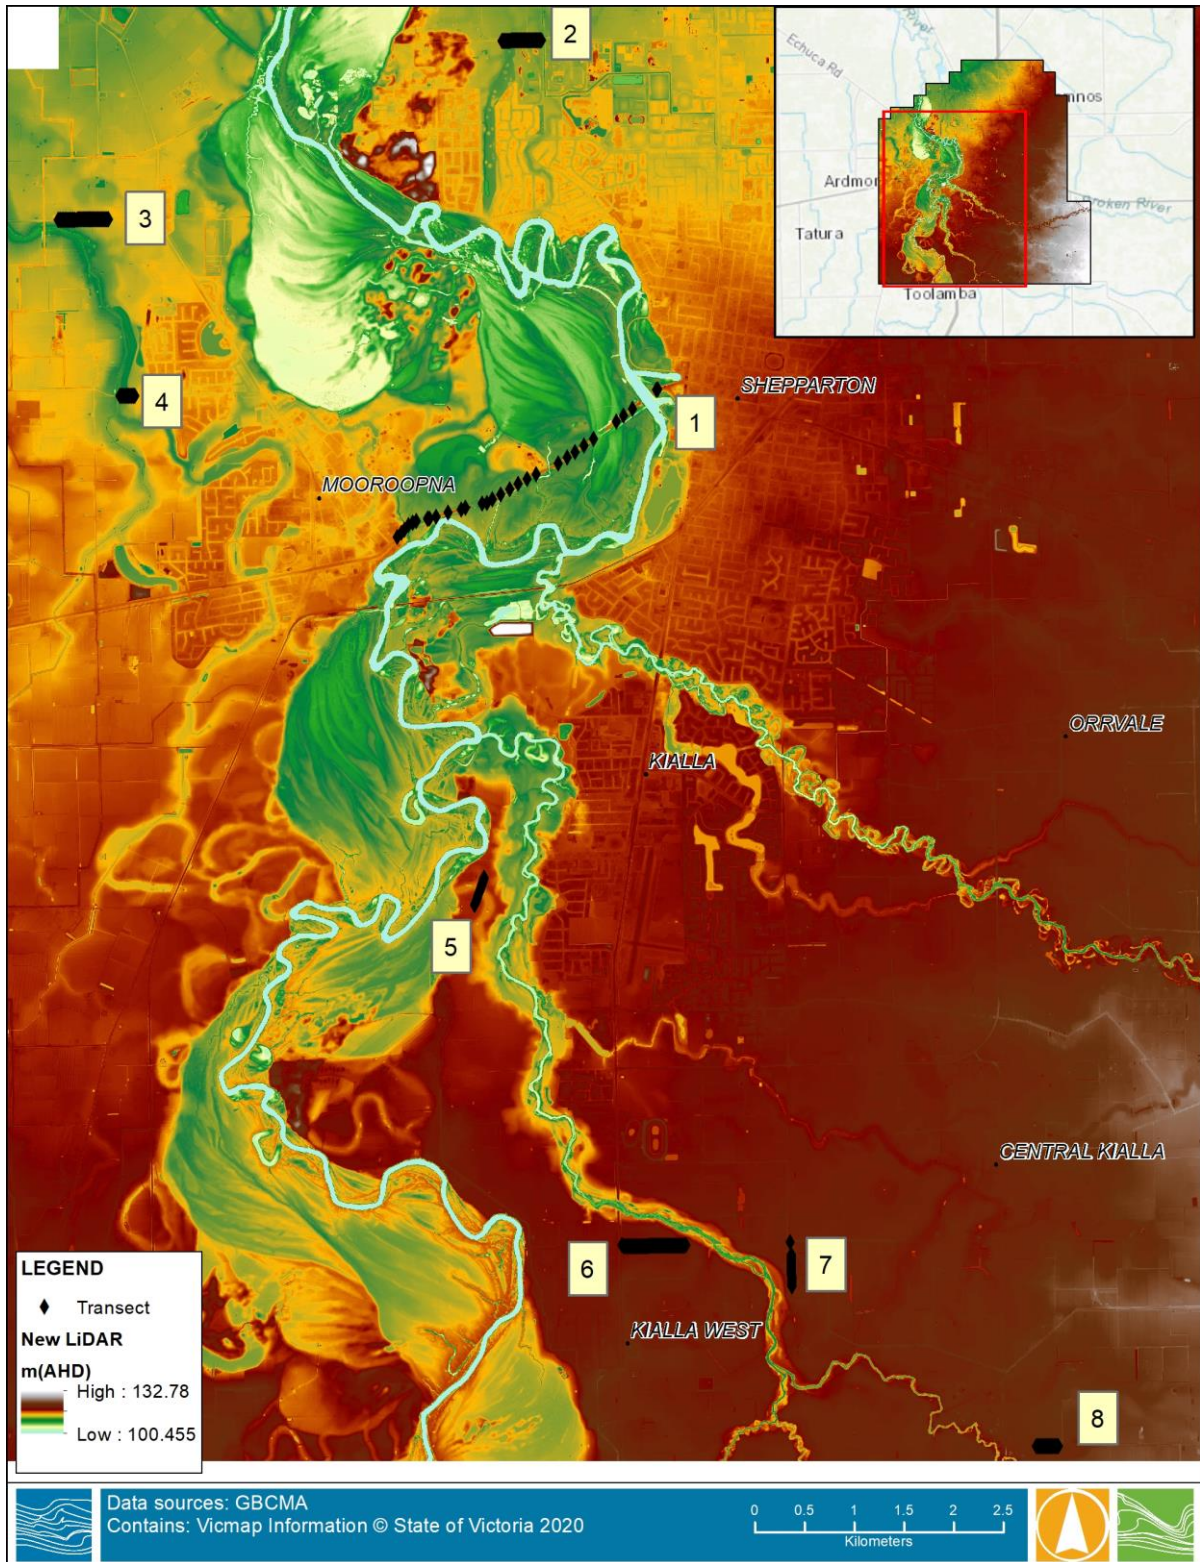
FIGURE 10-6 ADDITIONAL SURVEY TRANSECT LOCATIONS

Seven new road survey transects were made available by GBCMA in late 2020 to further strengthen the verification and check for any spatial bias in the accuracy of the new 2019 LiDAR. The locations of the seven new transects (transects 2 – 8) are shown in Figure 10-6 along with the original transect (1).

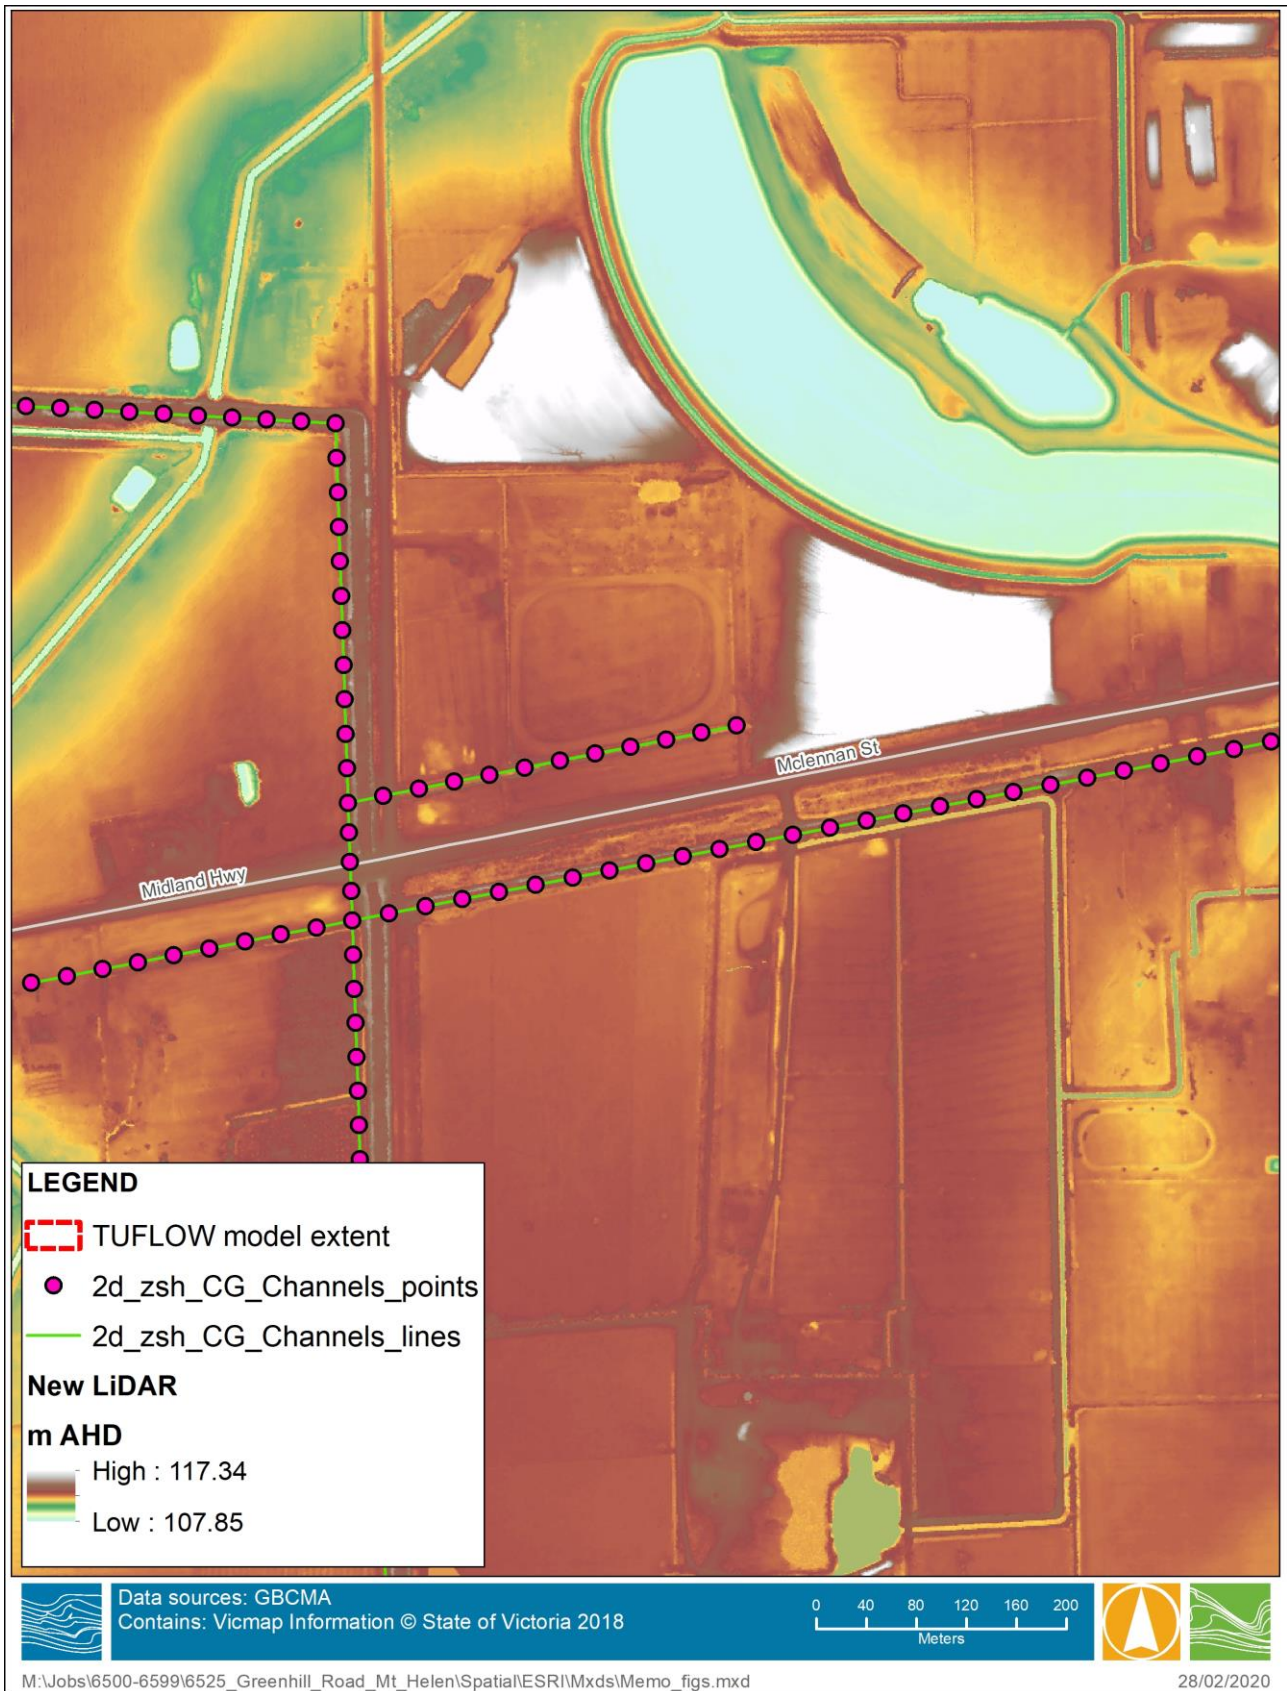
FIGURE 10-8 EXAMPLE OF “2D_ZSH” LAYERS FOR THE BANK OF IRRIGATION CHANNELS

A series of “2d_zsh” layers to ensure the model capture topographic features, such as the top of the bank of irrigation channels. With the update of new LiDAR, these “2d_zsh” layers need to be updated according to the new LiDAR values. The “2d_zsh” point layers were buffered to circles by 5m in diameter and the highest elevations with each circle were captured from the new LiDAR. These elevation values were used to update the existing values within the “2d_zsh” point layers. An example of “2d_zsh” layers for irrigation channels near Midland Highway is shown in Figure 10-8.
