## Lower Goulburn Floodplain Rehabilitation Scheme

ASSESSMENT OF FLOOD RISK TO THE TOWNSHIP  
OF BARMAH AND PRELIMINARY FLOOD  
MITIGATION REVIEW

- Final
- 12<sup>th</sup> August 2008

CATCHMENT  
MANAGEMENT  
AUTHORITY

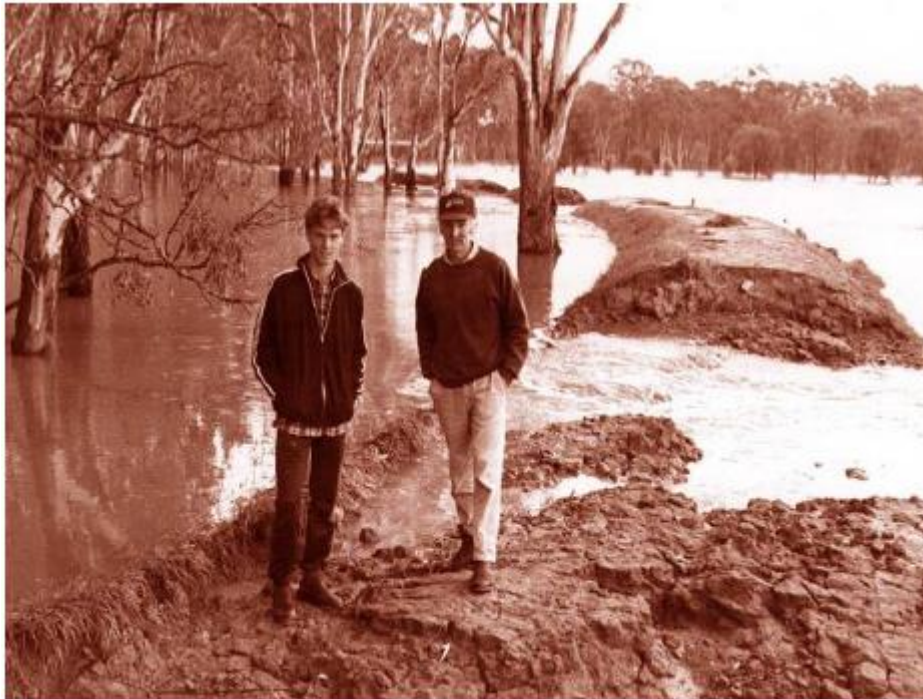
eight separate locations on the north bank in the proximity to McCoys Bridge. Levees were also breached at Madowla Park and downstream of Hancocks Outlet. Figure 2-1 shows a section of levee with a number of failures that occurred during the October 1993 floods.

- **Figure 2-1 Goulburn River levee failures during the October 1993 flood**

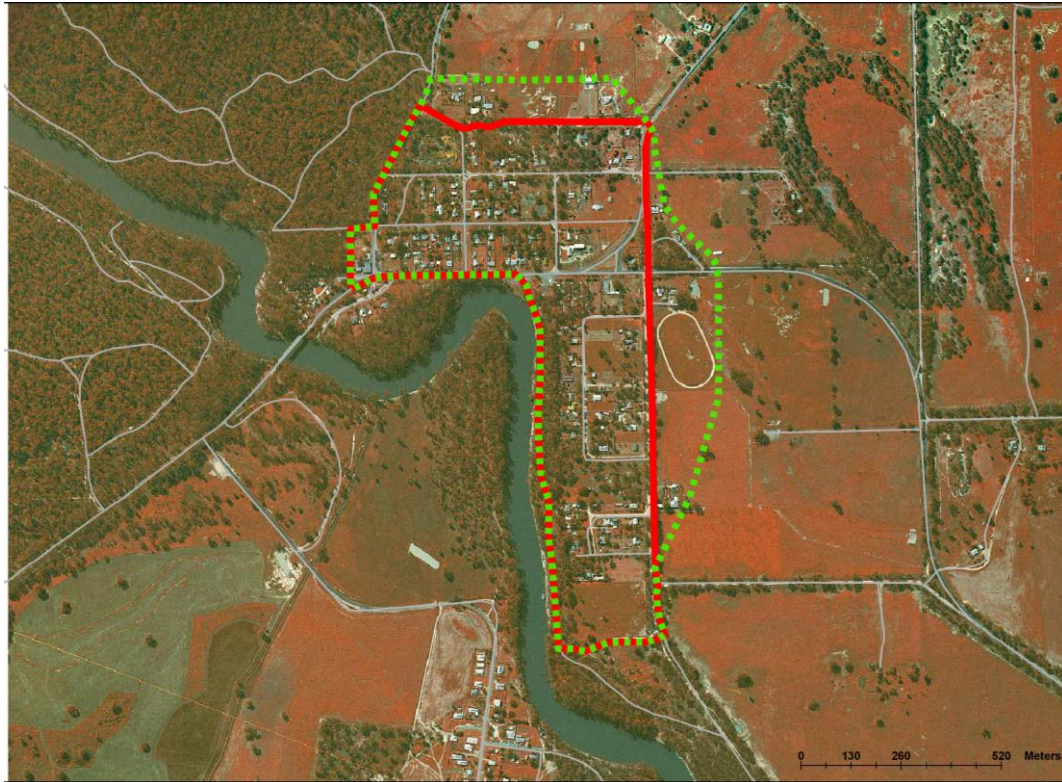
■ **Figure 5-1 Proposed levee alignments for Barmah township flood mitigation (alignment 1: red solid line; alignment 2: green dotted line)**

Both levee alignments cross existing roads at four locations. These locations must remain open to traffic, either the roads must be raised to the equivalent levee crest level, a drop bar arrangement installed or sandbagging (perhaps the cheapest alternative) carried out in times of flood.
